Catholic Community Service - Building Design and Renovation for Children's Behavioral Health and Family Services

CCS APARTMENT BUILDING CONDITION SURVEY

JANUARY 2013

The following report describes the condition of the existing apartment building at 1805 Glacier Highway, Juneau Alaska, and the feasibility of converting the building to serve as program space for the Child Care and Family Resources (CCFR) Division of Catholic Community Services (CCS).

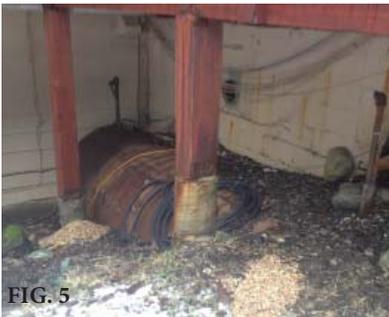
There is an abandoned oil tank, approximately 1,500 gallons under the elevated deck at the east end of the building. We have been told it holds approximately 40 gallons of old fuel (fig. 5).

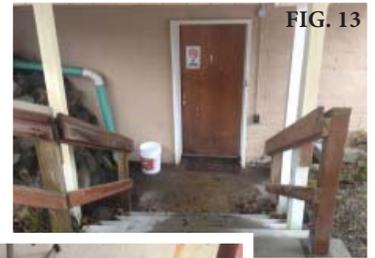
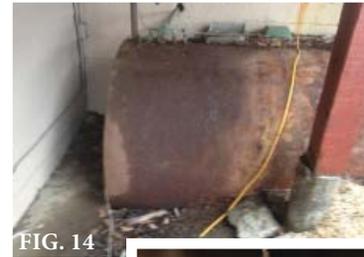
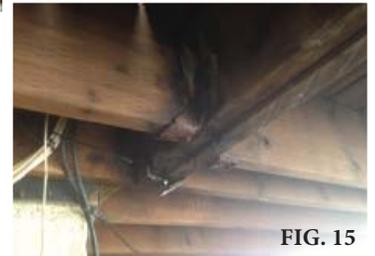
1. The rockery retaining walls flanking the basement entry doors do not appear to accommodate drainage from the recessed area outside (fig. 13).
2. The south and east end of the site immediately outside the building is saturated and provides unsafe footing for exit doors on that side of the building.
3. The abandon fuel tank does not appear to have been properly decommissioned and should be removed (fig. 14).
4. The decks on the north side of the building were built with standard galvanized framing anchors and have corroded to the point that they are unsafe and in danger of collapse. They are not properly anchored to the existing building wall at the ledgers (fig. 15).

1. Remove existing wood decks and replace with treated wood decks properly anchored to the existing structural wall, with separation membrane at any galvanized hardware, or replace such hardware with stainless steel.
2. Excavate and remove the existing abandoned oil tank.
3. Excavate around the building, install waterproof membrane and insulation below grade. Install drainage piping daylighted to grade at the low side of the site
4. Replace water service to building with service capable of supporting a fire sprinkler system.
5. Provide walkway at the south side of building to provide egress from exit doors in that area to an appropriate egress way.
6. Reconfigure rockery retaining walls at west elevation, and provide drainage for the area.

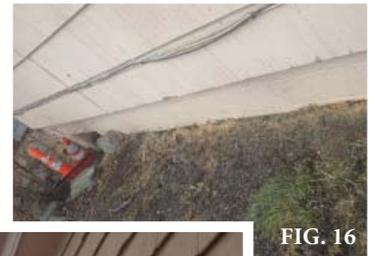
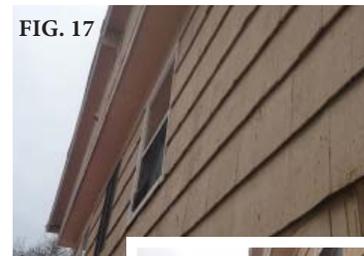
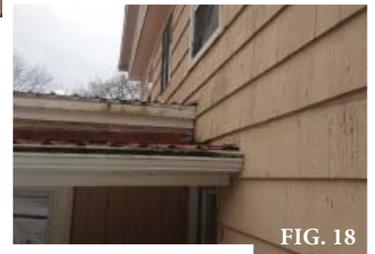
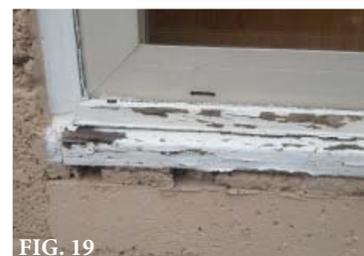
1. There does not appear to be a waterproof membrane on the exterior side of the CMU retaining wall, nor evidence of foundation drainage system. Given the large amount of groundwater on the site, it is only a matter of time before water leaks into the basement, unless such leaks have already begun under the plywood subfloor (fig. 16).
2. The plywood shingle panels are decayed, warped have reached the end of their useful life (fig. 17).
3. The metal roofing is corroded and at the end of its useful life. Fascia trim is dryrotted roof gutters are damaged (fig. 18).
4. The roof and wall insulation is either non-existent or of minimal thickness.
5. The vinyl windows are in good condition, but the wood brick mold trims around them are dryrotted in some locations (fig. 19).

1. Remove and replace main entry canopy.
2. Remove and replace covered stair at the east elevation
3. Replace all exterior doors and windows.
4. Replace shingle panels siding with metal siding in a rain screen configuration.

5. Replace metal roofing with concealed fastener metal roofing, or use asphalt shingle roofing to avoid problems with falling snow.
6. Increase wall R value to R21, roof to R30, minimum.

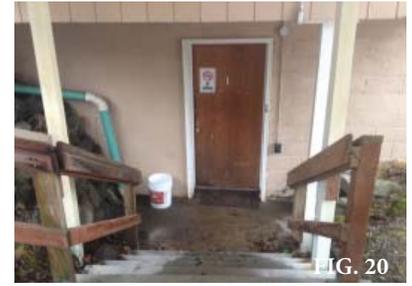
6. The metal doors and frames are rusted with frames exhibiting some deterioration (fig. 20).

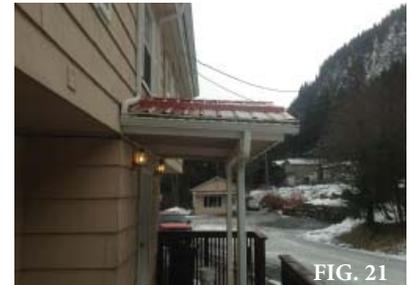
8. The entry canopy has begun to settle and is sagging away from the main building (fig. 21).

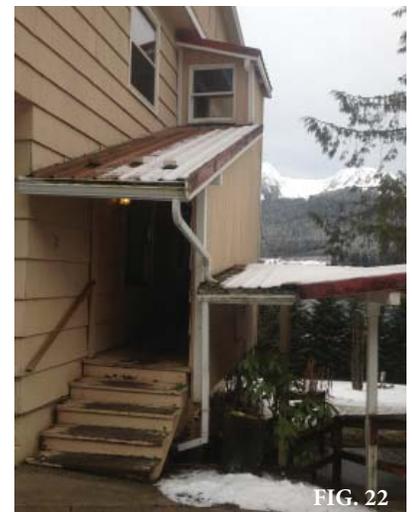
9. The covered stair on the east end of the building is settling and pulling away from the main building (fig. 22).

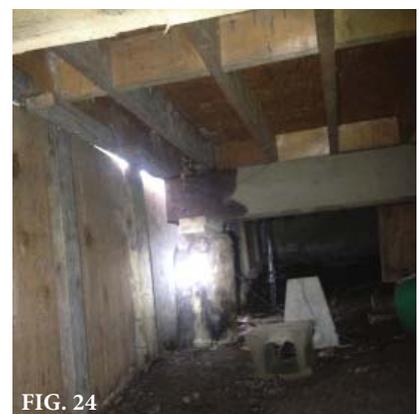
**FIG. 24**

The foundation appears to be a mix of treated and untreated timbers on various bases- rocks, pieces of concrete, and an occasional concrete pier (fig. 24). The timbers support 2x6 floor joists. The exterior siding is T-111 cedar plywood installed directly to wood studs. There is no insulation in the floor, we observed no insulation in walls. The roof was inaccessible.

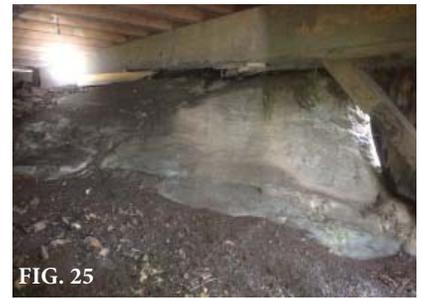
FIG. 25

The Annex building is badly deteriorated. The foundation is virtually non-existent, and is reported to have been jacked and leveled more than once in the past. There is noticeable settlement to the southeast corner. A large rock outcropping projects under the east side of the building, which projects into the beam space (fig. 25).

The original construction of the annex was very poor. The advanced state of deterioration and lack of foundation suggest that it would be simpler and more cost effective to tear down this portion of the building and replace it. The existing 500 gallon oil tank at the west elevation can be relocated to support the new renovation.

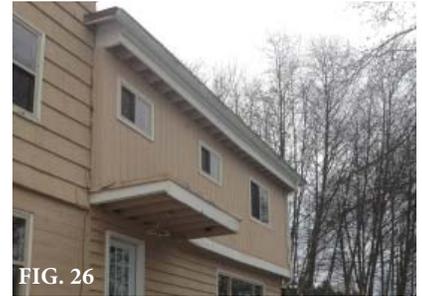
FIG. 26

The walls exhibit dryrot at base and at roof transitions due to the unorthodox method of construction. There is also dryrot present in windows frames and siding (fig. 26).

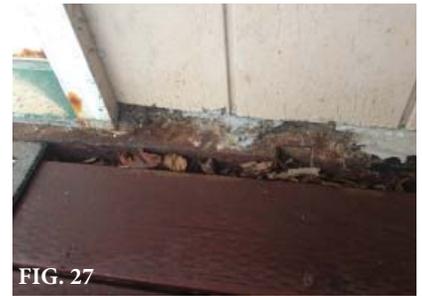
FIG. 27

The canopy and wood deck at the north side entry door was simply nailed to the plywood substrate. Not only have the galvanized joist hangers deteriorated, but it is likely that dryrot is occurring where the deck and canopy attach to other structure (fig. 27 & fig. 28).
