Ouzinkie - Mahoona Lake Dam Repair and Replacement

FIELD INSPECTION REPORT MAHOONA DAM (AK00207)

Field Inspection Report
Mahoona Dam AK00207
6/10/2011

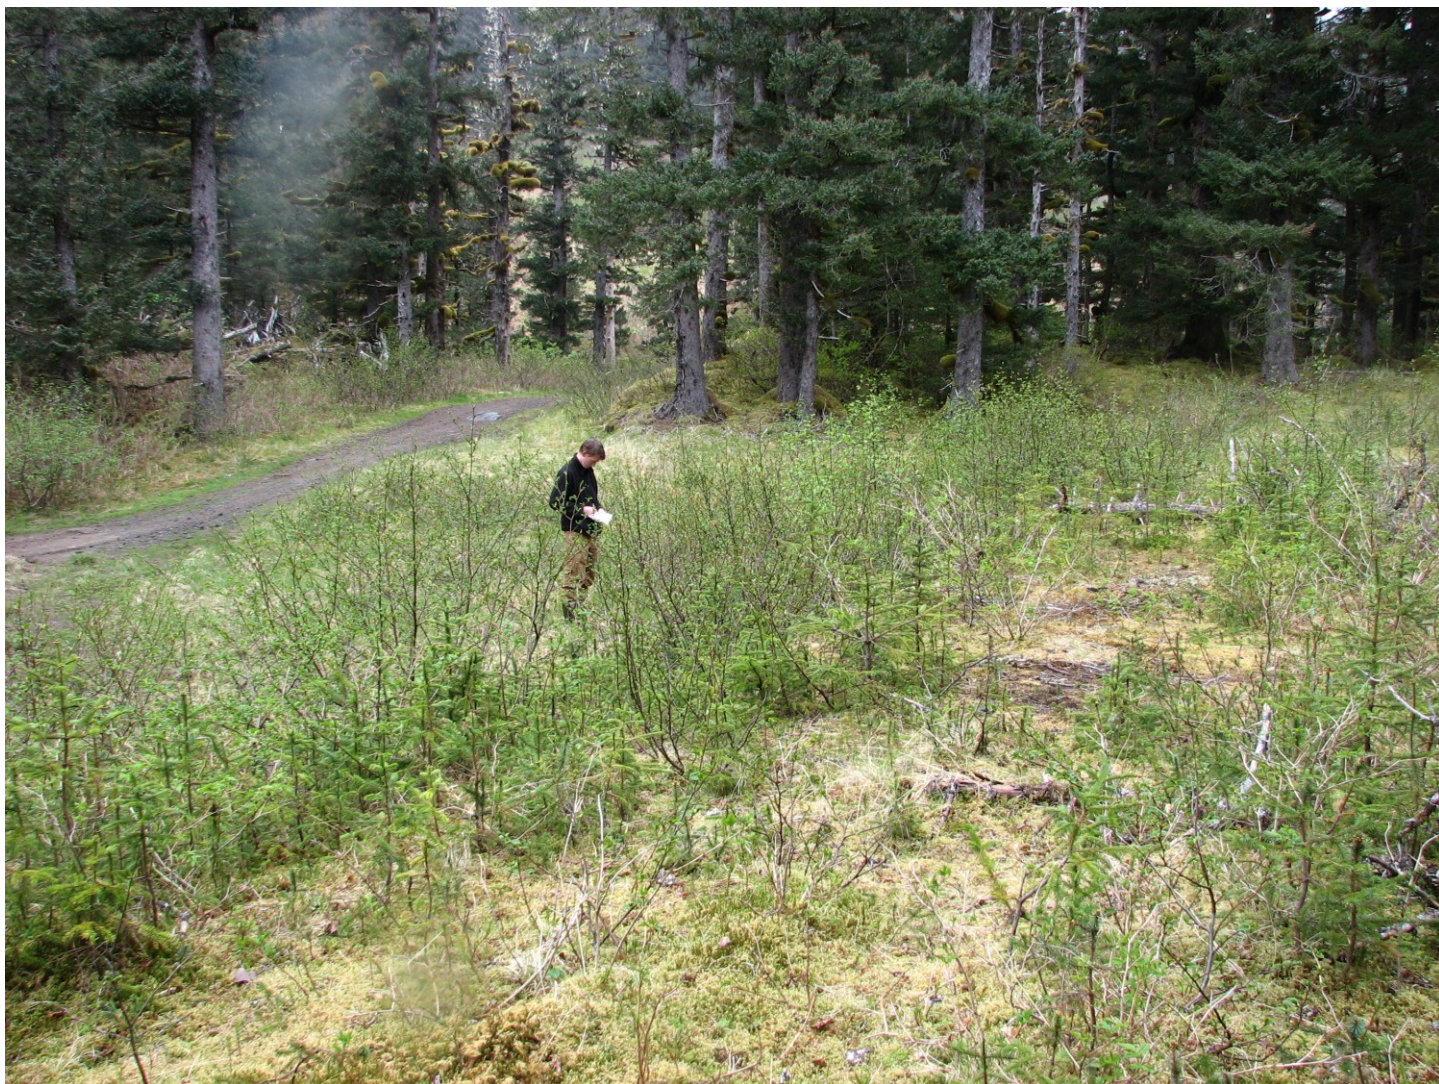
PHOTO A-1
SADDLE DIKE

There was no evidence of seepage or slope instability at the saddle dam. Woody growth was present on the dike, which can be seen in Photo A-1.

- Clear brush from the embankment faces and directly downstream of the timber section.
- Remove woody debris from around the spillway.
- Regularly monitor the large leak in the face lagging around the small outlet pipe.
- Monitor the spillway undercutting especially after high flow events.
- Report any significant changes in the performance of the dam to Dam Safety.
- Retain a qualified engineer to perform a Periodic Safety Inspection on the Mahoona Dam.
- Develop a plan to mitigate the hazards posed by the deficiencies identified in the PSI report and submit an application to Dam Safety for a *Certificate of Approval to Repair, Modify or Construct a Dam* as appropriate.

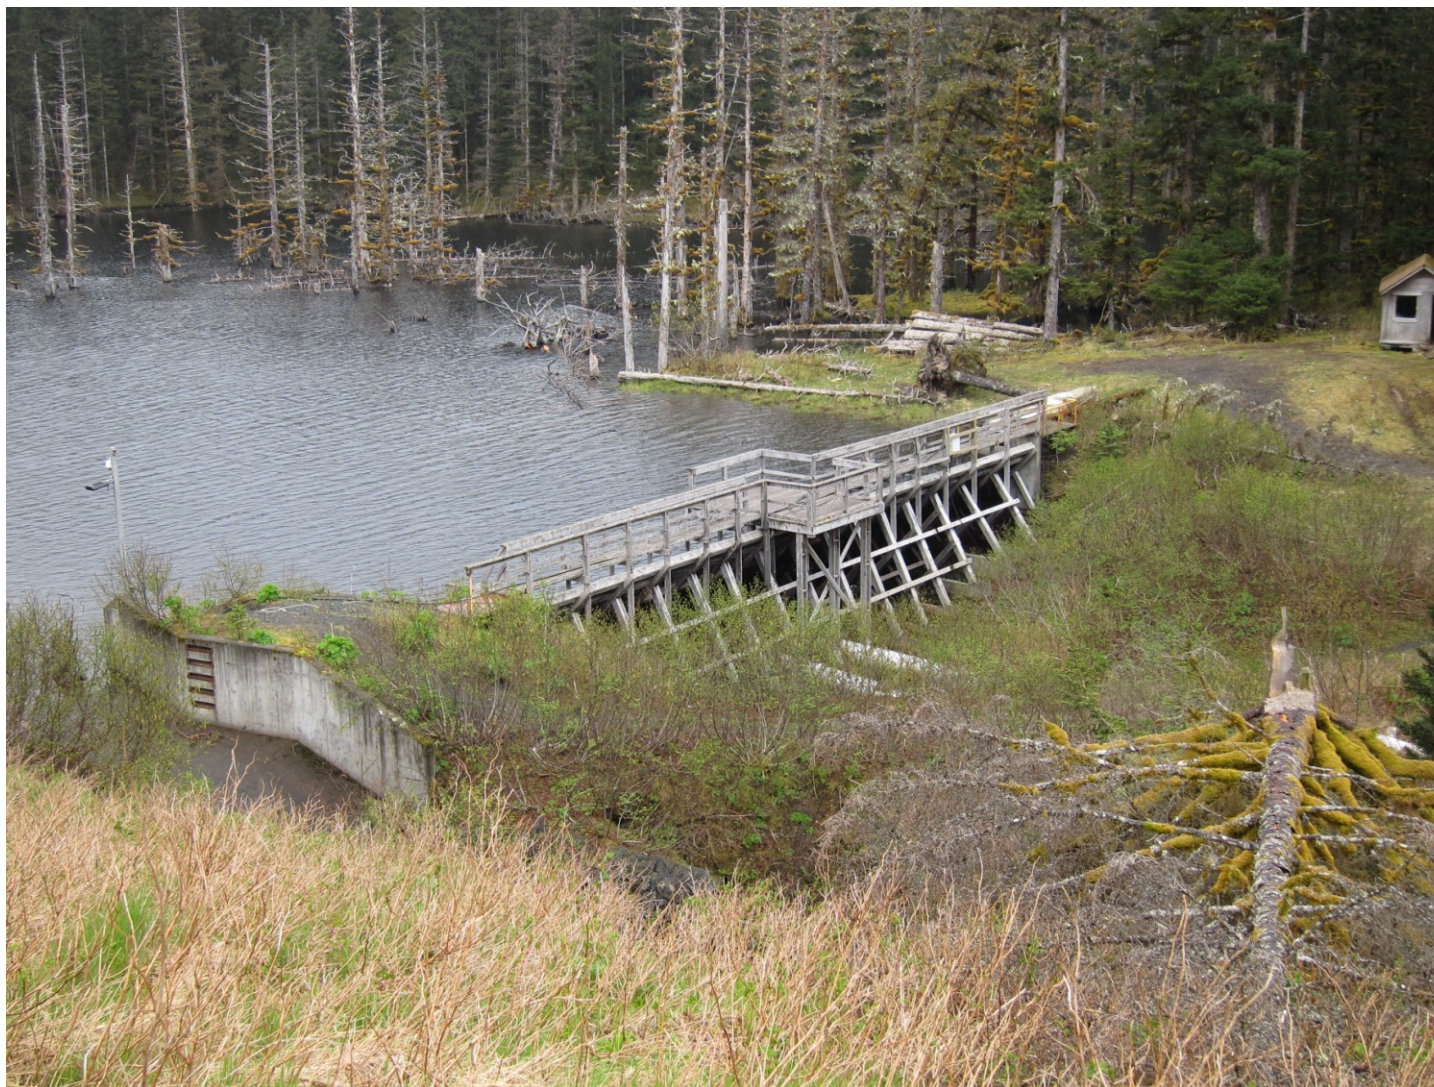
PHOTO A-2
MAHOONA DAM

The timber buttress dam section is the longest portion of the Mahoona Dam and can be seen in Photo A-2.

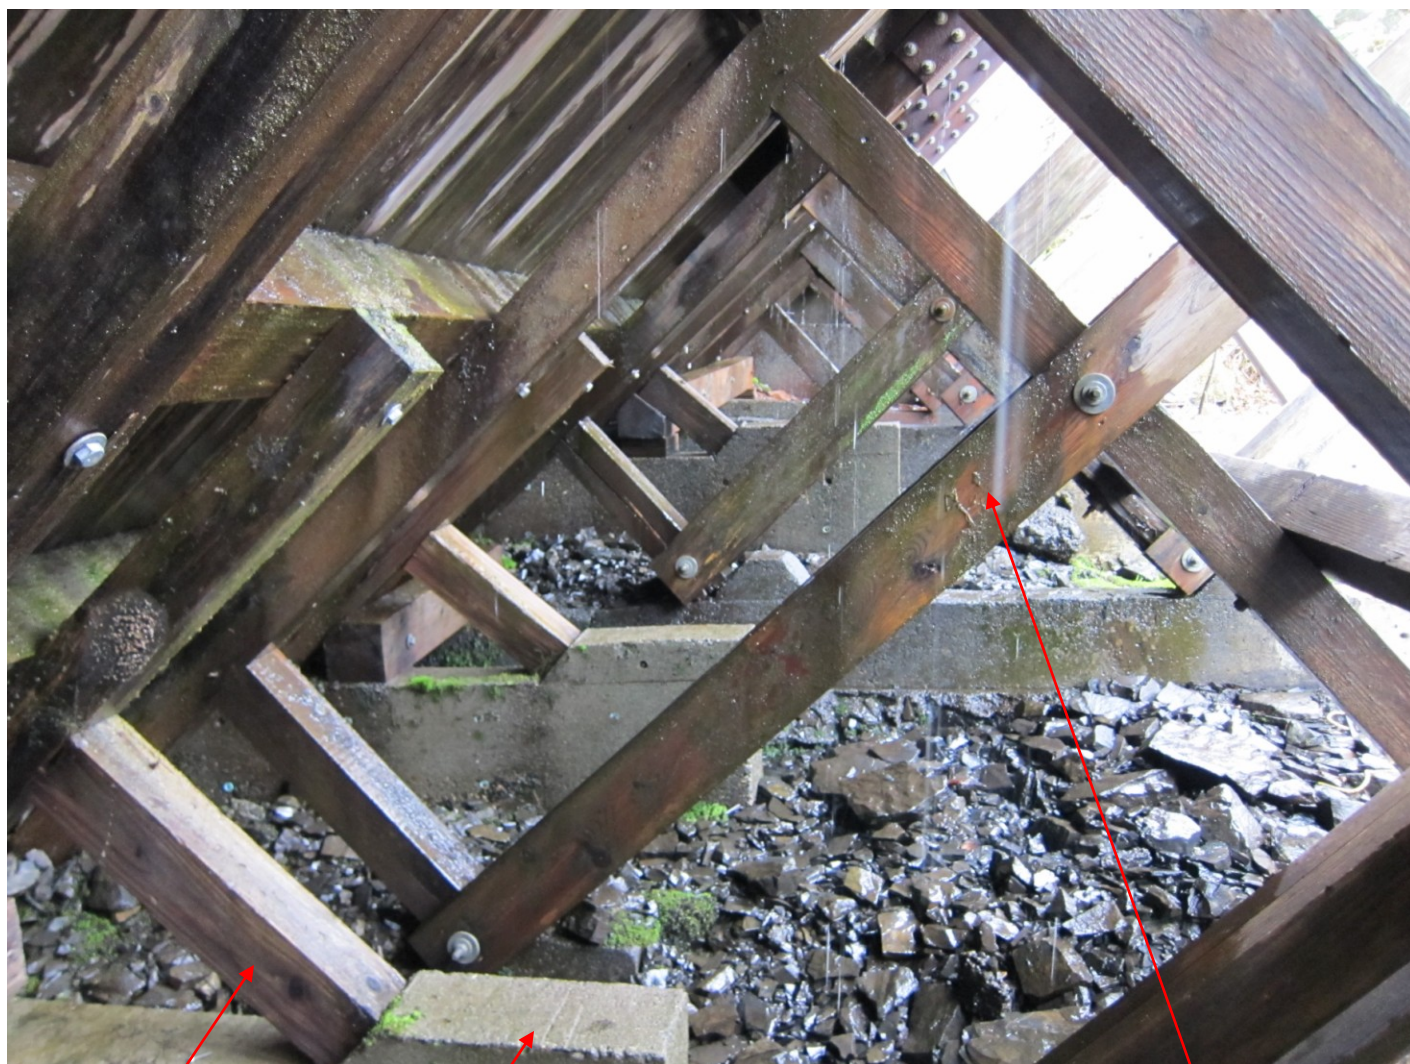
The wooden structural members of the Mahoona Dam did not appear to be treated with creosote or any other obvious material to inhibit deterioration. A significant portion of the structural members were observed to be very damp due to persistent flow through small seeps in the dam face. The lagging and studs appeared to be nearly saturated up to the current water surface elevation, the wales and the bottom two rows of struts were very wet, and the long cross-members were wet over half their length due to dripping water, as shown in Photos A-3 and A-4.

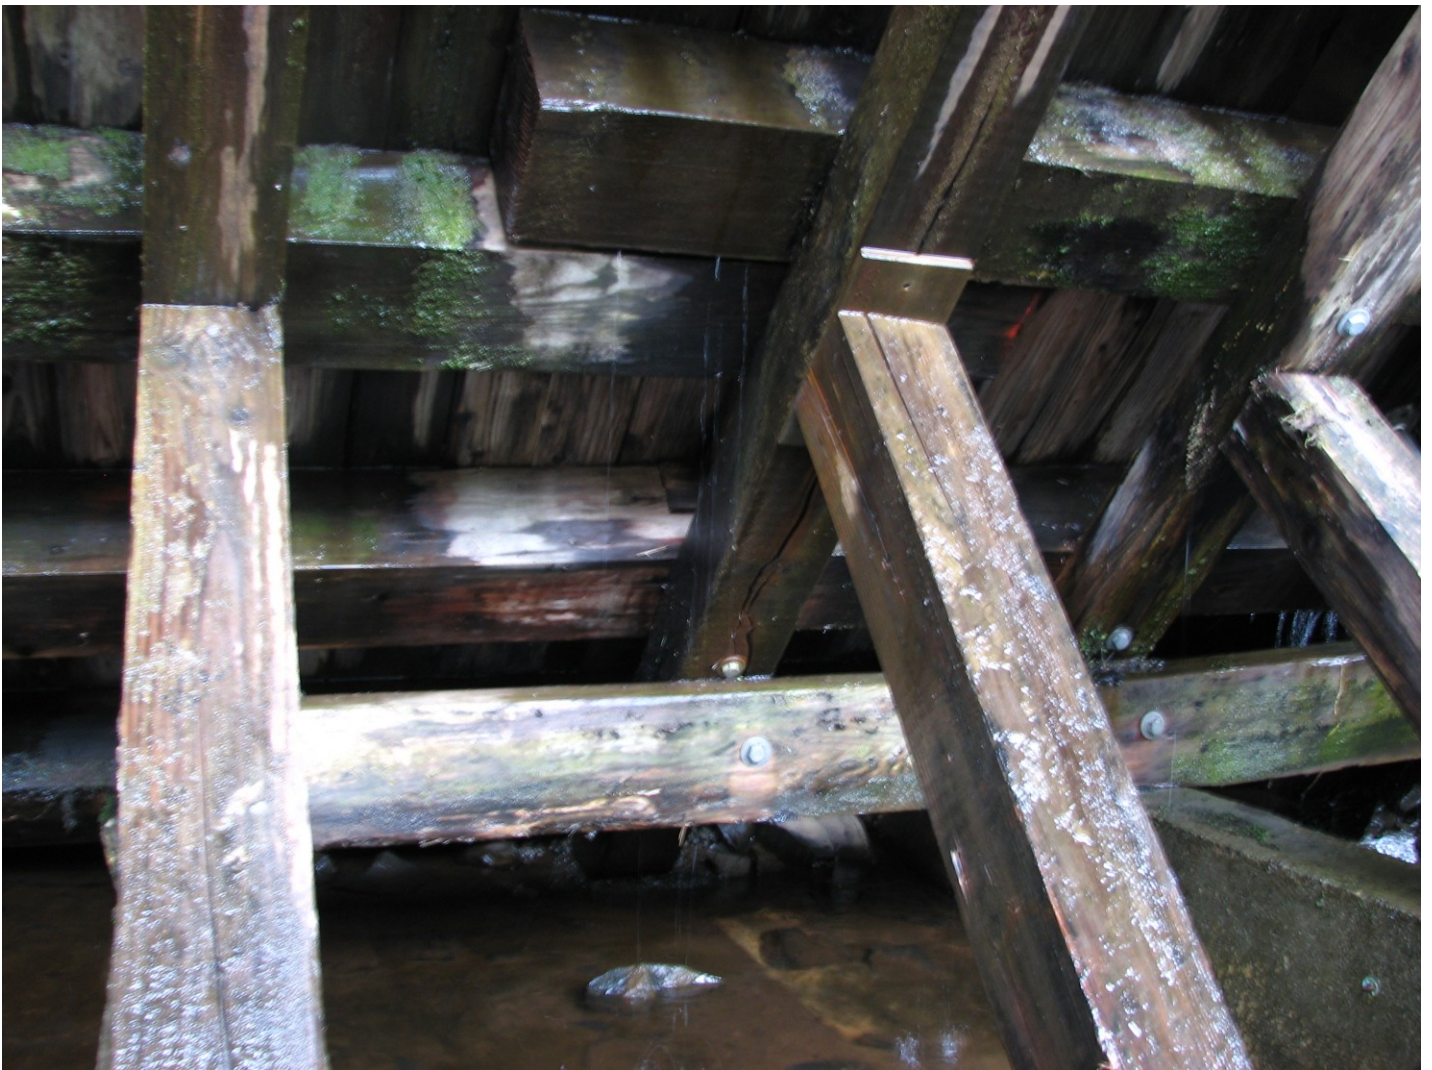
PHOTO A-5
SPLIT STRUT AND WALE

Splitting was observed in several of the wales and lower struts. The damaged wales were splitting longitudinally on the downstream face in line with the bolted connections, though some had complimentary splitting on the perpendicular face, seen in Photo A-5. The damaged struts were primarily in the shortest row and were splitting where they butted against the wales. In general the studs did not exhibit obvious signs of deterioration, but several of the very wet studs supported moderate moss growth. The lagging was very damp and water was observed seeping through the entire face below the reservoir elevation. With the exception of one location discussed below, the lagging appeared to be in fair condition.
