Alaska Department of Natural Resources
Dam Safety and Construction Unit

Field Inspection Report
Mahoona Dam AK00207
6/10/2011

MEMORANDUM

SUBJECT: Ouzinkie Dam Replacement Conceptual Alternatives

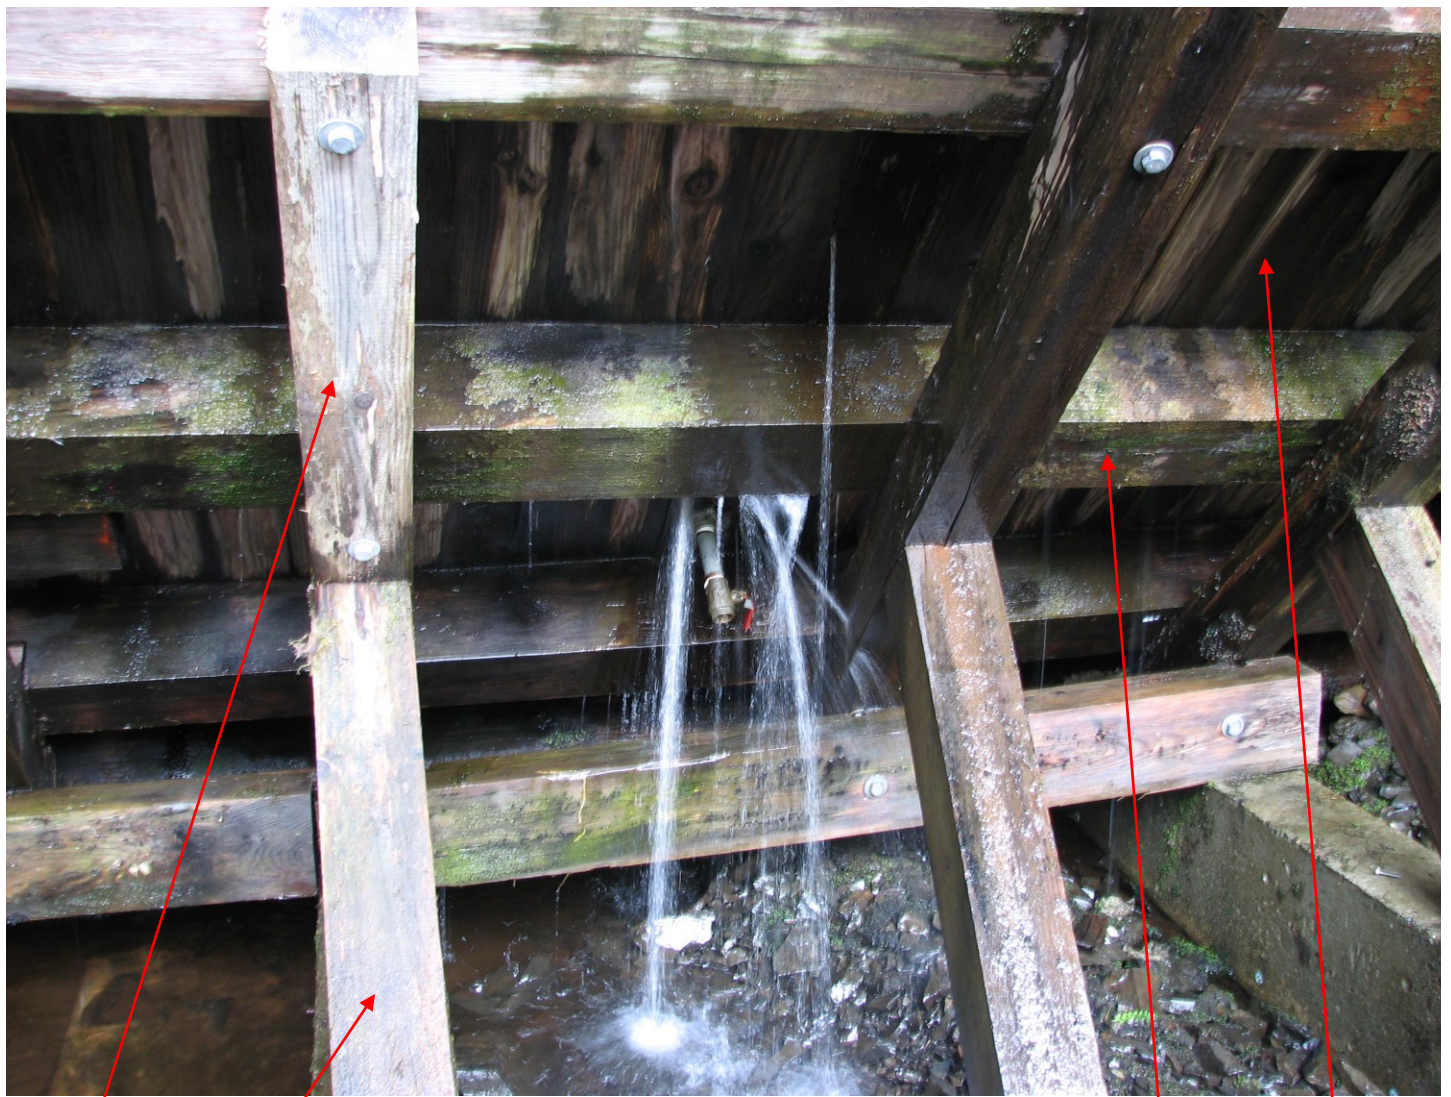
PHOTO A-6 OUTLET PIPE

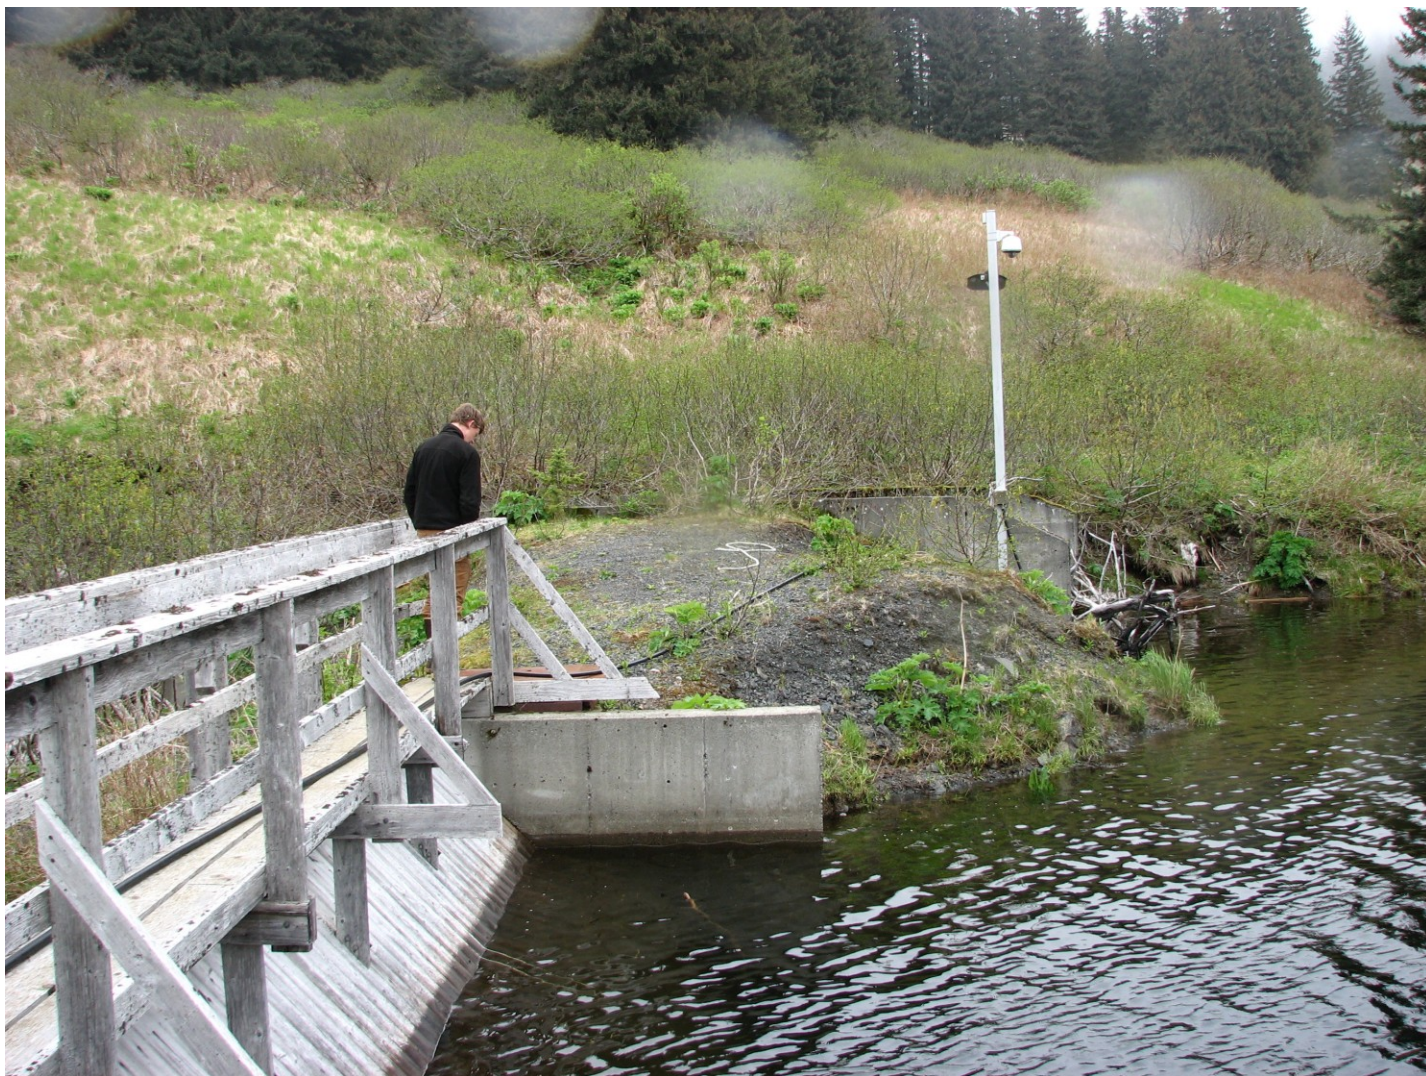
PHOTO A-7
RIGHT EMBANKMENT SECTION

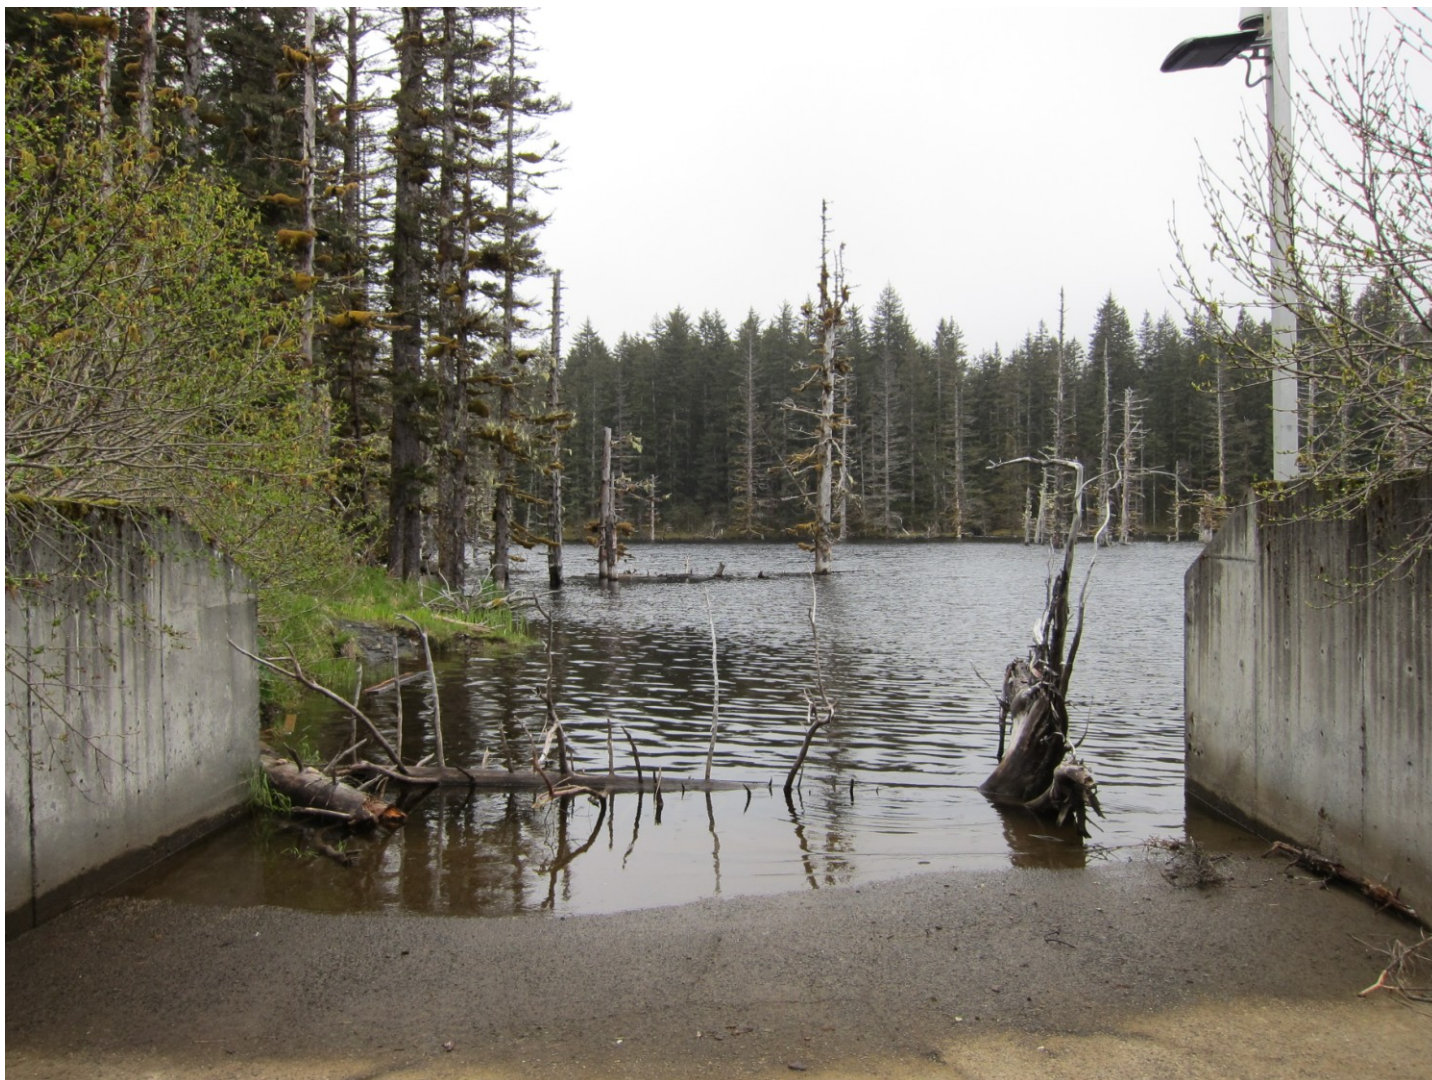
PHOTO A-8
SPILLWAY UPSTREAM VIEW

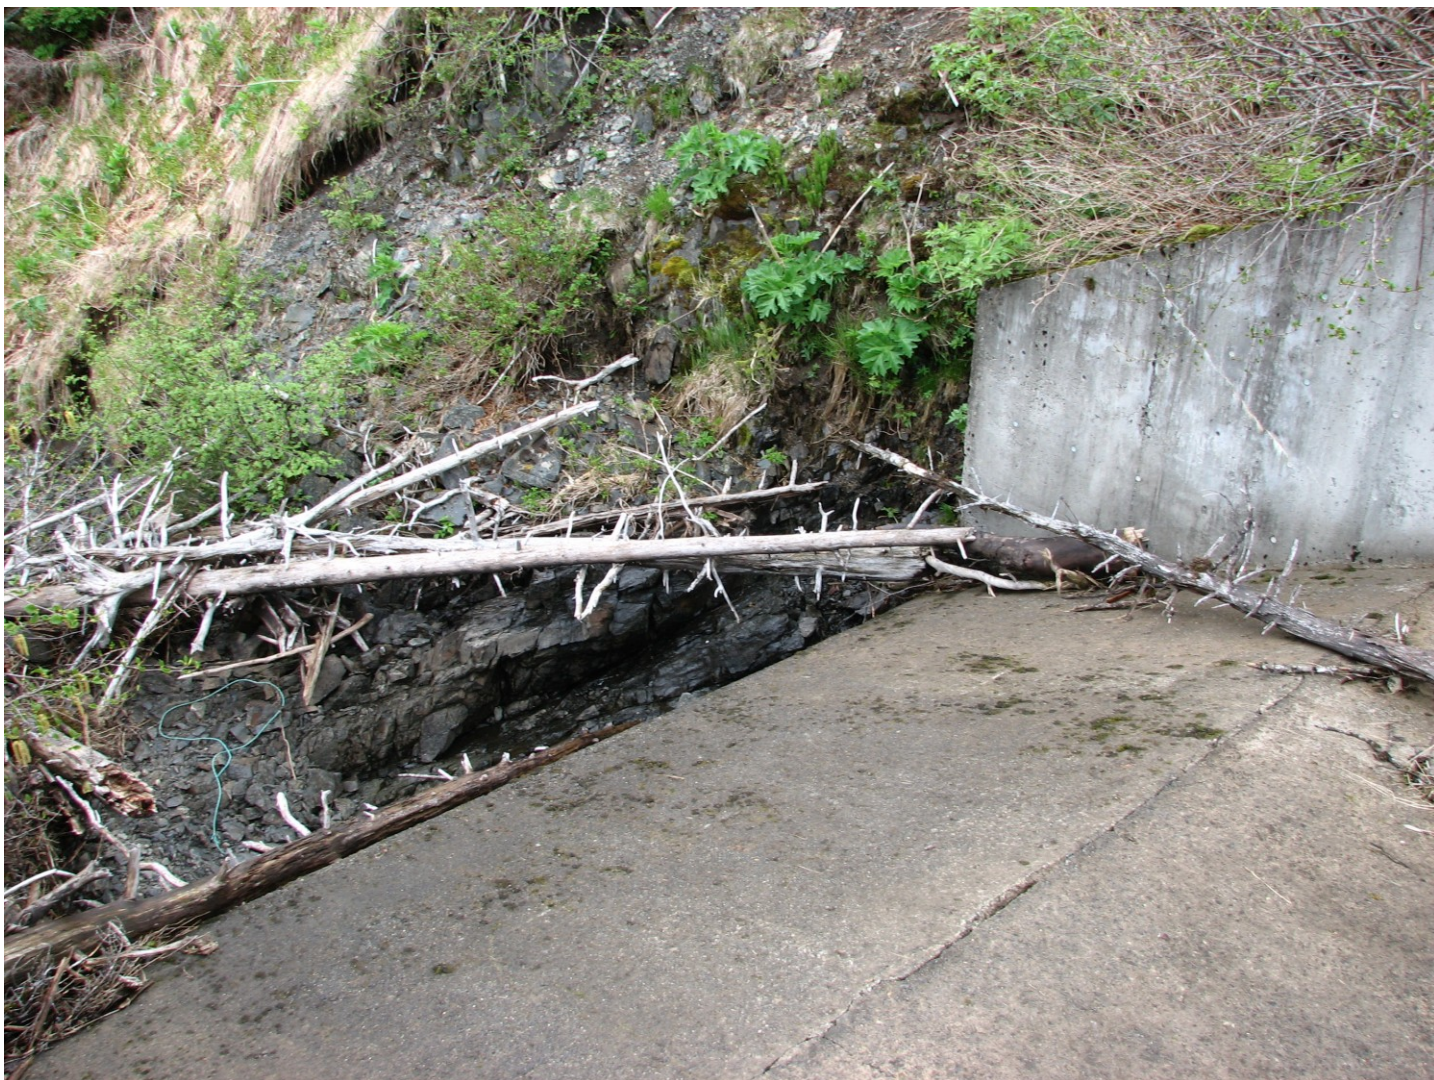
PHOTO A-9
SPILLWAY DOWNSTREAM VIEW

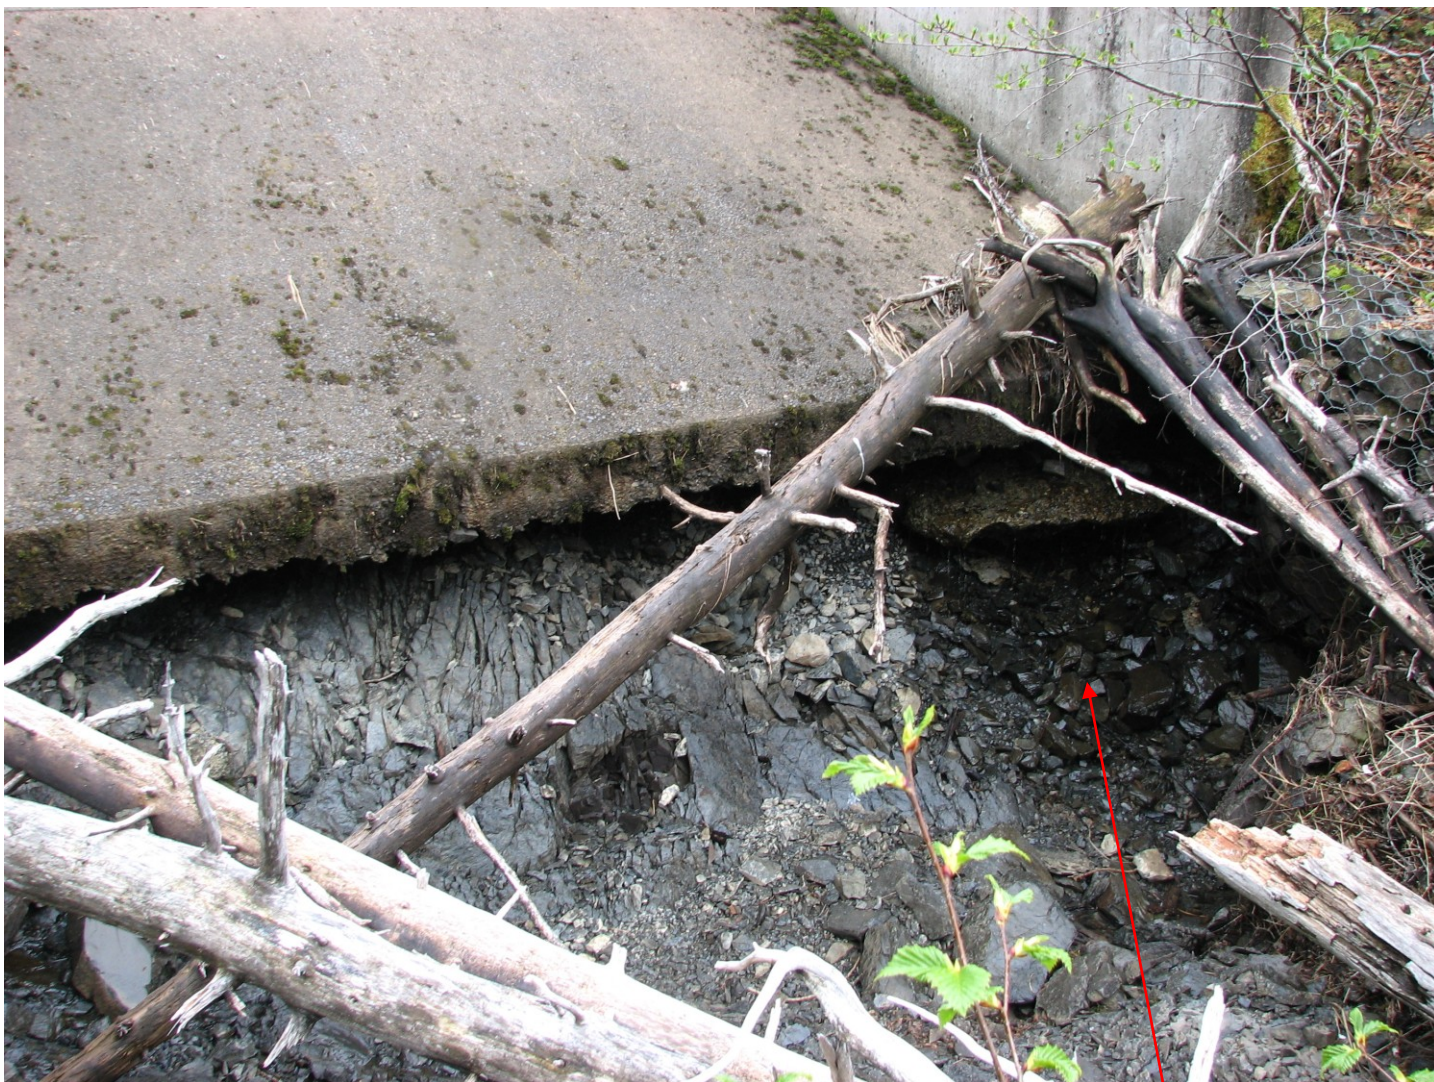
PHOTO A-10

Seepage

SPILLWAY UNDERCUTTING

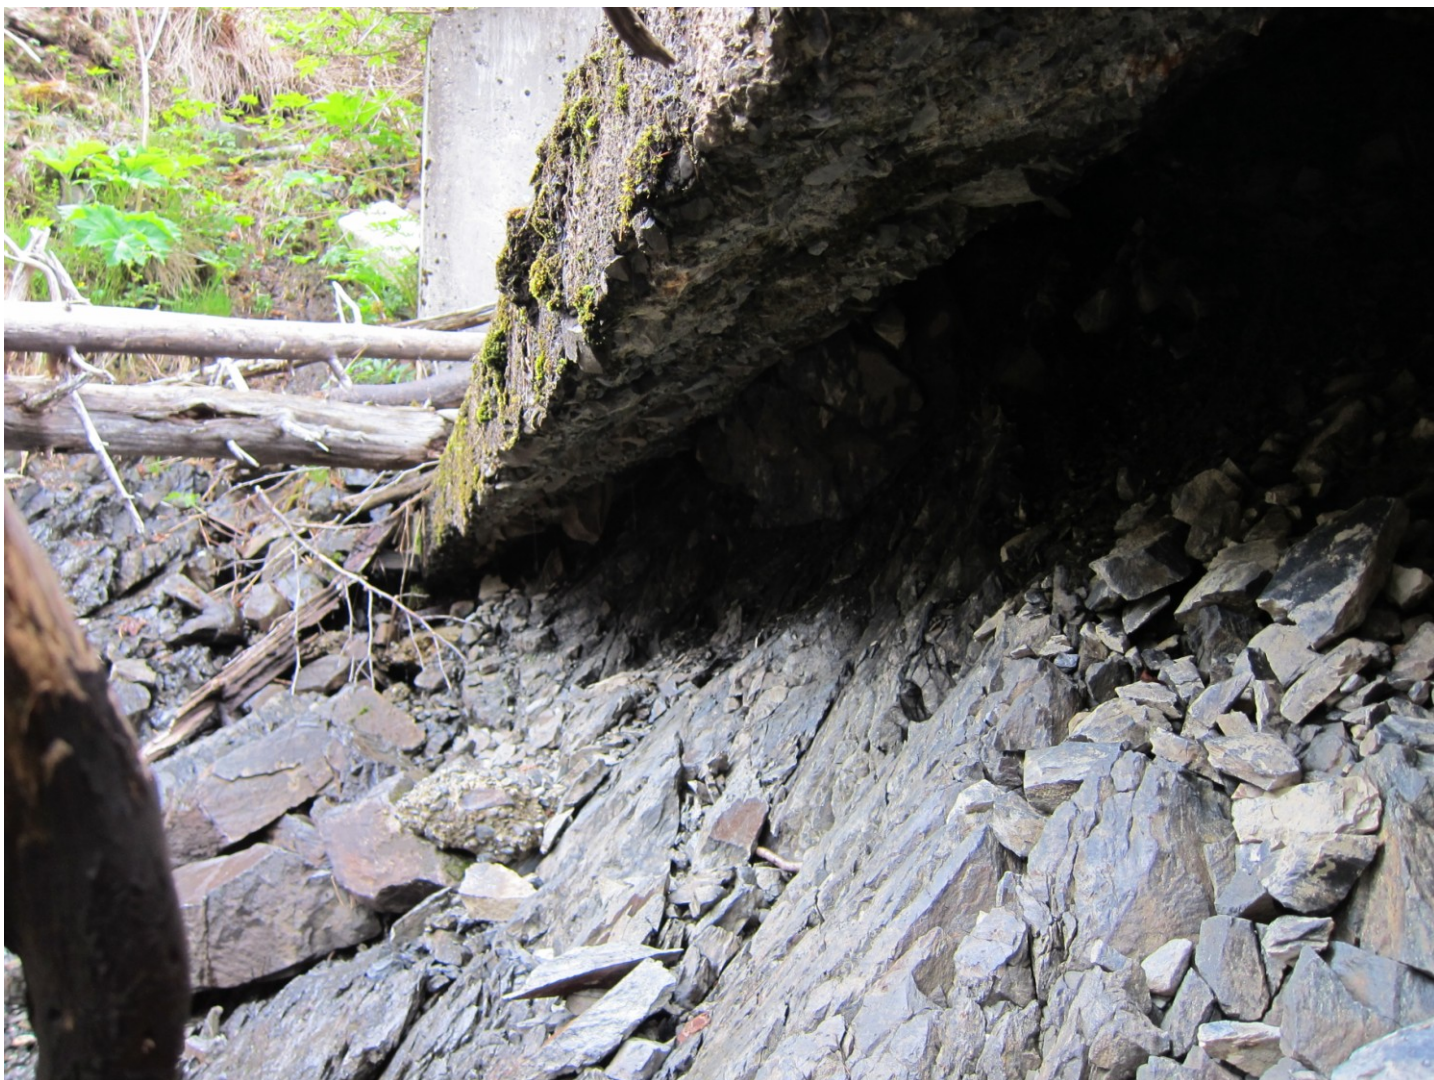
PHOTO A-11
SPILLWAY SLAB UNDERCUTTING

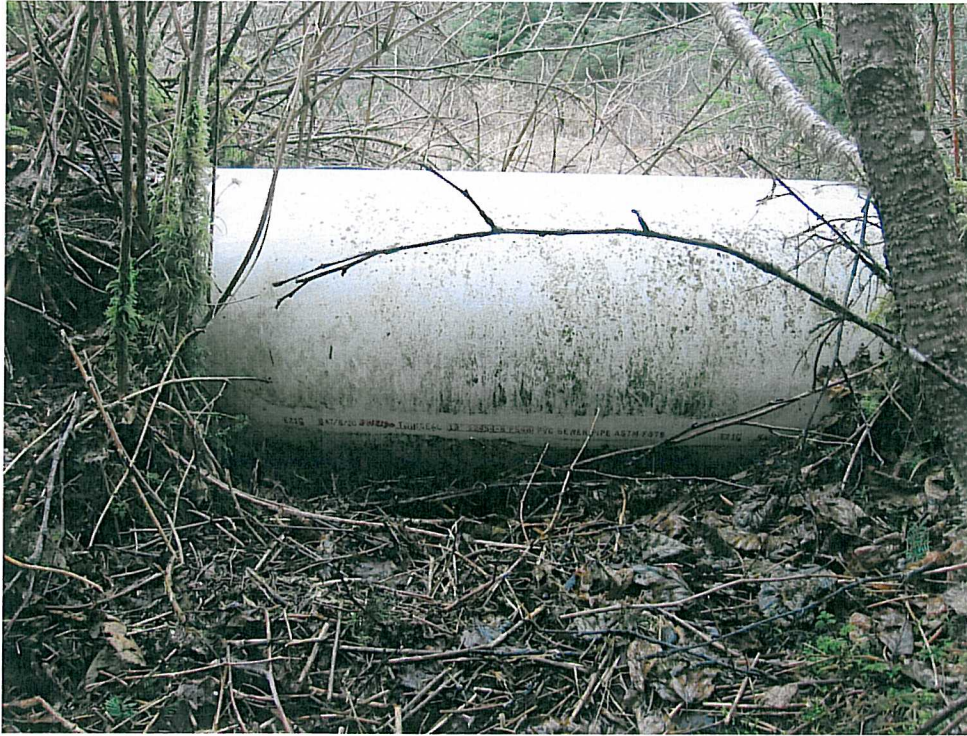
During a field examination of the transmission line on May 10, 2007, a Sr. Civil Engineer at ANTHC noticed certain deficiencies in the transmission line that are serious enough to warrant replacement. An 18-inch PVC non-pressure sewer pipe meeting ASTM F679 was installed as the transmission line (see Pictures #1). ASTM F679 says, "The requirements of this specification are intended to provide pipe and fittings suitable for **nonpressure** drainage of sewer and surface water." Picture #2 shows the pipe is clearly marked ASTM F679. The pipe was poorly covered during construction and has jacked and been pushed through time (see Picture #3). Exposed pipe can be crushed by falling trees as shown in a near miss (see Picture #4).

Picture #1 - 18" PVC Pipe Section Near the Hydroelectric Plant

Though the transmission line has performed adequately over the last 20 years, ANTHC recommends replacing the pipeline. The suggested material is 20" HDPE, DR 11, butt fused connections. This pipe is rated for this water pressure application and has much better freeze/thaw characteristics. Proper installation practices should be followed to provide an adequate bury depth below the frost line and for protection of the pipe.

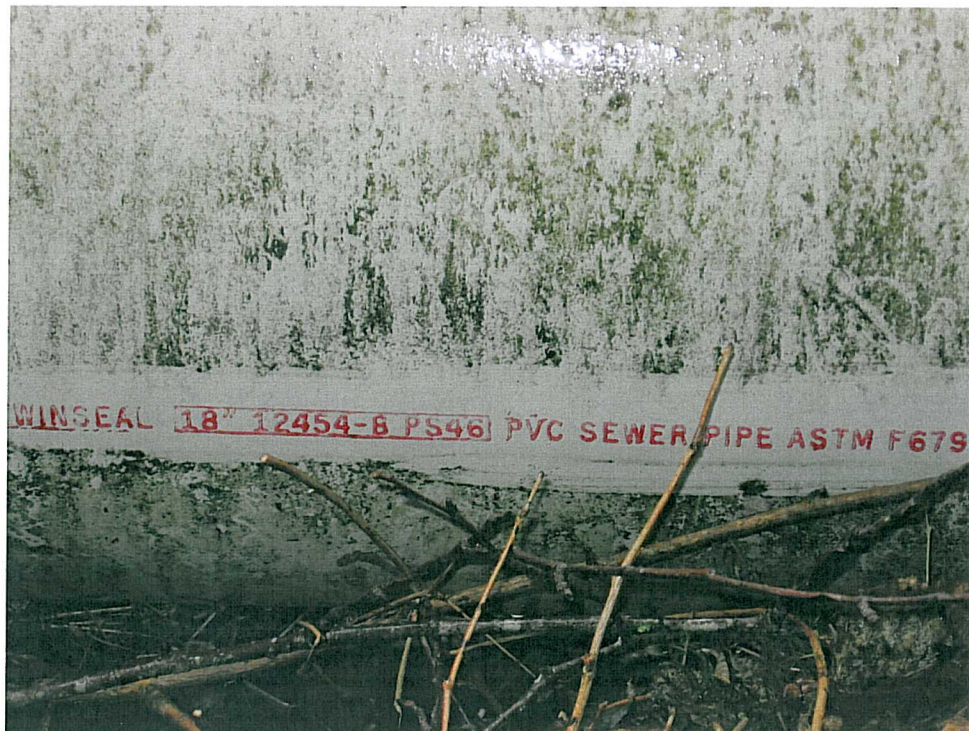
Picture #2 – 18" PVC Sewer Pipe

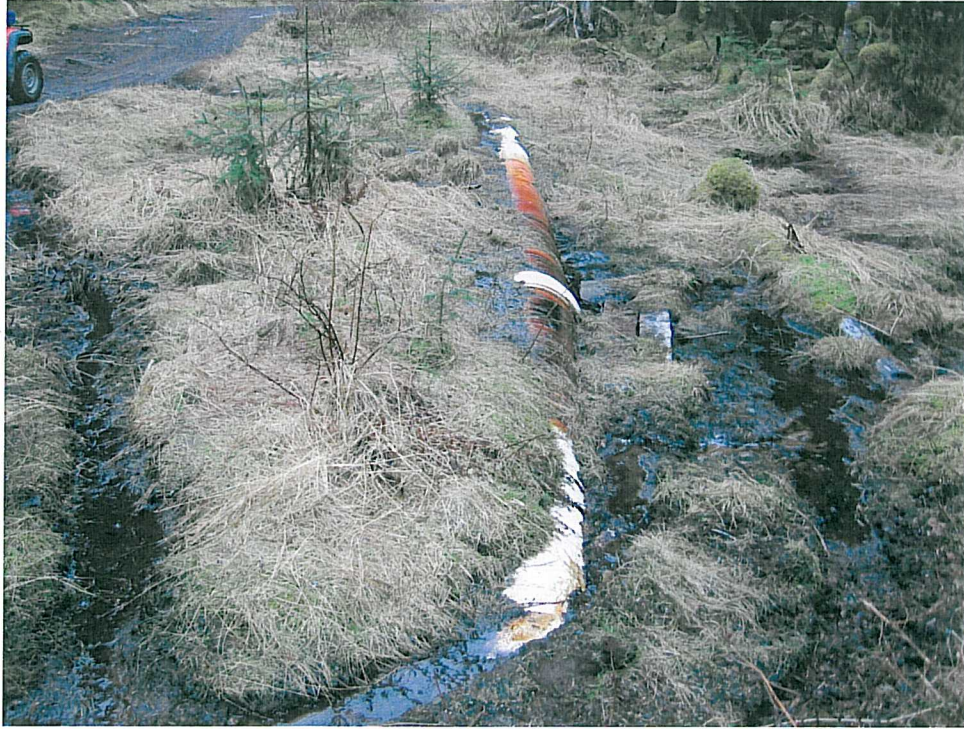
Picture #3 – Exposed Transmission Pipe

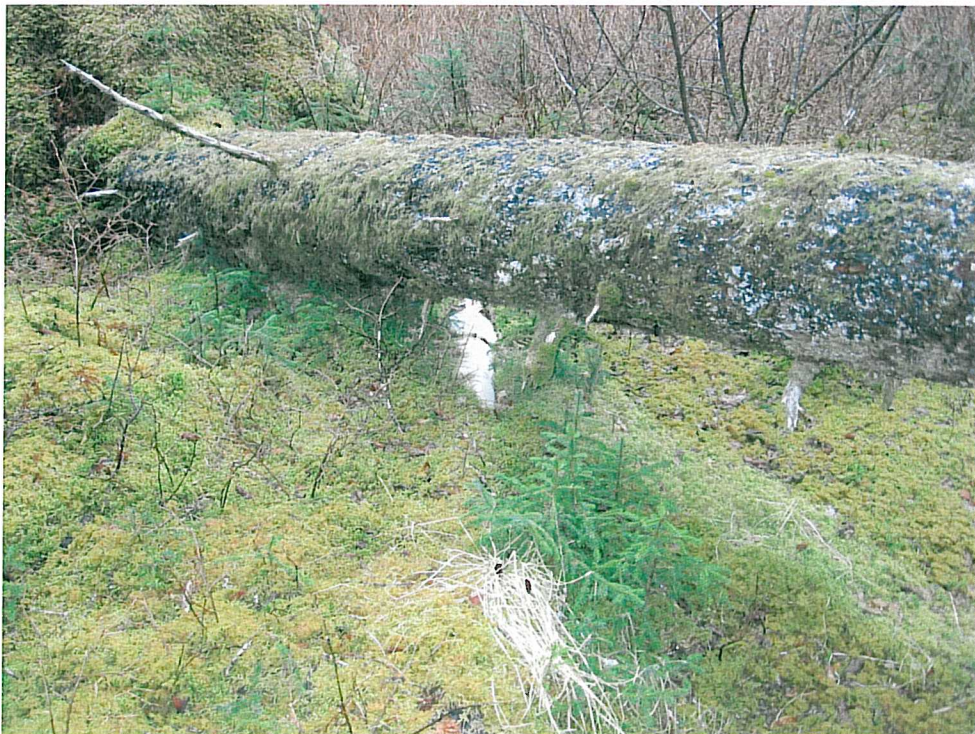
Picture #4 – Tree Across Transmission Line
