# Kodiak Regional Aquaculture Association - Kitoi Bay Hatchery Deferred Maintenance and Upgrades

Alaska Department of Fish and Game

March 2012

# KITOI BAY HATCHERY

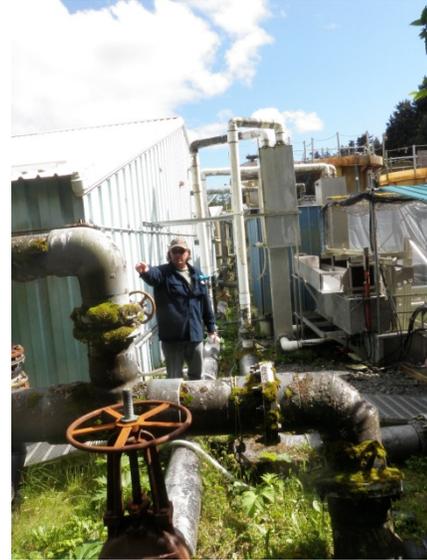
**Site Piping, Degassing Tower**

Process water distribution piping has been modified numerous times over the life of the hatchery. Much of the primary supply pipe is exposed, large diameter PVC. The operators have experienced breaks and other damage to the pipe as it has aged. In a few locations, PVC has been replaced with HDPE which is more durable and rated for operating at lower temperatures.

Because of the numerous modifications to the system, it is also relatively complex and not easily understood without training or experience. Replacement of aging pipe could also include simplification of the system where feasible and clear identification of different types of pipes and valves.

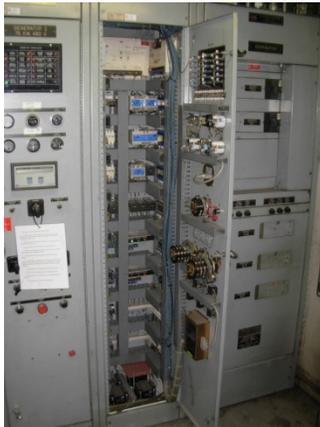
**Switchboard and Generator Controls**

The controls are comprised of programmable logic controllers (PLC's) for the engine-generator operations, status conditions, and alarms. Additionally, they monitor the electrical conditions via solid state protective relays and secure the system appropriately for fault conditions. They also facilitate paralleling operations allowing switching of the generators and two generators to operate together to power the hatchery. The PLC and accessories is outdated and in poor condition. Some of its functions are no longer used due to newer generators and motors not being compatible with the old PLC system. Although this control system was well devised when it was fabricated, it is complex and difficult to maintain in a remote location.

Along with replacing the generators within five years, the switchboard should be replaced with one using modern components. However, attention must be made to select a simpler control system with fewer components. Such systems are available today.

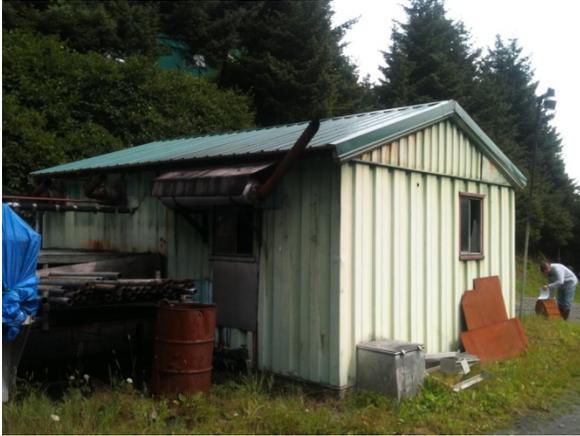
**Generator Building**

The generator building exterior envelope is in poor condition. The original metal roofing failed and exposed fastener metal roof was installed over it as a stopgap measure. It was not designated for wind uplift, lacks flashing, insulation or ventilation measures. Windows and doors are all badly deteriorated. Combustion air intake and exhaust are in poor shape, heavily corroded and lacking weather integrity. The wall siding is a dual skin metal siding with approximately 1.5" of fiberglass insulation between the painted metal panels. It is corroded through in places, lacks weather integrity and has a very poor prognosis. The panels do still appear to have sufficient structural integrity to serve as a backing for replacement panels.

Roofing and siding could be replaced along with doors, windows, louvers, and other exterior envelope elements if it is decided to retain the primary equipment inside the building (generators, switchgears, etc.) However, if it is determined to replace the primary generation equipment the existing building could be replaced with a new generation building installed on the site while the existing plant remains in operation. Demolition of the existing building could take place after the new building is brought on line. It is likely some site clearing, including excavation of adjacent uplands slope would be required to accomplish a level site on which to build a new generation building.

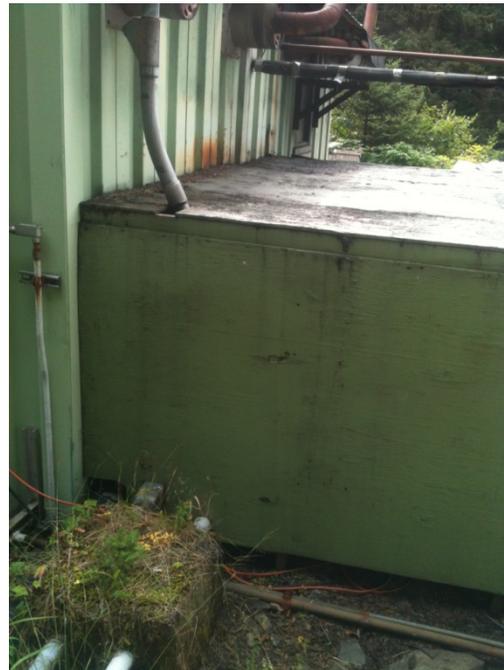
**Plywood Exhaust Plenum**

A plywood plenum was constructed that directs radiator exhaust heat to adjacent fuel oil tanks. This helps raise fuel temperature so that it does not gel in the winter. The system should be investigated to ensure that it does not adversely affect the flow of exhaust air from the generators.

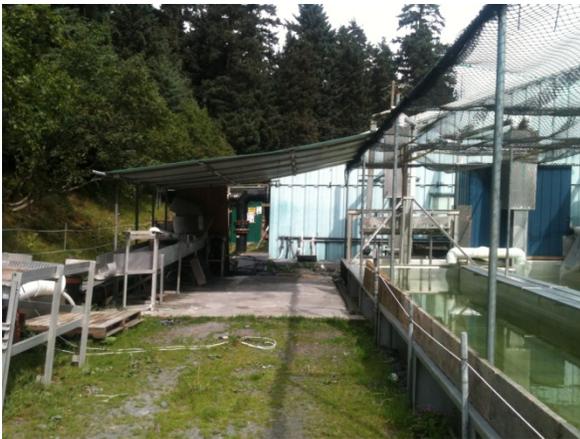
**Slope behind hatchery building**

**Grade:** A steep slope aligns along the north side of the building. It drains into the area between the toe of slope and the long axis of the building. Over the long life of the building organic material has built up in the area, as well as debris washed down from above. It should be excavated back and drainage structure installed at the base of the slope to permanently stabilize grades and drainage in the area.

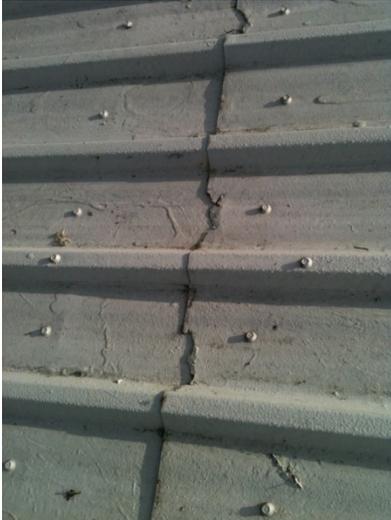
**Roof:** Metal roofing was painted approximately 2 years ago in effort to stretch the useful life of the assembly. Staff states that the roof was heavily corroded prior to the paint being applied. Corrosion is evident under the paint, especially at panel edges. The paint was a stopgap measure- the roof is past its useful life and should be replaced. The existing roofing can remain in place and a new metal roof installed on top of it. Insulation can be placed in the void space between existing and new roof panels as an inexpensive way to raise the thermal performance of the roof. Spray fireproofing has become dislodged from the urethane foam adhesive in a number of places. Trowel on fireproofing patch material should be applied at all areas where the urethane is exposed.

**Roof panel corrosion**

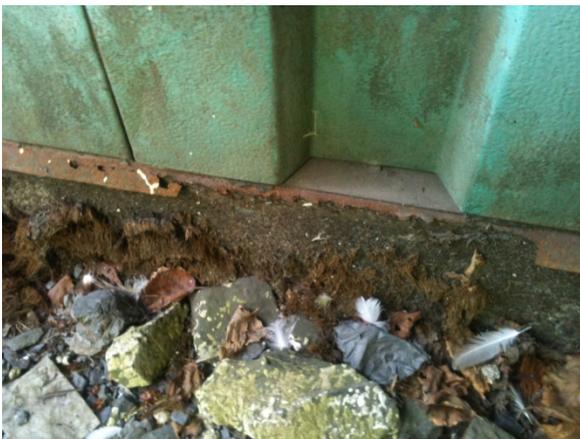
**Siding:** Metal siding is past its useful life. Base flashings have essentially rusted away. The paint finish is heavily chalked and eroded. Flashing at windows and doors are deteriorated. New siding is recommended, either as an overlay or as a complete remove/replace process. Siding replacement will be complicated by the large amount of electrical conduit and process water piping and equipment attached over the years to the sides of the building. Siding replacement should be coordinated with the planned reconfiguration of process piping.

**Corroded base flashing.**

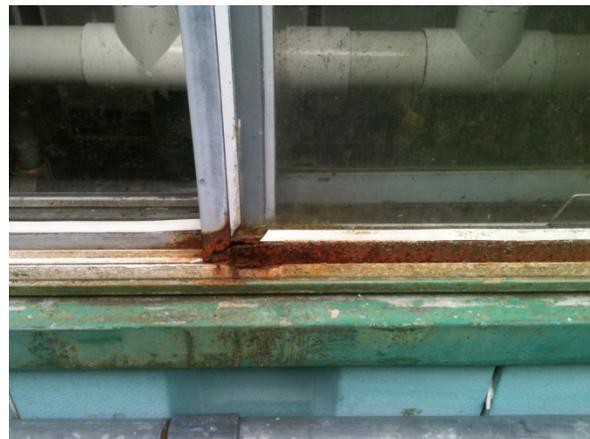
**Deteriorated window frame.**

**Windows:** Of the 17 original windows on the building, two have been replaced with insulated vinyl units. The remainder are single pane steel frame windows. All exhibit corrosion, leak in heavy weather and are passed their useful life. They should be replaced along with the metal window flashing.

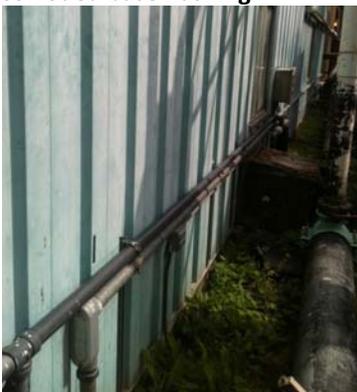
**Deteriorated siding.**

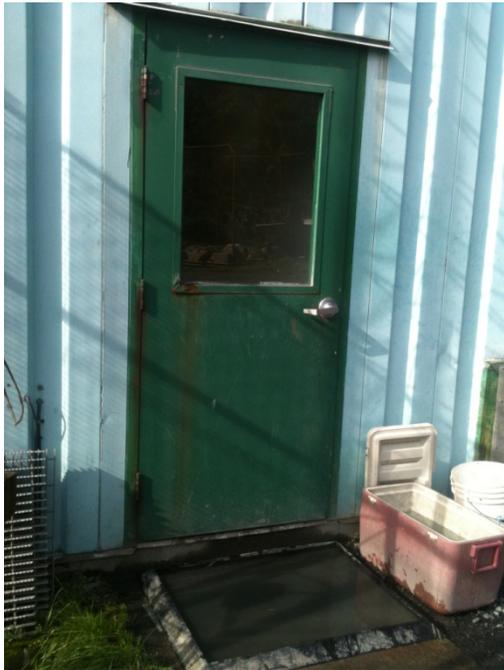
**Personnel Doors:** All doors exhibit heavy wear, many do not fully close. All exterior doors should be replaced with insulated G90 galvanized doors, frames and hardware.

**Existing deteriorated door**

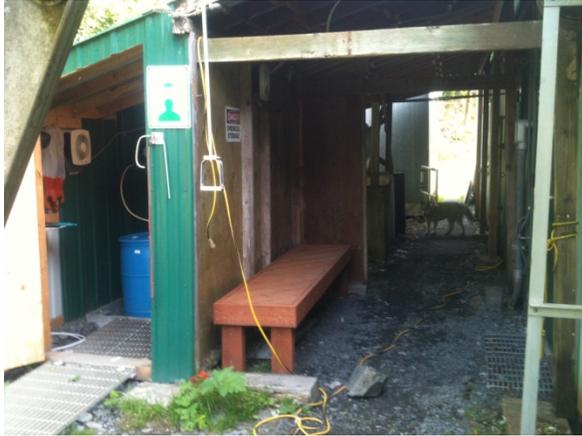
**Canopy at Formalin Room**

**Canopy:** a canopy was installed at some point in the past on the north side of the building approximately in alignment with the metal roof of the hatchery. The canopy was a site designed and built response to a serious operational challenge and protects walkways, doorways, process piping, fuel tank, fuel distribution from sliding snow and weather. It is a light wood structure of indeterminate structural capability and has no foundations. The canopy is important to the maintenance and operations taking place in the building, but appears to be a temporary solution and is considered a liability. It should be replaced with a galvanized steel canopy structure sheltering approximately the same general area.

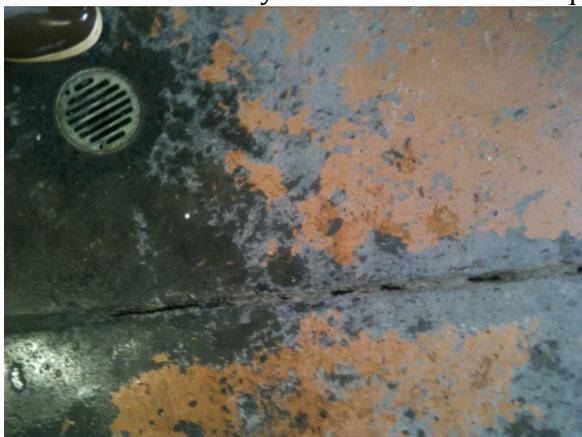
**Floors:** Concrete floors were once sealed and painted over time the finish coatings have failed, leaving fissures and bubbled surfaces that trap debris and are virtually impossible to clean. Fibrous expansion joint material originally placed at certain slab joints has largely disappeared leaving gaps in the floor open to the subgrade below. During cleaning activities debris laden water seeps down into these ½” gaps. It is suggested that the concrete floor surfaces be scabbled to remove existing coatings and loose concrete, followed by power washing using high temperature pressure washing equipment. Once an acceptable surface is achieved, slab topping could be applied, followed by sealer and/or epoxy type coating. As part of this work, permanent boot rinse/sterilizing basins can be formed at doorways to eliminate the loose plastic basins presently used.

**Failed floor sealer**

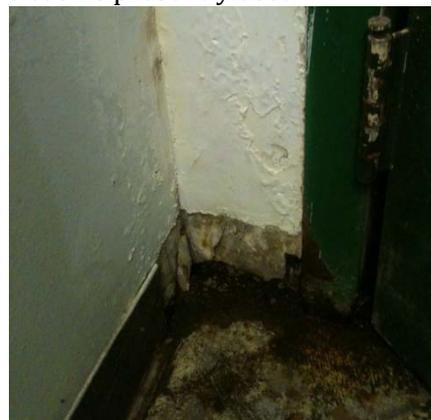
**Typical water damage at wall and door**

**Walls:** Walls between wet areas (incubation rooms) and occupied areas (lab, toilet rooms etc) are saturated from years of condensation and cleanup operations. Rot is present in the wood framing, and the lack of curbs has allowed water to run into adjacent areas. The drywall in these areas should be replaced with new moisture resistant assemblies, such as mold resistant drywall covered with FRP, possibly factory laminated, on galvanized metal studs. Curbs should be provided under all walls at wet areas. All surfaces, (existing to remain and new), should be painted, except where prefinished.

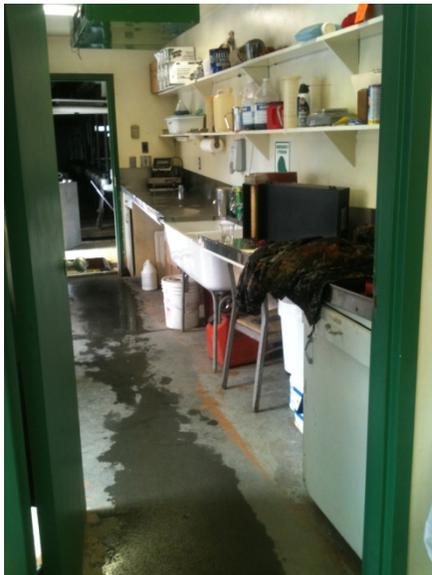
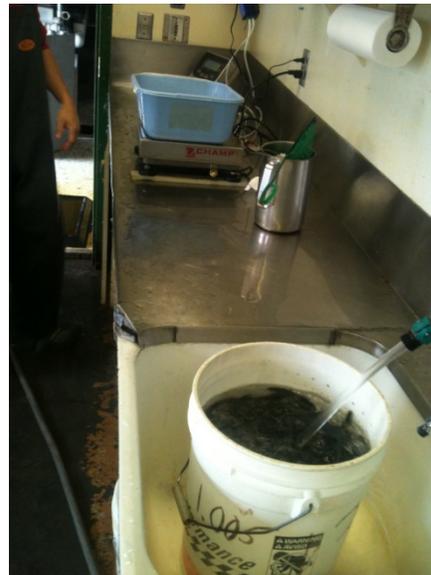
Lab Counter

**Laboratory:** The laboratory area includes fish food storage, stainless steel dissection table, sinks shelves, counters and other casework. All is unsanitary, heavily worn and well past useful life. All furnishings in this area should be replaced. It is suggested that some sort of palletized storage be provided for the large, heavy fish food bags to reduce the amount of handling required. It is also suggested that when the laboratory casework is replaced, that consideration be given to including more modern equipment to reflect the current state of hatchery technology and to more readily provide for future developments. Some receptacles are scattered through these spaces, but the presence of extension cords indicates a need for more. The circuiting in these spaces also uses single conductors in EMT. Most of it is in fair to good condition. However, it should be upgraded to support more receptacles. The control circuits utilize open cables that are in poor condition and should be replaced. The lighting in these spaces includes high pressure sodium (HPS), incandescent, and some linear industrial strip fluorescent. The HPS and fluorescent luminaires are manually controlled with wall switches. The incandescent lighting in the incubation areas is controlled with dimmers. The lighting is in fair condition with less than five years of service life remaining. The application of LED lighting with dimming control should be considered with the next project. It will provide better control response, lower maintenance costs, and lower energy consumption.

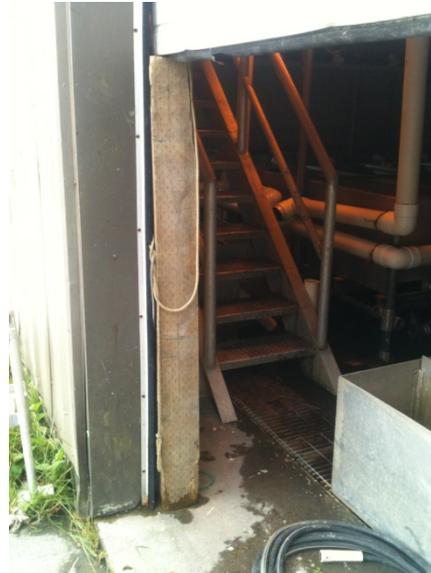
**Non-compliant Stair**

**Storage Mezzanine:** The ceiling above the occupied areas (except the high bay work room) is actually a structural floor for the storage mezzanine. One stair provides access to the mezzanine, located in the main hatchery area. The stair has 8.5" treads and 9" risers. It should be replaced with a galvanized stair compliant with current codes.

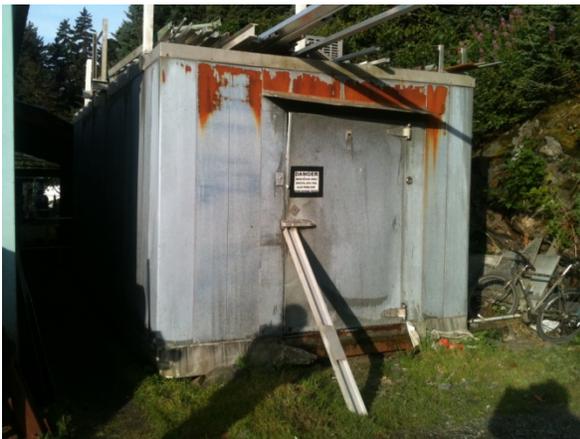
Roofing has reached end of useful life and is rusting through. The refrigerator doorway no longer secure, allows heat to enter cooler area. The latch is no longer functional, and could lead to a person being trapped inside. The refrigeration equipment does maintain freezing conditions, but cannot be considered reliable over the duration of this report. The cooler is used for long term storage of fish food, and while short shutdowns are not critical, the existing installation is not serving its original purpose. It is located directly against the slope, with debris, vegetation and sediment building up against the north side of the cooler. It is suggested that the cooler be replaced. One possible configuration would be to locate a new cooler under the replacement canopy so that it is no longer exposed to the elements.

**Non functional refrigerator door**

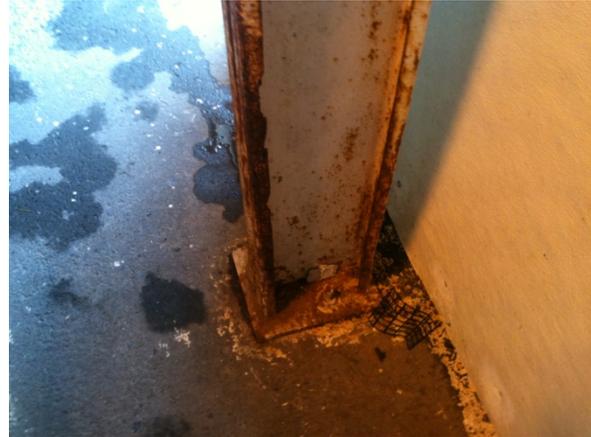
**Structural:** The structure is a pre-engineered steel building. The steel columns, roof beams, and roof purlins all are corroded. The corrosion is significant enough that the structure should be demolished and replaced.

Corroded columns

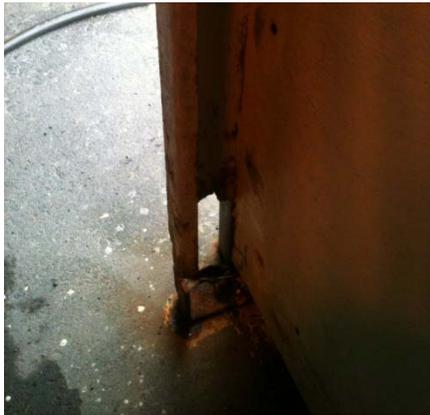
Structural corrosion

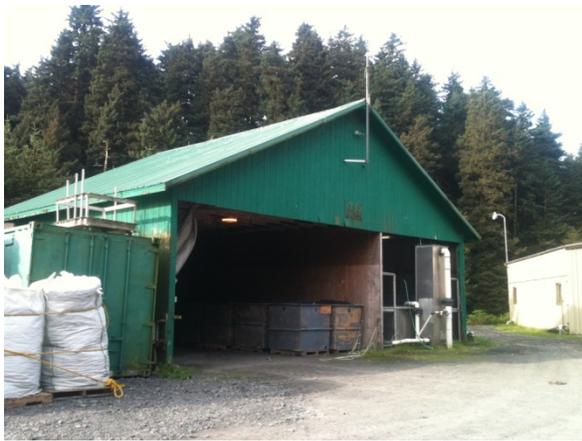
**Hangar/Warehouse Building**

This building is structurally unsound. Trusses are not engineered and exhibit deformation. Rot is occurring in walls, siding. This building is a life safety hazard and should be replaced.

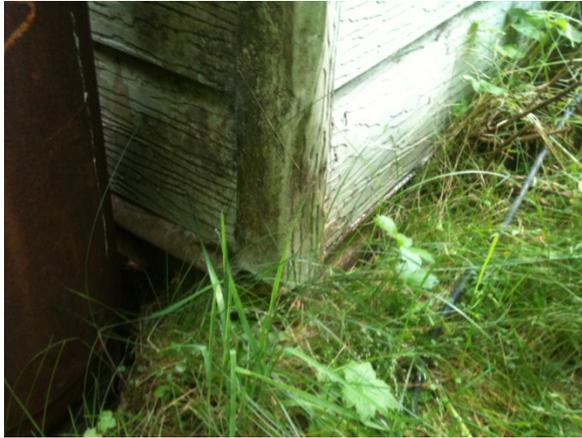
**Damaged siding**

All aluminum siding should be powerwashed and replaced where damaged.

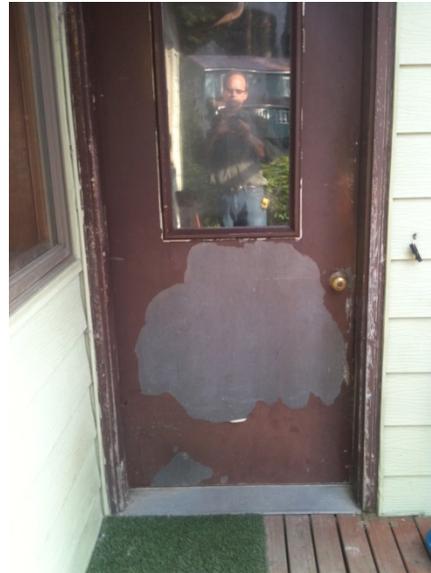
**Deteriorated Exterior Door**

Exterior doors are deteriorated and should be replaced.

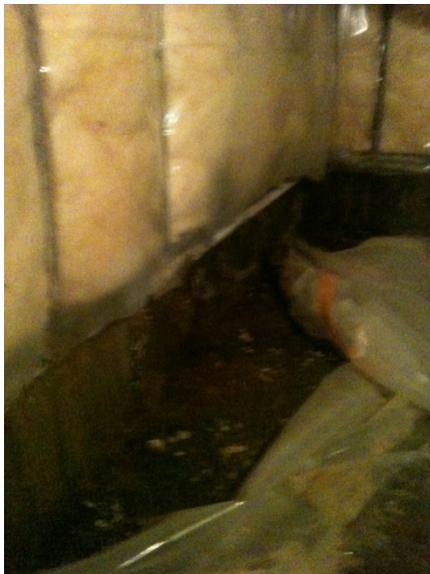
Crawl spaces in building 2 are wet due to water from the adjacent hillside, which is leaking through the pressure treated wood foundation wall. The area outside the building should be re-graded to redirect surface drainage. The crawlspace drain should be replaced, and additional crawl space vents installed. It is also suggested that the fiberglass insulation on the all weather foundations be removed. Floor joist space should be insulated and the treated foundation repaired as required.

**Moisture in crawl space**

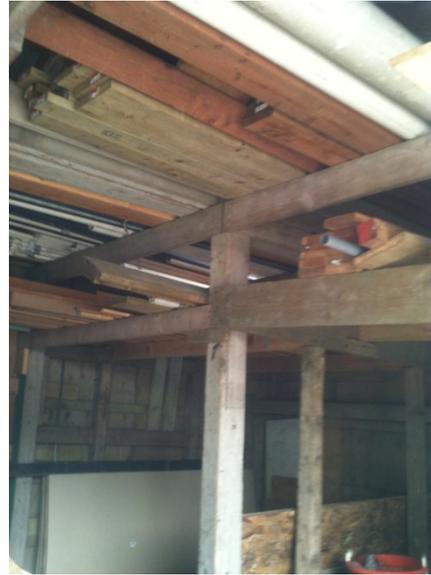
**Storage Building interior- no structural support**

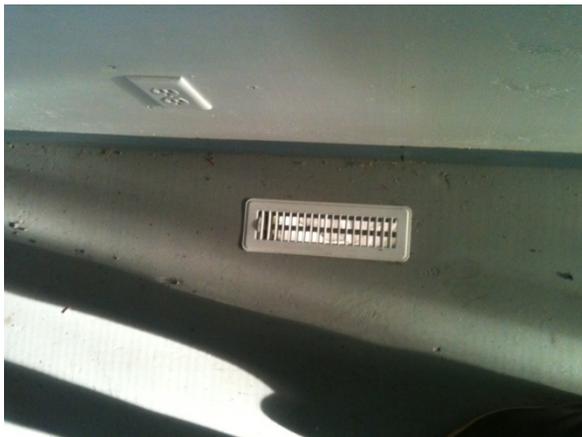
**Floor louver**

No fire separation between floors- floor louvers (4-9"x4") allow heat from downstairs to raise to upper level- open to boiler room. If the building is assumed to be all one occupancy type this is allowable.
