Kenai - Water Storage Reservoir Construction

Water Tank Inspection Report

City of Kenai, AK

3.0MG Reservoir

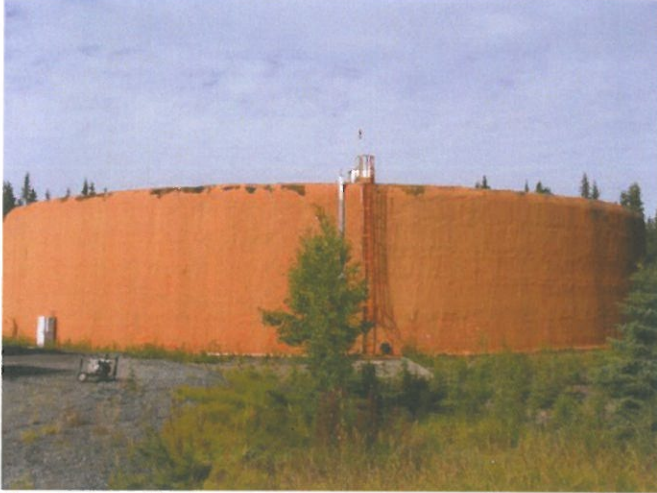
DP#1

An overall view of the tank can be seen in DP#1.

Overall view of tank

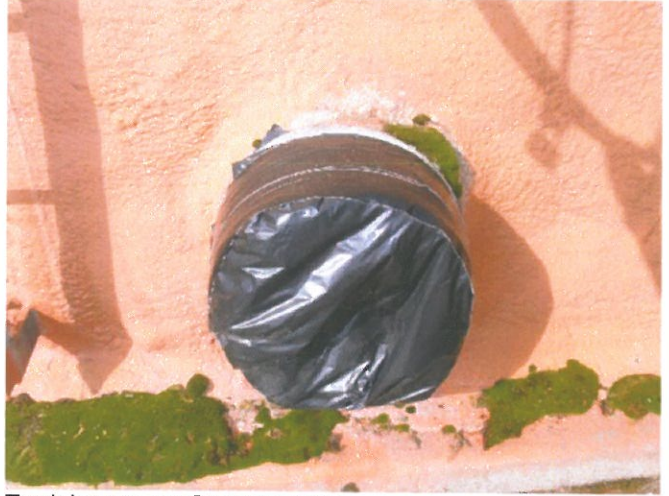
DP#2

The overflow pipe was a cone top with a top termination shown in DP#19. The overflow has a splash pad that discharges into an adjacent ditch. There was no screen present at the bottom of the overflow shown, however it is covered with a trash bag. DP#2.

Trash bag on overflow discharge

The overflow pipe will require having a screen put on the end of it immediately for sanitary reasons.

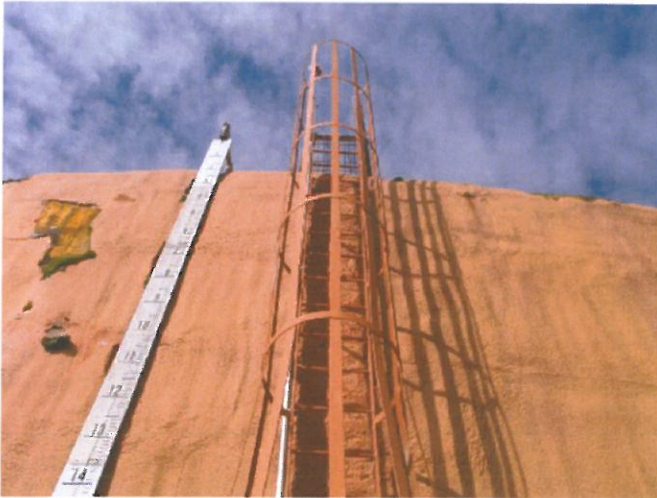
DP#3

The shell has a vertical ladder that is OSHA compliant, with a safety cage. The ladder is equipped with an anti climb device seen in DP#3. The bottom ladder rung is located one foot above the ground. There are handrails around the hatch on the top of the tank; this railing system can be viewed in DP#9.

Exterior shell ladder with safety cage

The ladder cage should be fitted with a locking gate to prevent unauthorized access. It may also be necessary to install a sheet metal cover over the ladder cage to prevent climbing.

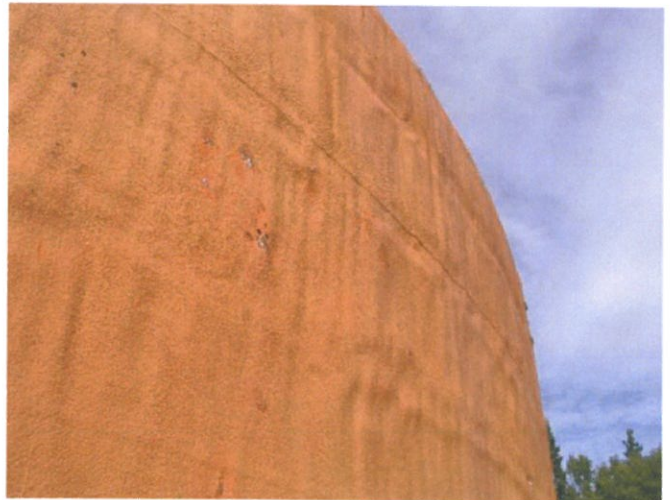
The tank shell had an insulation wrapping the outer shell, which appeared to be in fair condition, seen in DP#5. Areas that have been subject to rock and bird damage can be seen in DP#4 Some slight deterioration of the shell insulation can be seen in DP#7

Upper shell insulation with rock damage

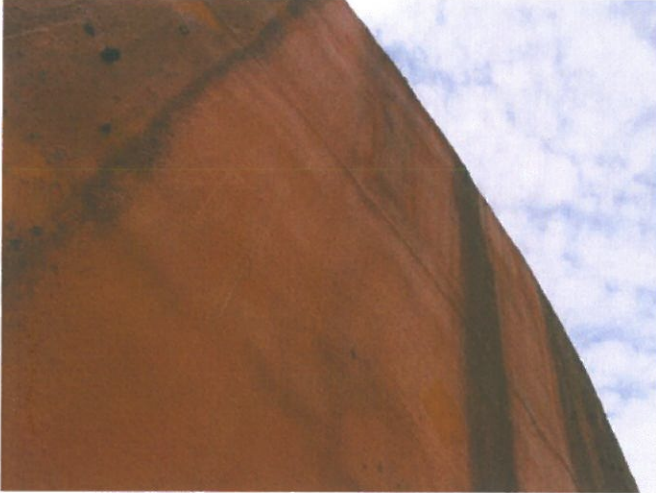
DP#5

Upper shell insulation in good condition

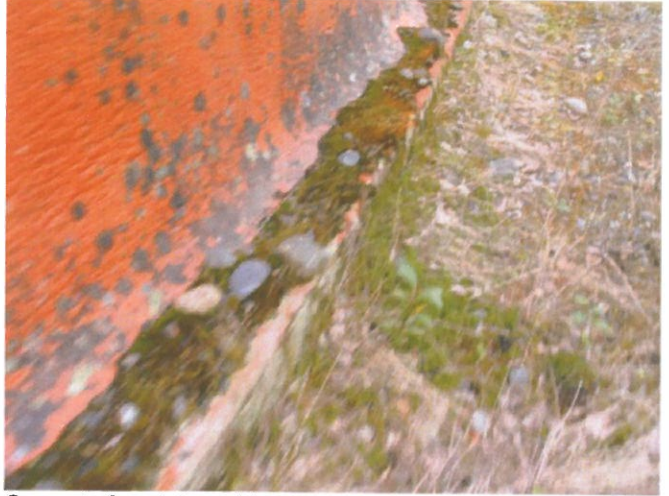
DP#6

Concrete foundation with minor spalling

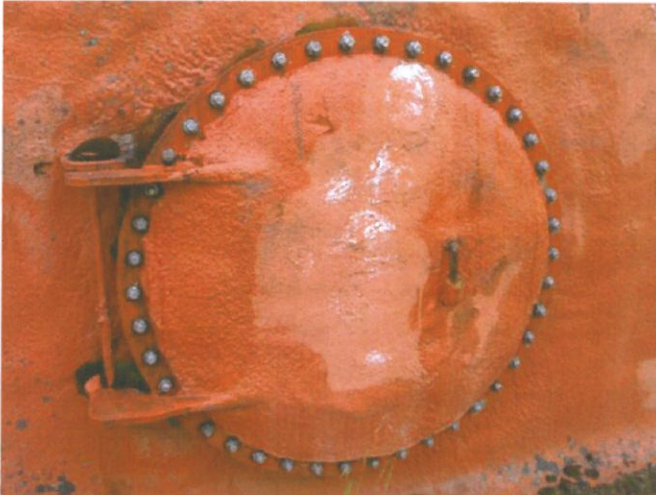
DP#7

36-inch shell manway

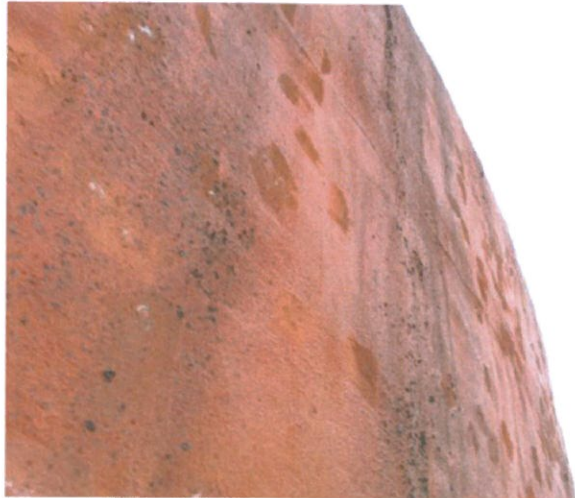
DP#8

Upper shell insulation has slight deterioration

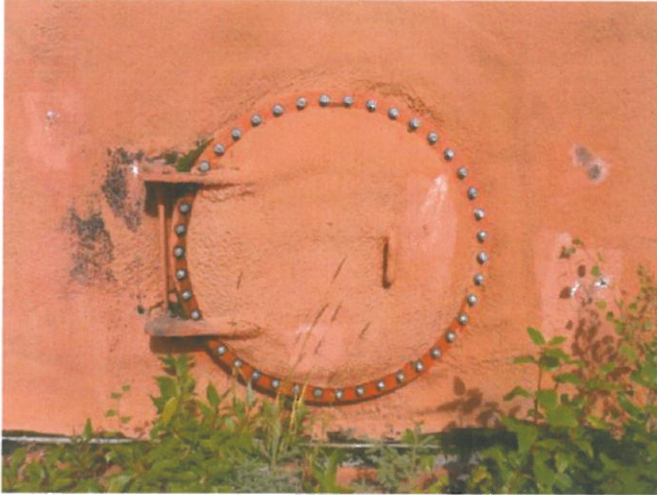
DP#9

Second shell manway 36-inch diameter

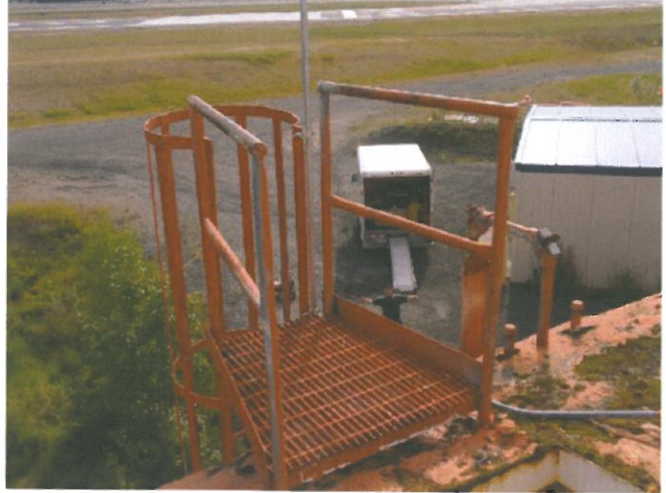
DP#10 Railing system adjacent to roof hatch

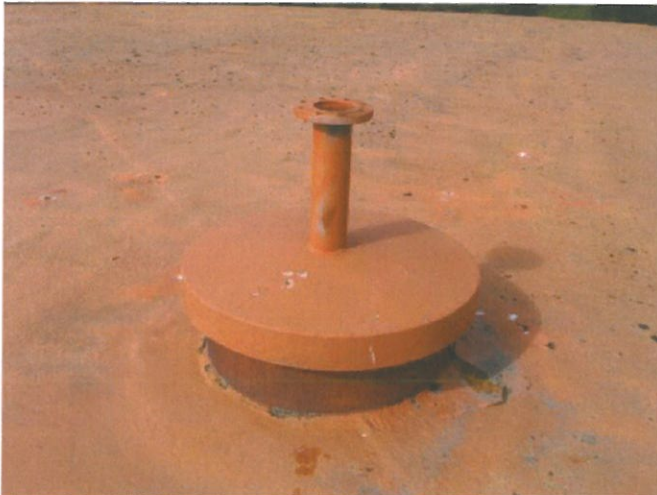
The tank is equipped with one, 20-inch diameter vent, DP#10. There appeared to be visible damage to the vent steel shown in DP#11 and DP#12. The vent screens were in poor condition and will need to be replaced. The roof vent opening is very close to the roof and possibly susceptible to blockage by snow. Reduced air flow could create a vacuum or over pressure situation.

Center roof vent cap

The roof vent should be replaced with a vacuum/frost free design and a fine mesh insect screen
Estimated Cost \$5,000

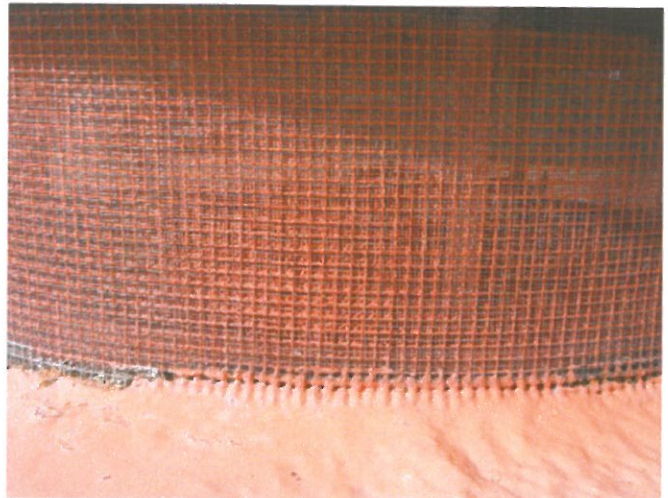
DP#12

Coarse and fine mesh screen on roof vent.

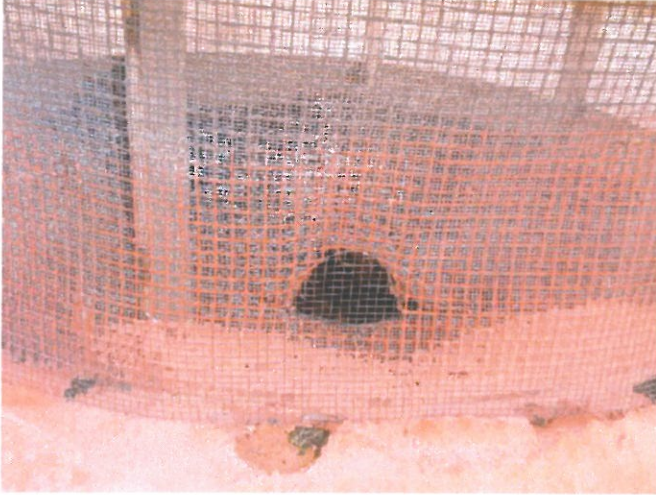
DP#13

The roof had a layer of insulation so we were not able to view the condition of the coating. The condition of the insulation is fair with numerous areas of bird damage, see DP#18. The condition of roof insulation can be viewed in DP#13-16, where bird damage is seen but no widespread delamination.

Hole in coarse screen

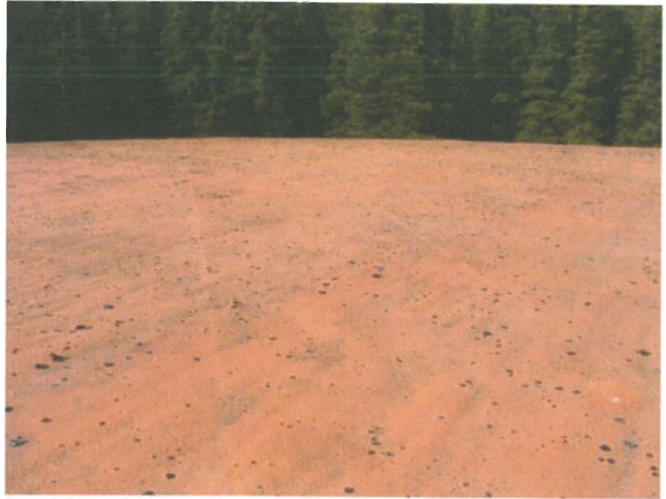
DP#14

Insulation deterioration on exterior roof

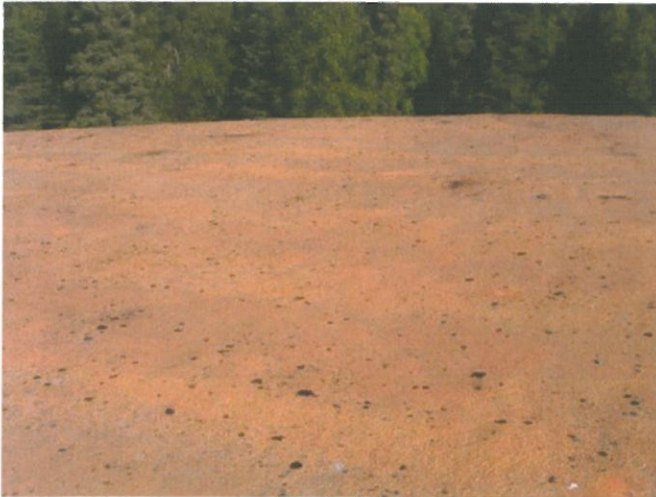
DP#15

Insulation deterioration on exterior roof plates

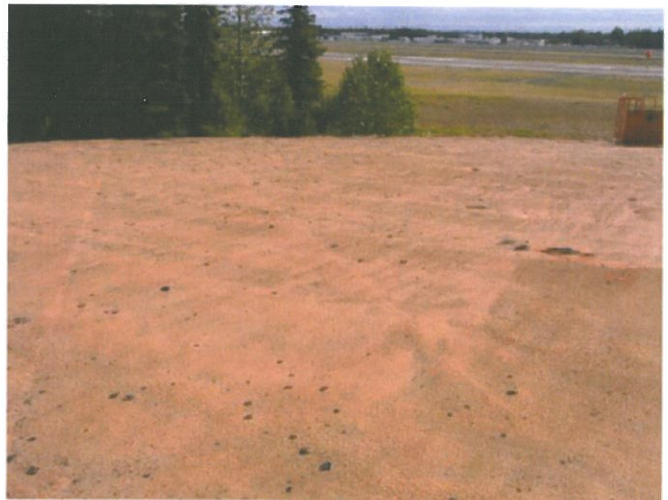
DP#16

Insulation deterioration on exterior roof plates

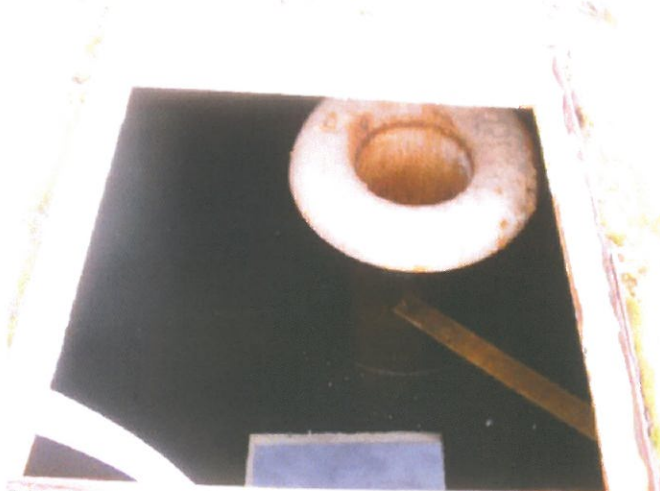
The tank has one 36-inch square roof hatch that can be seen in DP#17 and two 36-inch round bolted ground level hatches, they’re pictured in DP#6 and DP#8. The roof hatch is equipped with the required sanitary curb which has been subject to edge corrosion, DP#17.

36-inch square roof hatch with edge corrosion on sanitary curb

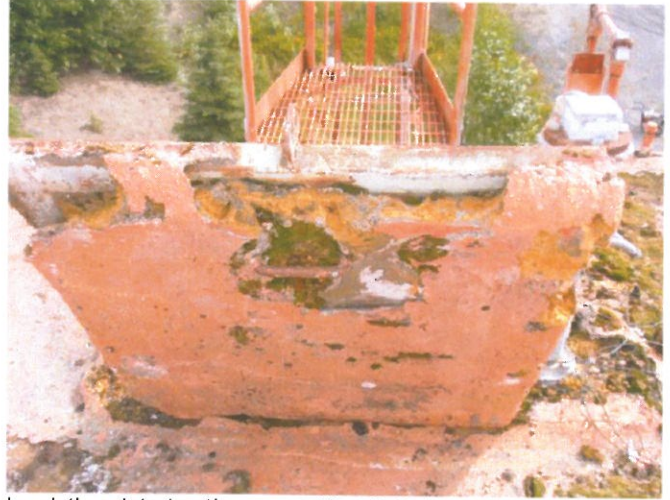
DP#18

The interior of the tank was accessed through the existing 36-inch square perimeter hatch, which was not locked at the time of the inspection. The hatch’s insulation is deteriorating which can be seen in DP#18. The water level during the inspection was consistently one foot below the overflow.

Insulation deterioration on roof hatch lip

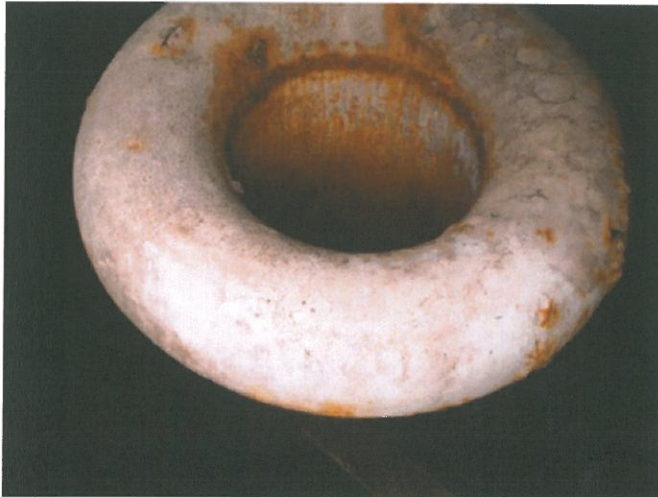
DP#19

Overflow pipe with cone top

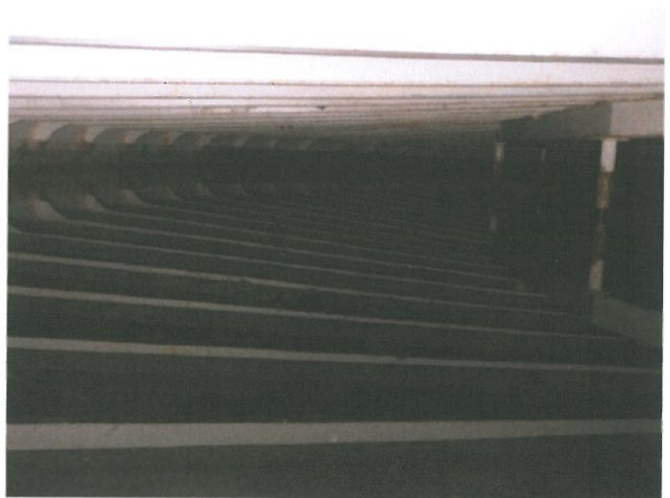
DP#20

The roof is a flat cone structure with a central support column and radial “C” section rafters. The tank also contained numerous support beams surrounding the central support column. The roof has widespread coating failure with active surface, pinpoint, and edge corrosion. These conditions can be viewed in DP#20-27 and VS#1-4.

Interior roof support beams with minor edge corrosion

Consideration should be given to scheduling interior repainting in 1-3 years. The interior will need to be completely blasted and painted. Although the tank shell and floor corrosion could be controlled with a cathodic protection system the roof is failing quickly and that area cannot be protected with cathodic protection.

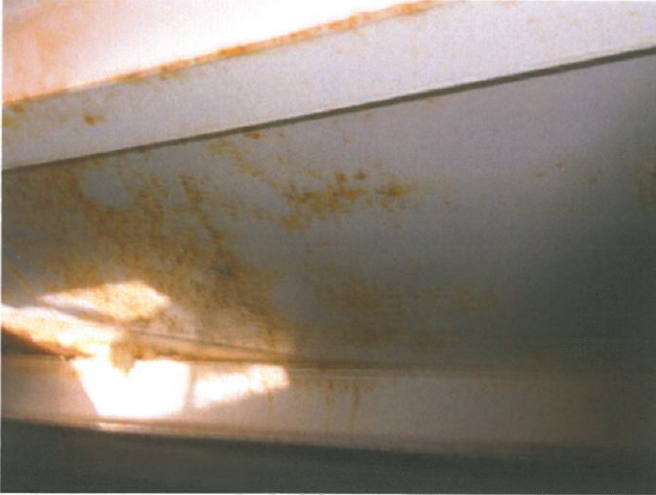
DP#21

The roof plates have widespread edge and surface corrosion developing. There is 55-60% coating failure on the surface of the plates. These conditions can be viewed in the above mentioned digital pictures and video snaps.

Pinpoint corrosion on interior roof plate

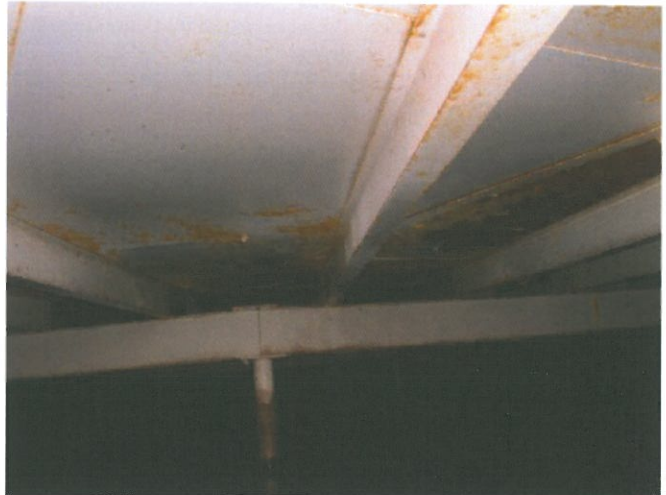
DP#22

Pinpoint and edge corrosion on interior roof plates and beams

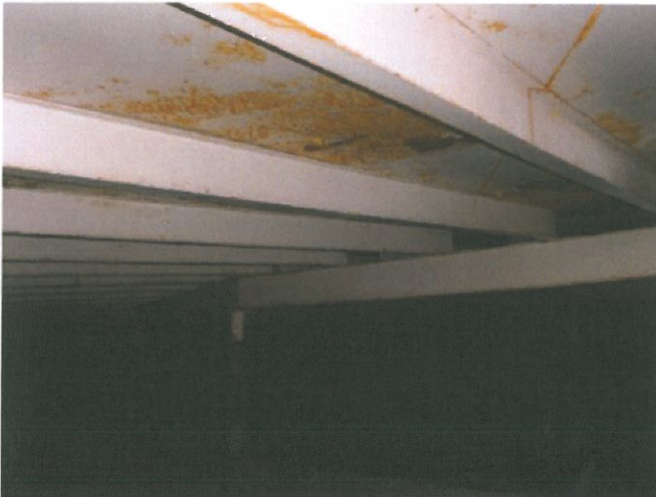
DP#23

Pinpoint corrosion on interior roof plate

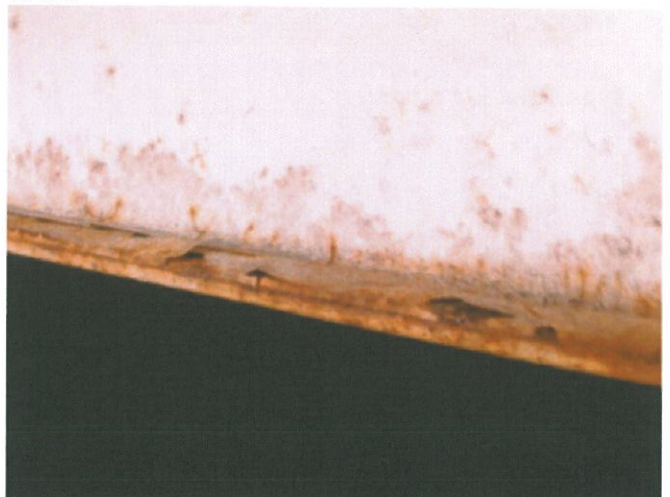
DP#24

Corrosion and coating failure on roof support beam

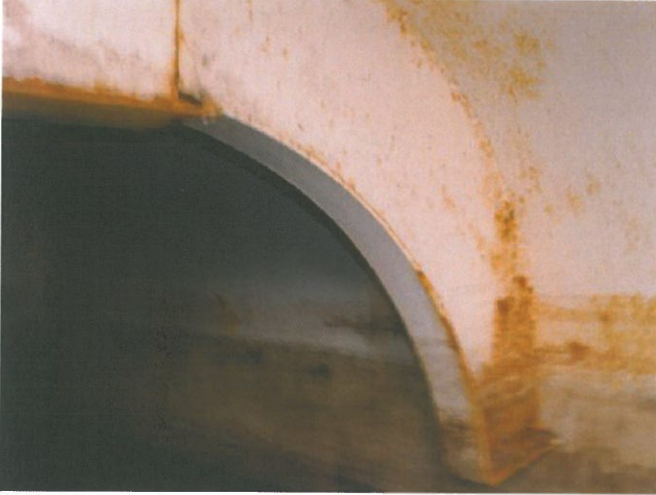
DP#25

Pinpoint and edge corrosion on roof support bracket

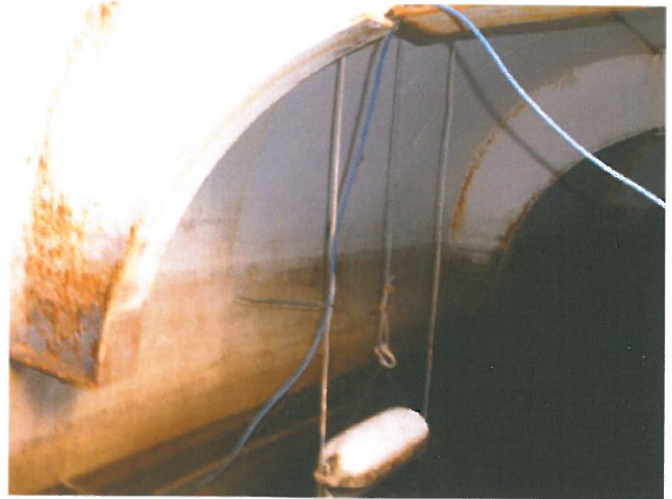
DP#26

Pinpoint and edge corrosion on roof support bracket

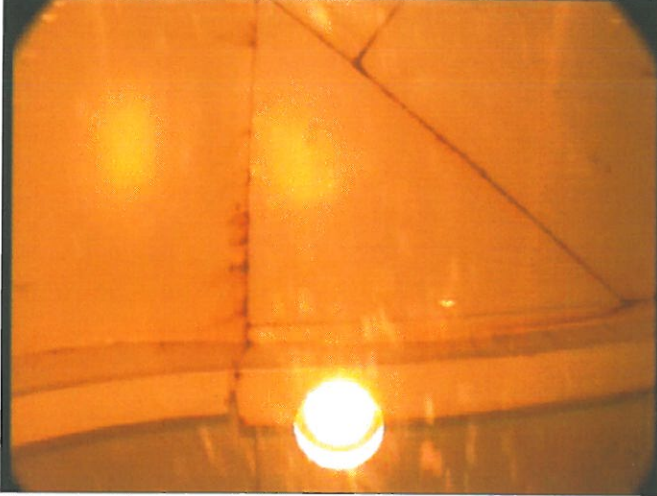
VS#1

Edge corrosion on roof plate welds
(Time 1:08)

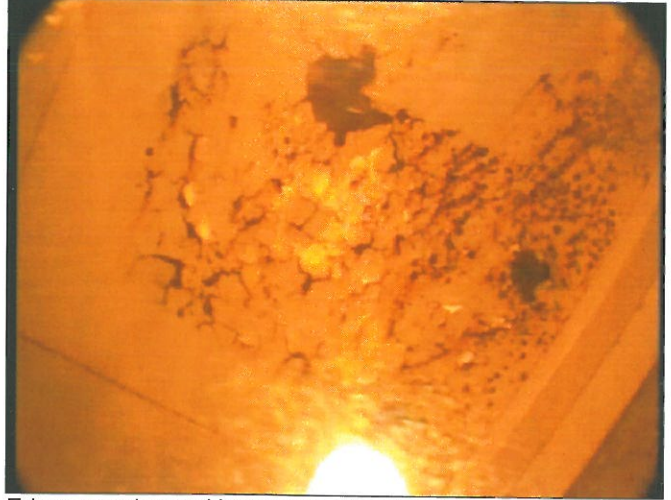
VS#2

Edge corrosion and large area of coating failure on roof plates
(Time 2:53)

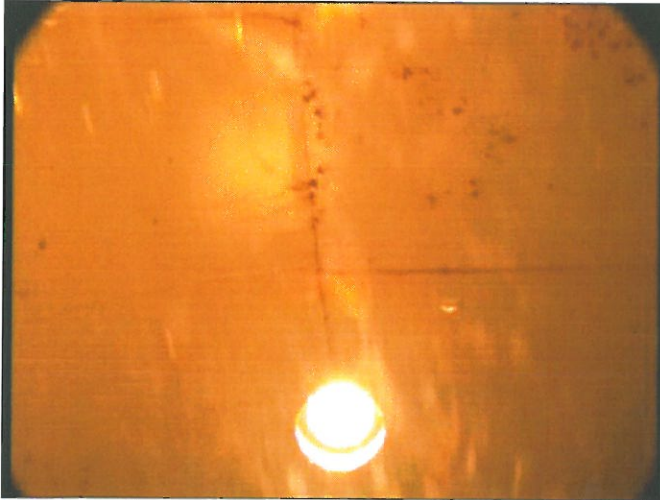
VS#3

Edge corrosion on roof support beams
(Time 3:39)

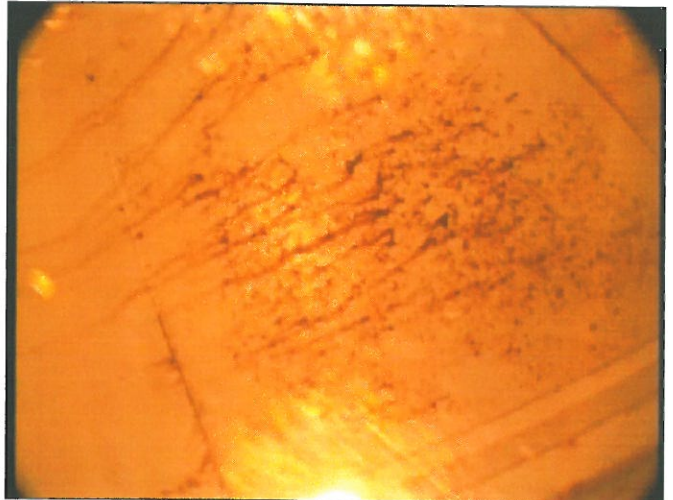
VS#4

Coating failure and surface corrosion on roof plate welds (Time 5:07)

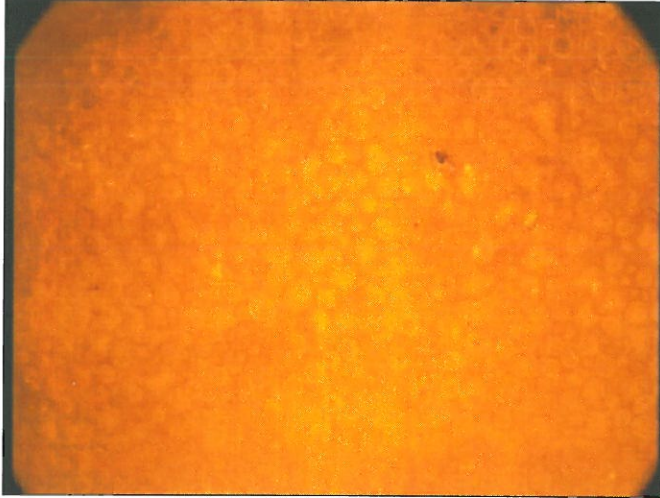
VS#5

Small corrosion cell and blistering on upper shell coating
(Time 6:41)

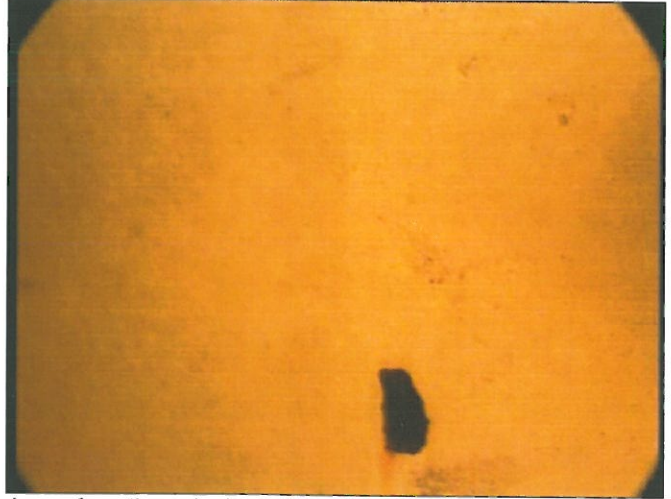
VS#6

Area of coating missing with surface corrosion
(Time 9:00)

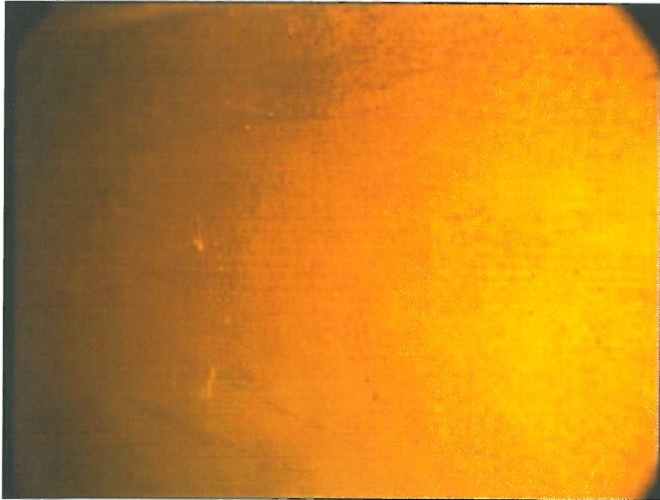
VS#7

The shell has extensive blistering that is leading to surface cracks coating, exposing the underlying steel. These issues can be seen in VS#7-11. Coating blistering was noted on 85% of shell surfaces. The exposed steel is not rusting due to the protection offered by the impressed current cathodic protection system.

Large area of blistering on upper shell coating
(Time 10:52)

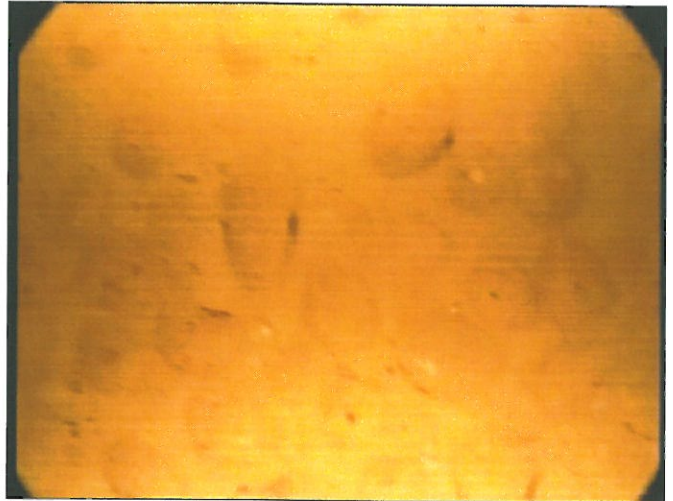
VS#8

Large area of blistering on mid shell coating
(Time 12:42)

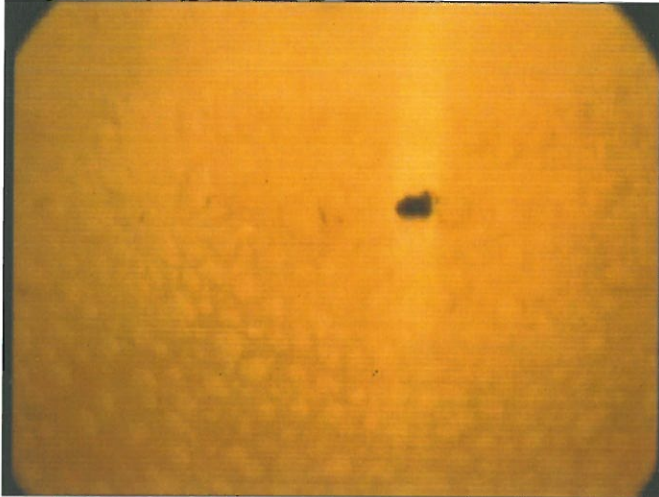
VS#9

Cracked blister to steel substrate on mid shell
(Time 15:12)

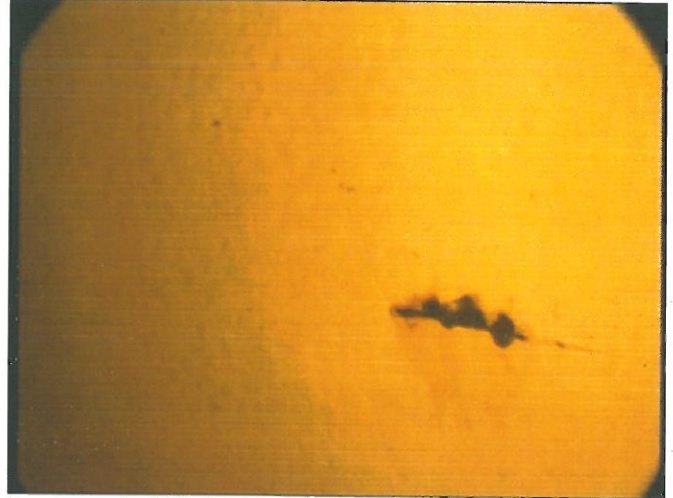
VS#10

Large cracked blister on mid shell coating
(Time 17:33)

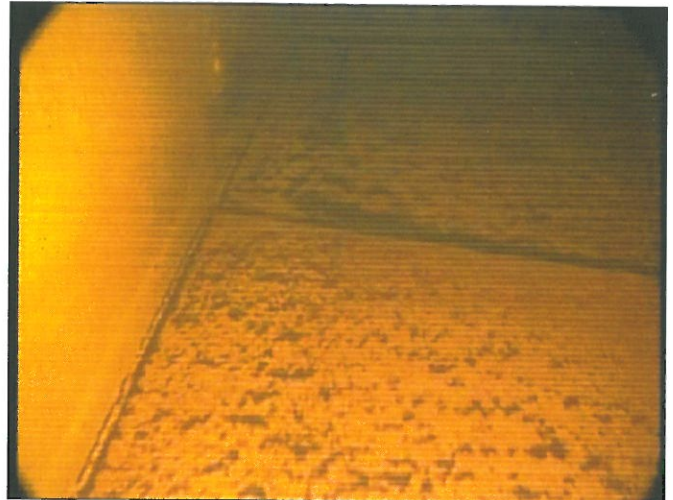
VS#12

Minor dusting of sediment on floor
(Time 24:59)

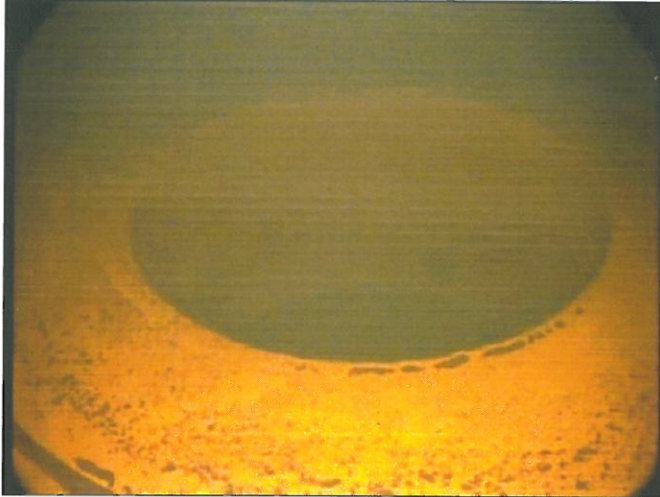
VS#13

Large tank drain on floor
(Time 24:59)

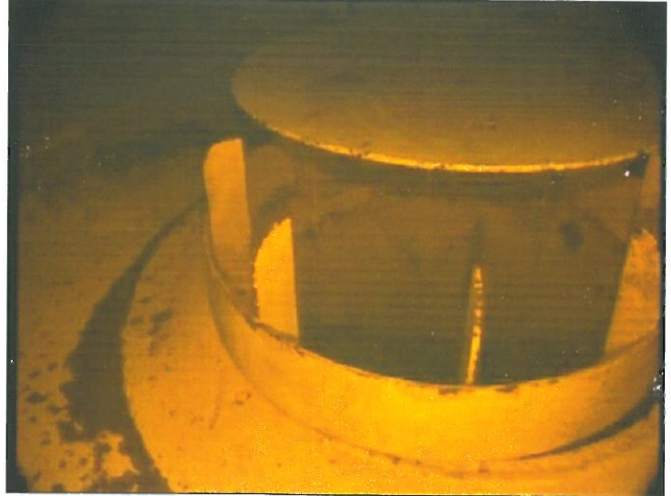
VS#14

The reservoir uses a combination inlet/outlet pipe with a combination diffuser and vortex breaker. The diffuser is broken, as seen in VS#14.

Combo inlet/outlet pipe with broken vortex breaker
(Time 26:31)

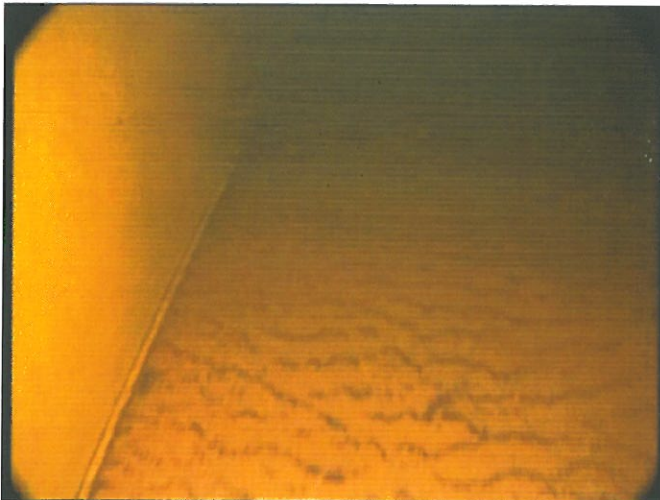
VS#15

Minor dusting of sediment on tank floor
(Time 27:29)

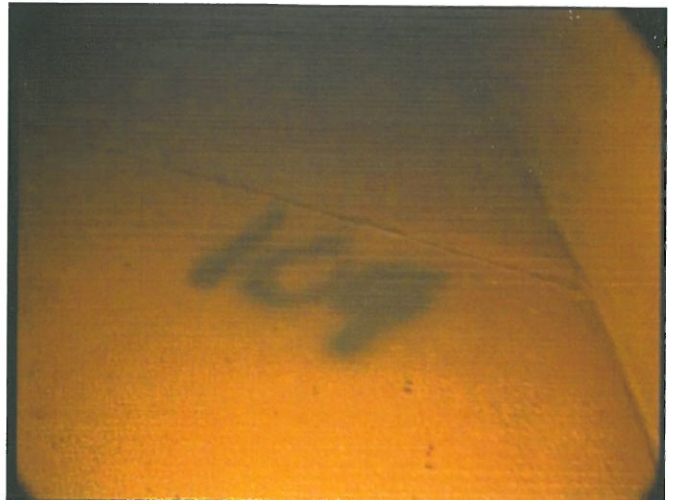
VS#16

Light staining on floor plates
(Time 36:01)

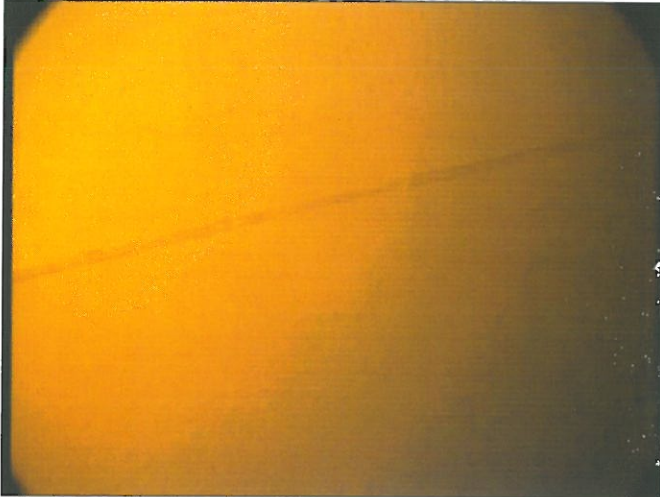
VS#17

Blistering on lower shell coating
(Time 37:54)

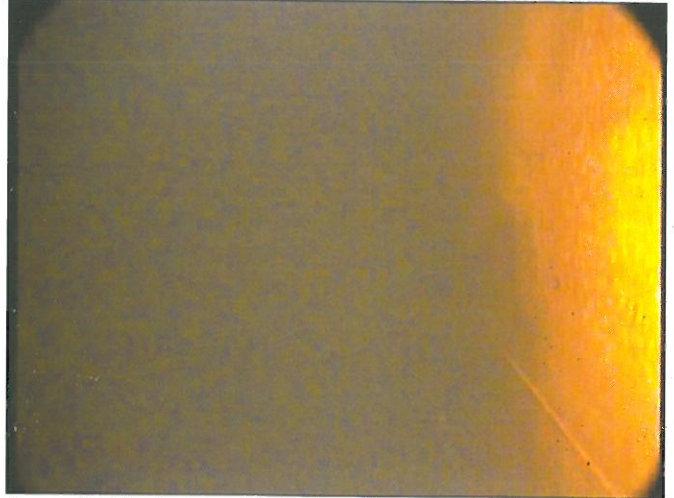
VS#18

Area of blistering on mid shell coating
(Time 42:27)

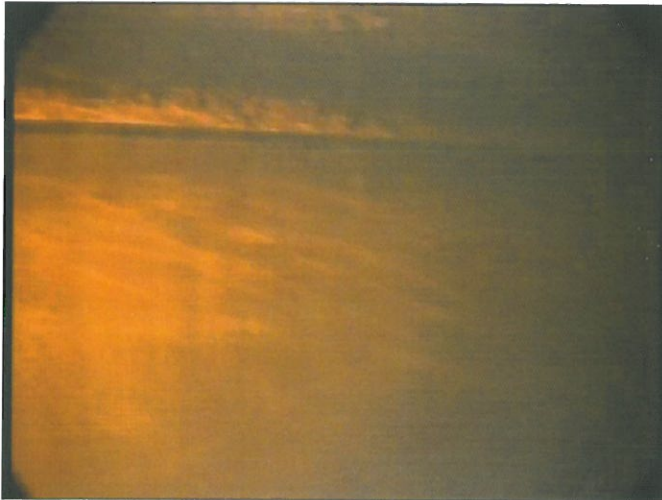
VS#19

Staining and corrosion on painters ring
(Time 46:13)

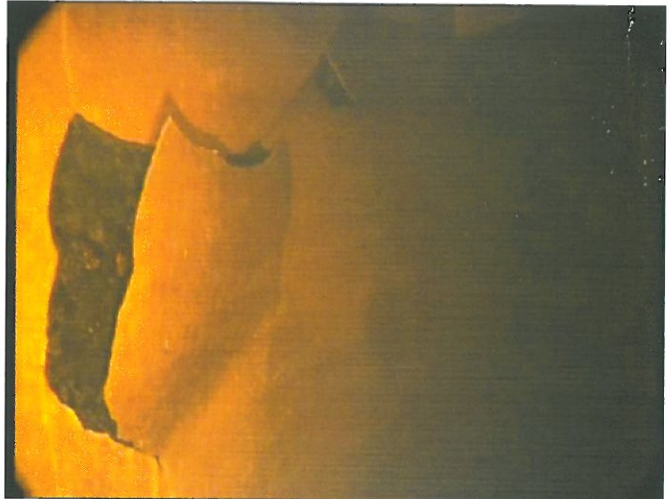
VS#20

Large area of coating failure and surface corrosion on upper shell plate
(Time 47:47)

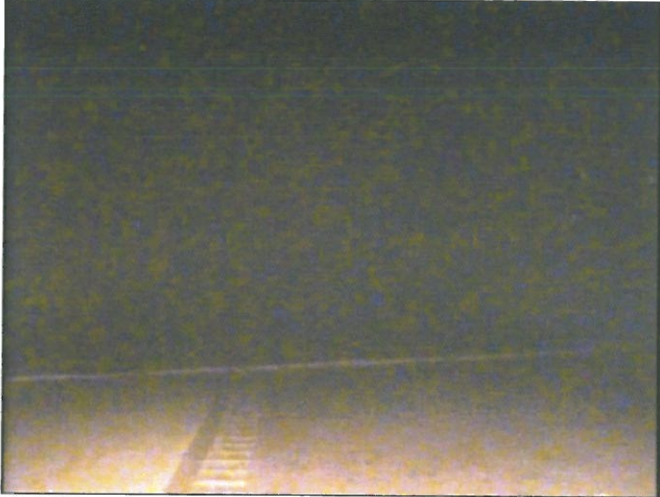
The floor of the tank is in good condition and covered by a thin film of sediment shown in VS#21 and VS#22. We did not see the same blistering in the coating on the floor. The floor was viewed before and after the removal of the sediment.

Light film of sediment on floor plates
(Time Ch. 2 00:10)

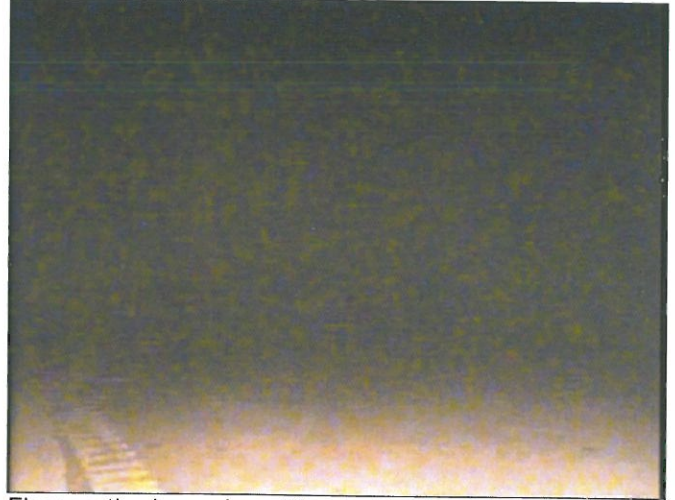
VS#22

Floor coating in good condition
(Time Ch.2 1:25)
