Bethel - Sewage Lagoon

Bethel Lagoon Truck Dump Site Field Report

PREPARED FOR:	City of Bethel Public Works Department
PREPARED BY:	Mark Parent, P.E./CH2M HILL
COPIES:	Tom Wolf, P.E./CH2M HILL, Bud Alto, P.E./CH2M HILL
DATE:	April 10, 2014
PROJECT NUMBER:	492385

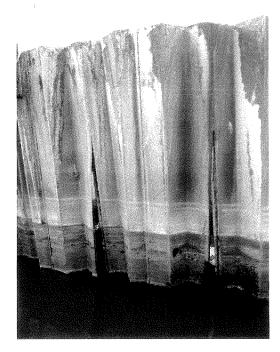
Multiple seams of the interlocking sheet pile sections were also observed to be separating from the bottom up. The two most extreme instances of this separation appeared to have separated by approximately 4 to 6 inches at the water surface level and extended half- to three-quarters of the way up the wall (See Photos 5 and 6). Voids in the soil behind the wall were also noted indicating soil migration into the lagoon.

Photo 5: Separation at wall seams.

The current condition of the sheet pile bulkhead wall at the lagoon signifies a failed structure. The extreme angle of the sheet pile wall and the large separations at the interlocking seams indicate that the wall is not structurally fit for its intended use of supporting 4,000 gallon sewage trucks. The separation of the sheet pile sections appears to be undermining the stability of the soil it is meant to retain. The soils were frozen at the time of these observations, but soil migration into the lagoon can be expected to increase in the spring as it thaws. It is recommended that the City of Bethel restrict vehicle access to a minimum of 15 feet from the edge of the existing bulkhead wall until it can be replaced.

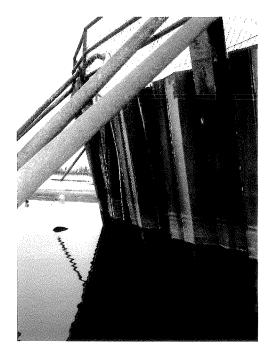
Photo 6: Separation at wall seams.

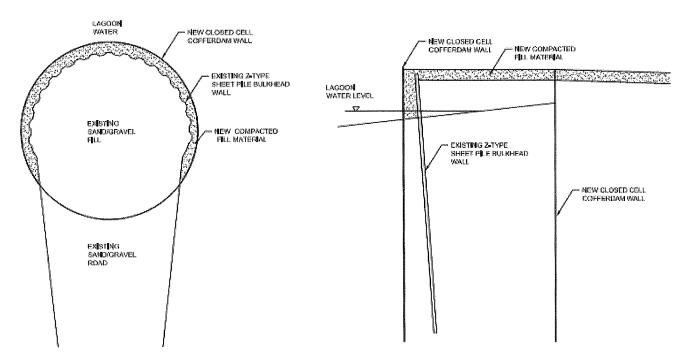
Figure 1: Closed cell cofferdam wall conceptual sketch. Not to scale & not for construction.

The existing design of the bulkhead wall is somewhat unusual due to its curved profile with Z-type sheet pile. Z-type sheet pile is generally not designed to resist the additional stress created by a curved profile. Additionally, the cantilevered height of this wall above the water surface is fairly high considering the truck loading requirements and the section size of the sheet pile. CH2M HILL recommends the existing bulkhead wall be replaced with a closed cell cofferdam wall (See Figure 1). Cofferdam walls can be designed as self-supporting wall that do not require supplementary waling and anchoring.
