**CITY DOCK AND FERRY TERMINAL IMPROVEMENTS
REAL ESTATE APPENDIX C
PORT LIONS, ALASKA**

**CITY DOCK AND FERRY TERMINAL IMPROVEMENTS
TRIP REPORT APPENDIX D
PORT LIONS, ALASKA**

Final Underwater Inspection Report

**2009 UNDERWATER INSPECTION REPORT
EXECUTIVE SUMMARY**

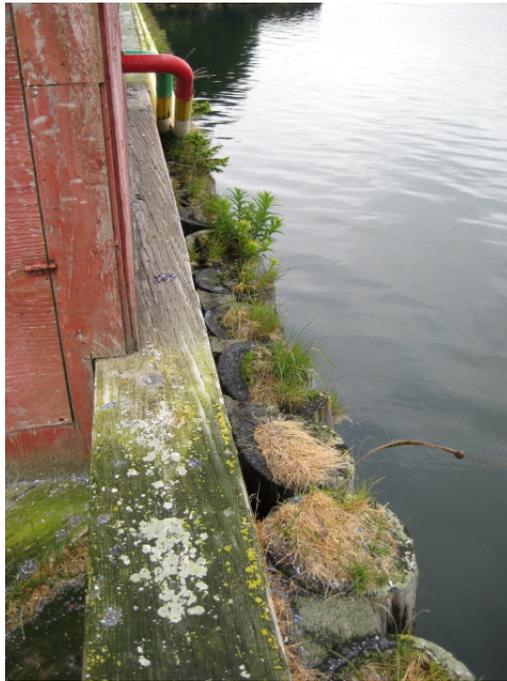
The tops ends of most of the piles along the outside of the dock are recessed and have vegetation growing in them.

Figure D-1. Vegetation growing atop pile ends

- Cut and cap outer piles to prevent vegetative growth

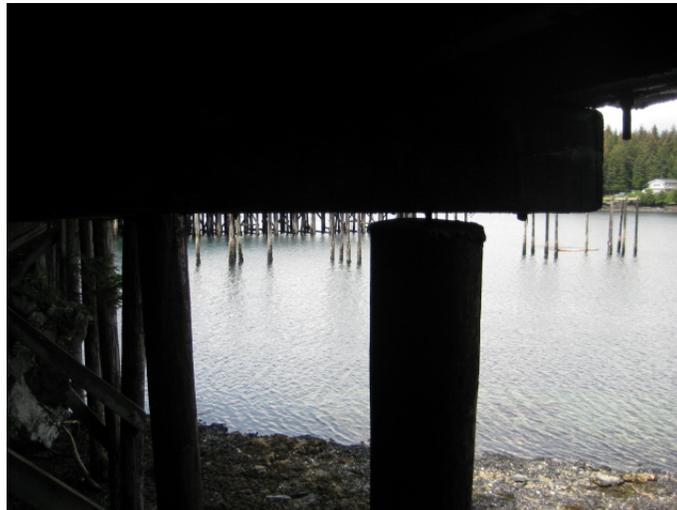
Multiple piles and drums were noted that are not touching the bottom of the deck.

Figure D-2. Gap between pile and dock

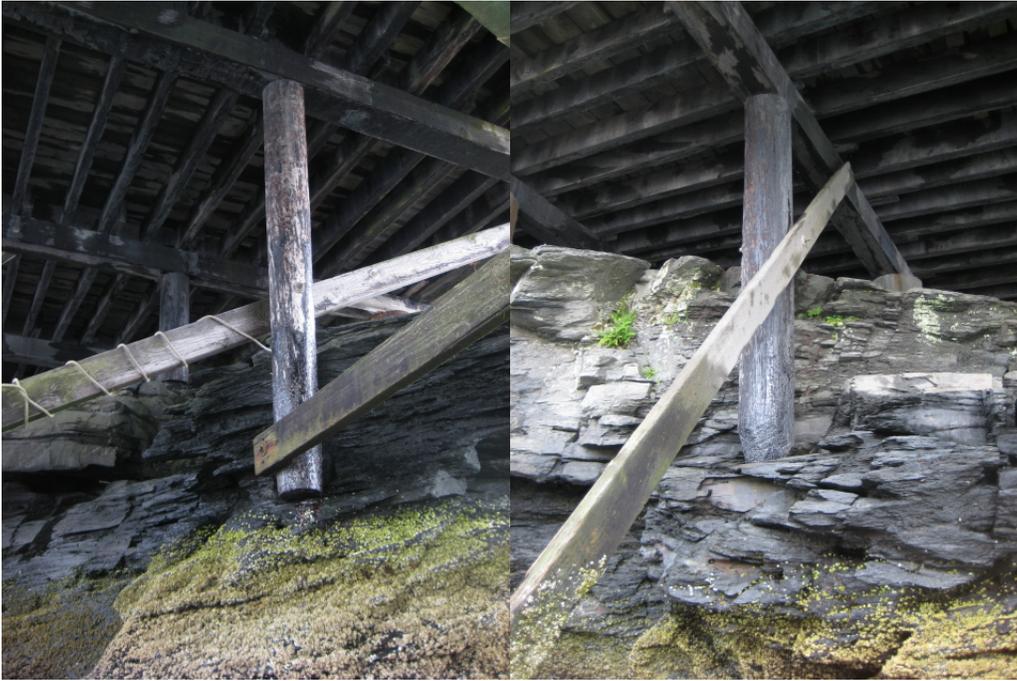
All bracing below a certain elevation are missing or obviously decayed.

A pile tapered at the bottom was noted resting upon bedrock.

Figure D-3. Unbraced piles on bedrock

- Replace all bracing

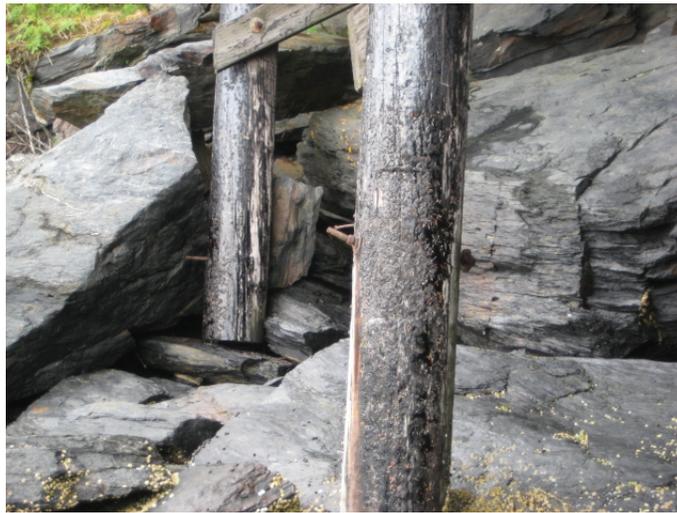
Bolts with nothing attached to them indicate a missing lowest level of cross bracing.

Figure D-4. Unbraced piles on bedrock with bolts indicating missing bracing

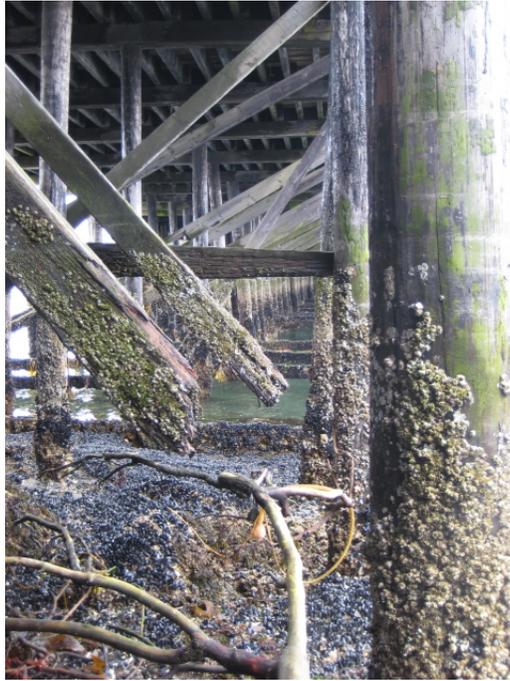
Figure D-5. View underneath causeway

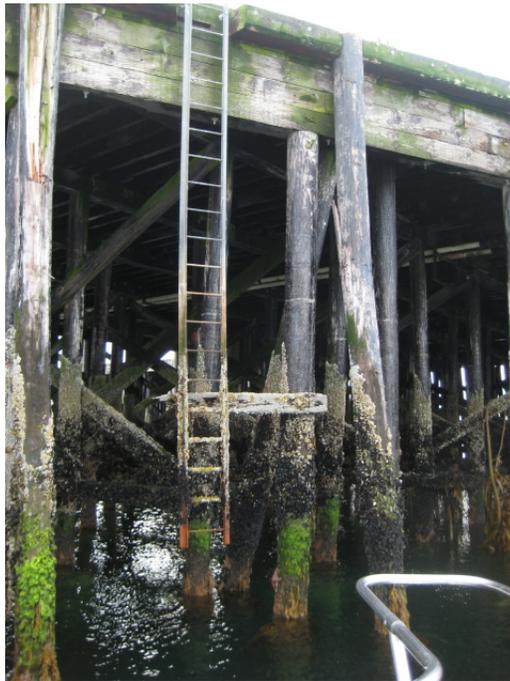
Bracing for the dock ladders are missing. The ladders are only supported by their attachment point to the dock at the top of the ladder. This is a safety concern.

Figure D-6. Dangling ladder missing supports due to decay of bracing

- Replace ladders

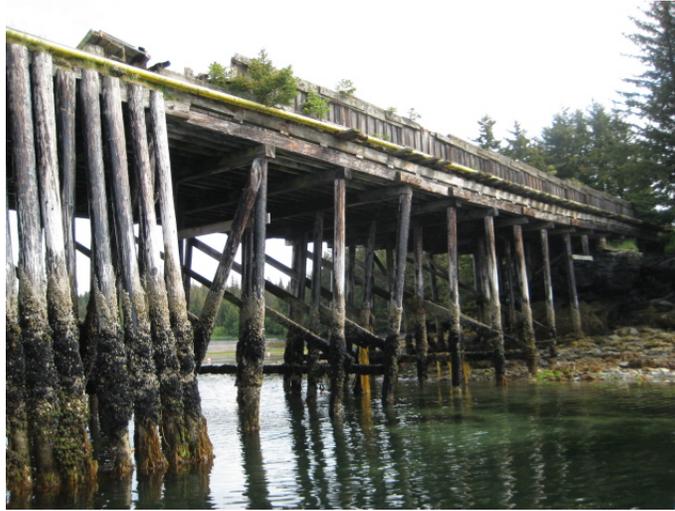
Numerous crooked, non-batter piles were observed.

Figure D-7. View showing misaligned pile under causeway

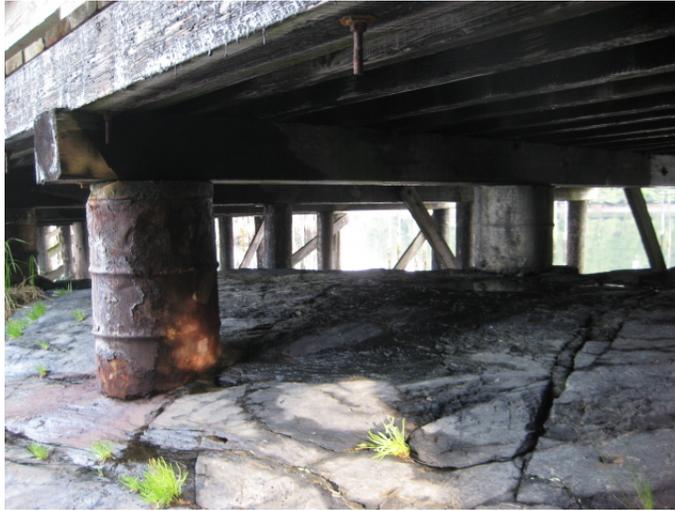
The causeway portion of dock is partially supported by concrete filled drums, some of which have eroded away from the concrete within. We observed no bracing at the top or bottom of these drums.

Figure D-9. Unbraced concrete barrel supports atop bedrock under causeway

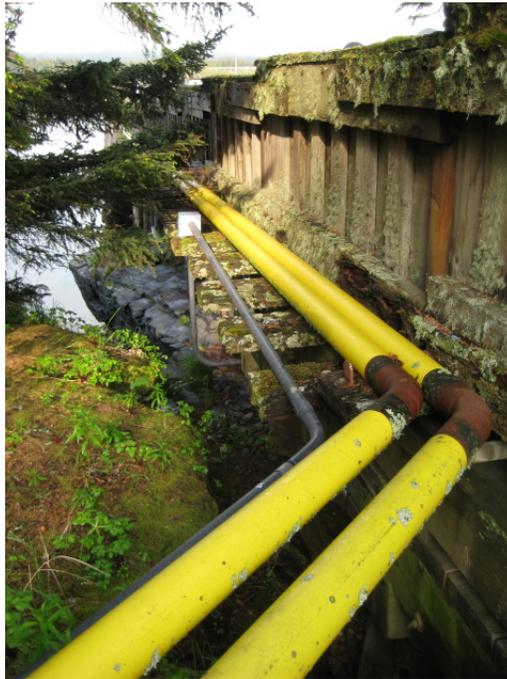
Figure D-10. Fuel lines on edge of dock

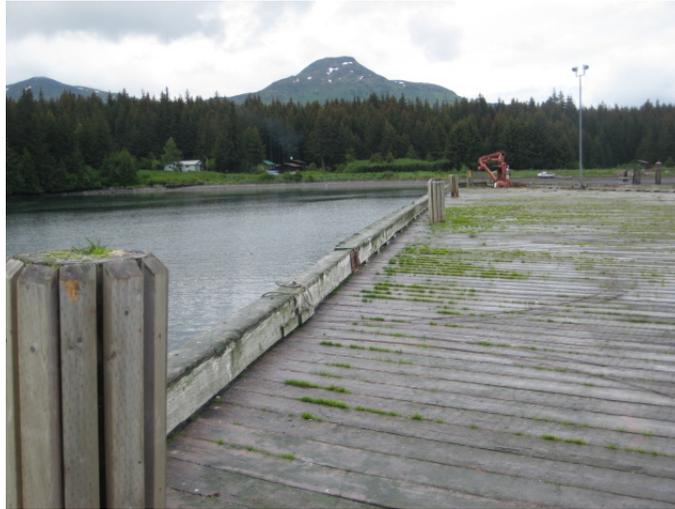
New surface decking was constructed directly atop old decking material. This prevents adequate drainage through the decking. There is much vegetation, mostly grass, sprouting out of the cracks of the decking. Small trees were also observed, especially along the perimeter on the deck and along the bulk fuel lines.

Figure D-11. Typical dock surface with vegetative growth

- Replace decking

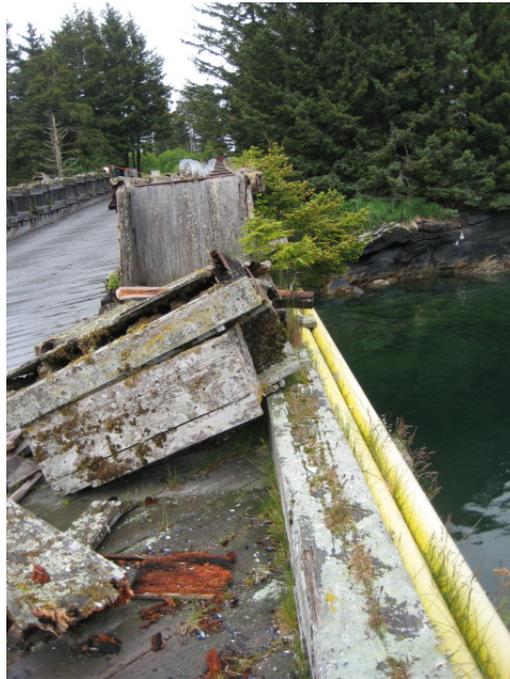
Throughout the dock there is antiquated equipment including, pipes, pumps, and decaying wooden live crab traps, mostly related to its origin as a cannery dock. Removal of this equipment may be a consideration as part of any dock repair efforts.

Figure D-12. Decaying live crab pots, fuel lines, and vegetative growth including trees

- Remove live crab tanks

- Remove old equipment

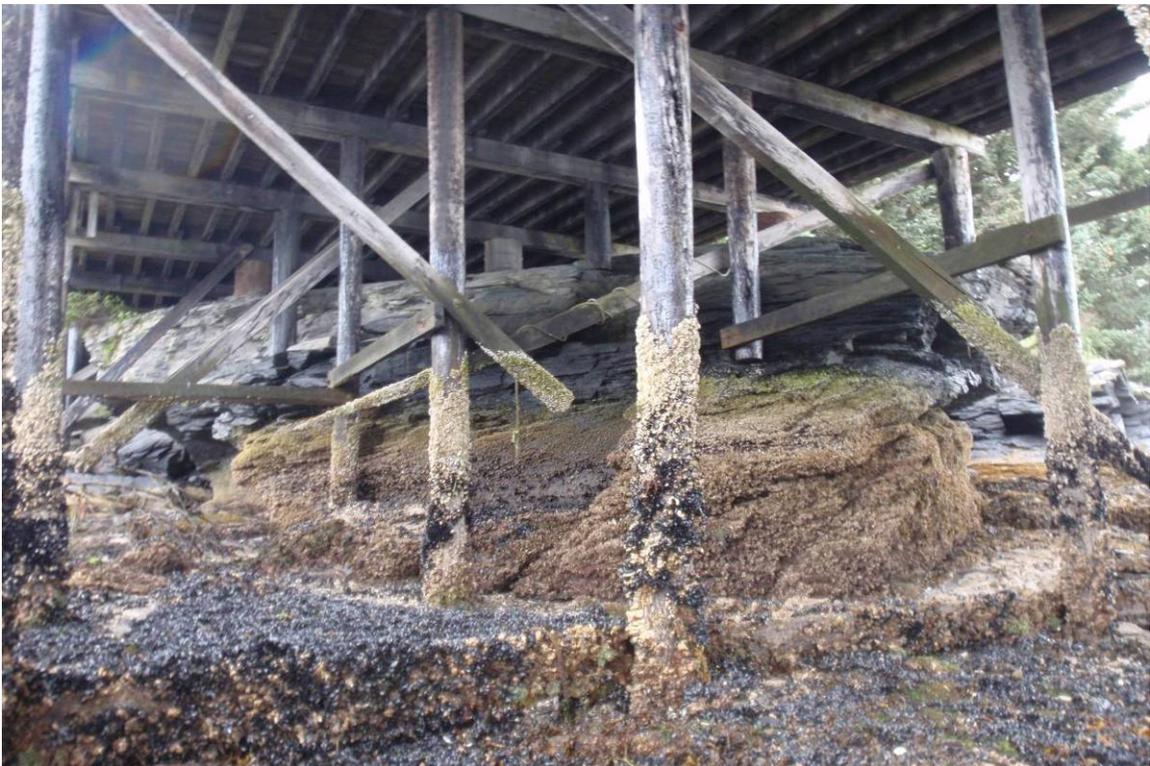
The banks along Kizhuyak Bay in the vicinity of the ferry terminal were observed to be in stable condition. Embankment protection in the form of large riprap was observed along the shore at the ferry terminal. There was no sign of active erosion. Refer to Photograph 6 for a view of the embankment. The channel bottom consisted of sand and silt.

Photograph 6. Bent 7, View of Embankment

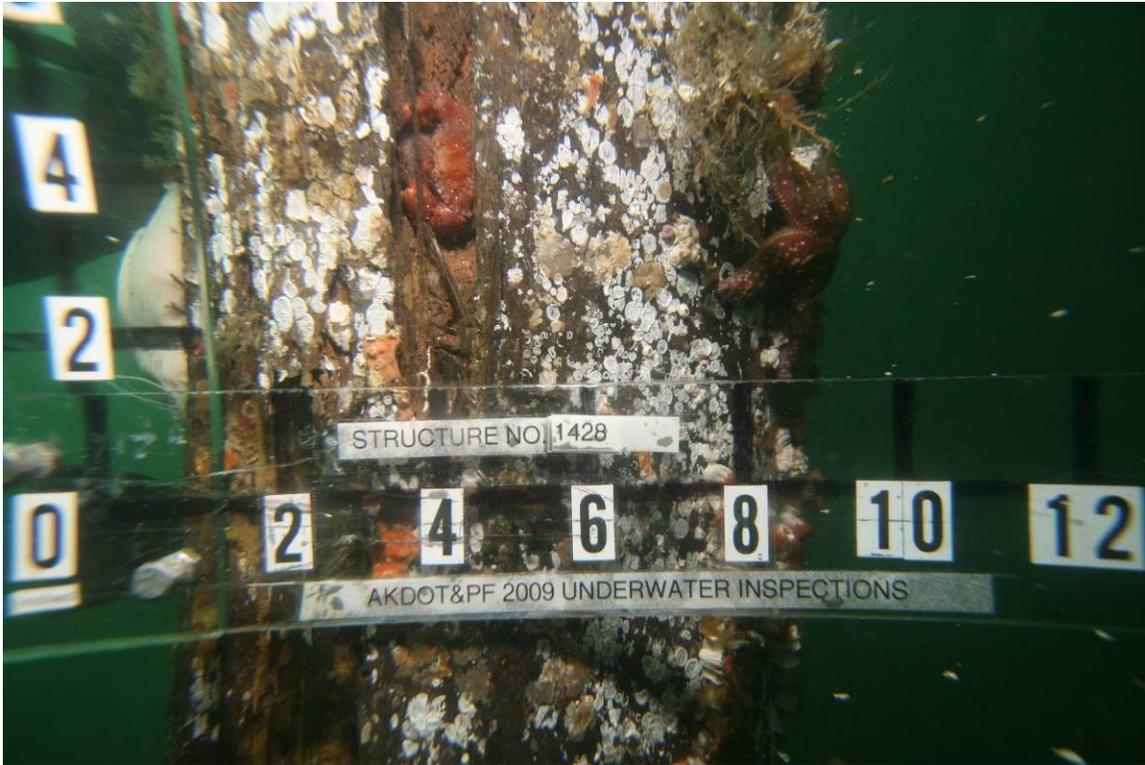
The piles were covered with light to moderate marine growth consisting of barnacles and vegetative growth from the channel bottom to the high watermark. There are several piles that have minor to moderate amounts of decay. The most severely deteriorated pile is 37-I, which has an area of decay near the channel bottom, 14 in. high by 8 in. wide, with 4 in. of penetration. Refer to Photograph 7. The majority of the piles are sound with no evidence of decay.

Photograph 7. Pile 37-I, Decay

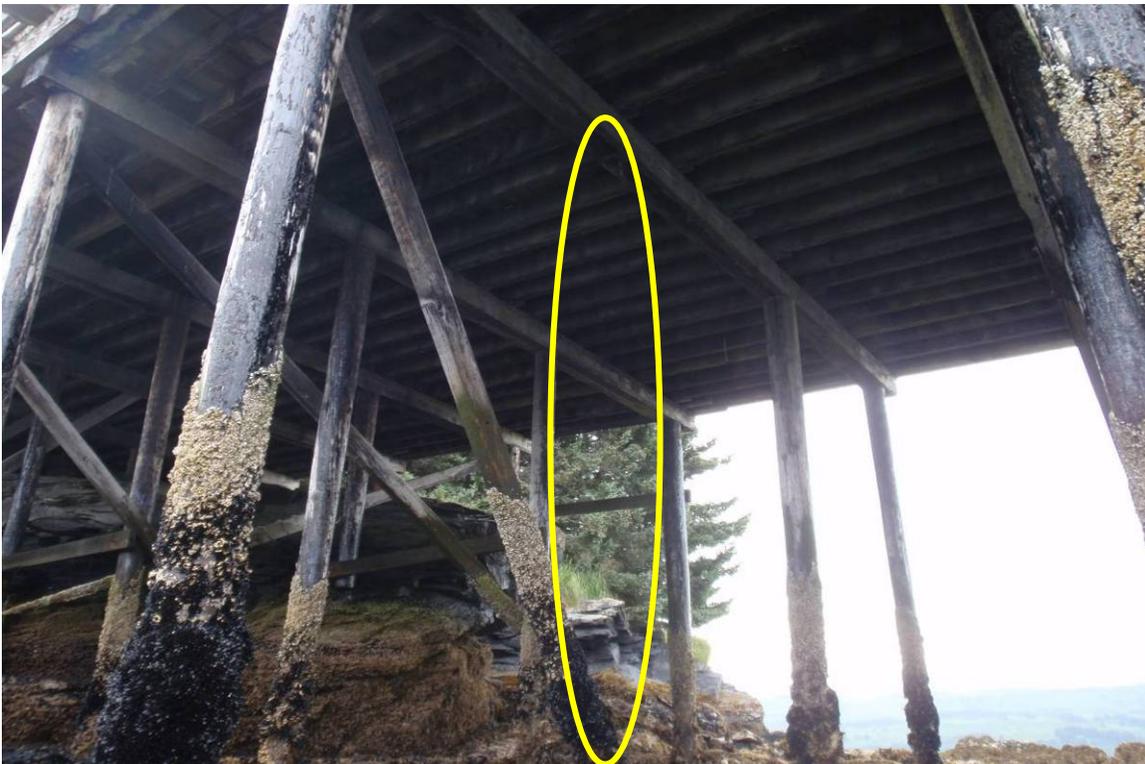
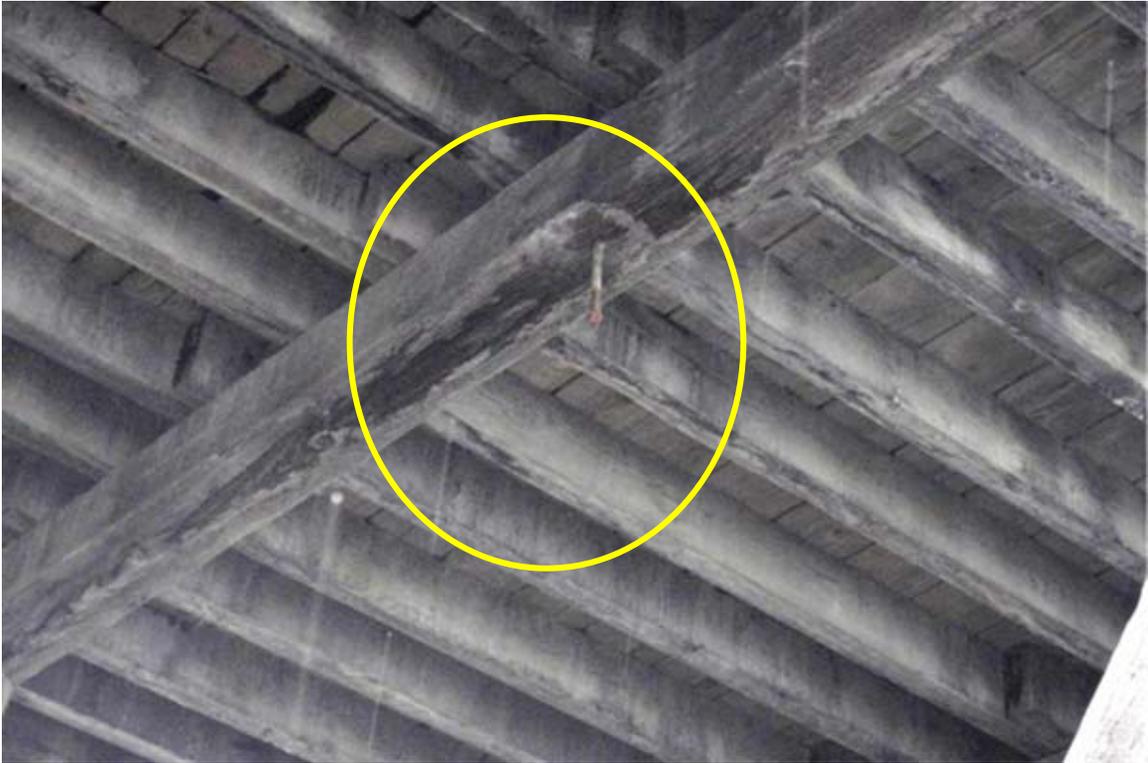
The inspection revealed that Pile 10-C is missing. This is the third pile in a four pile bent. The drift pin still extends out of the cap, evidence of where the pile attached to the cap. There was no sign of the pile and no evidence of the pile below water at the channel bottom. Also there was no sign of any structural overloading of the cap in the location of the missing pile. Refer to Photographs 8 and 9.

The inspected bents are rated as **Good to Fair (Code 7 to 5)**, with the exception of Bent 10, which is rated as **Serious (Code 3)** in accordance with the FHWA National Bridge Inspection Standards (NBIS) coding information. Condition rating forms in both NBIS and Bridge Management System (BMS) formats for this ferry terminal are presented in the Appendix.

Photograph 8. Bent 10 – Pile C Missing

Photograph 9. Bent 10 – Pile C Missing – Cap with Drift Pin

- Confirm or perform a load rating analysis of Bent 10. Stripe or block access so that traffic travels over Piles A and B of Bent 10, until the pile can be replaced.
- Evaluate fender system to upgrade and accommodate vessels that currently dock at the pier or at a minimum replace missing and deteriorated fender piles.
- Replace or repair Pile 37-I
- Replace and repair cross bracing.
- Rock socket piles near shore into bedrock.
- In accordance with NBIS recommendations, the next routine underwater inspection for this structure should be conducted at an interval not to exceed 60 months.

Overall, the inspected bents of the structure were found to be in **fair** condition. The deterioration of the support piles is relatively minor considering the number and typical load path redistribution found in timber piles. However, with the exception of Bent 10, having one of four piles missing and an interior pile at that, the capacity of the bent has been significantly compromised. Even though the previous underwater report did not indicate the missing pile, a review of several cycles of topside reports indicated that this pile has been missing for a number of years. The pier is load restricted, which may be a result of the missing pile. It is recommended that the load restriction be reviewed and the capacity of Bent 10 be evaluated. Traffic may need to be routed over the fully supported section of the Bent until the pile can be replaced.

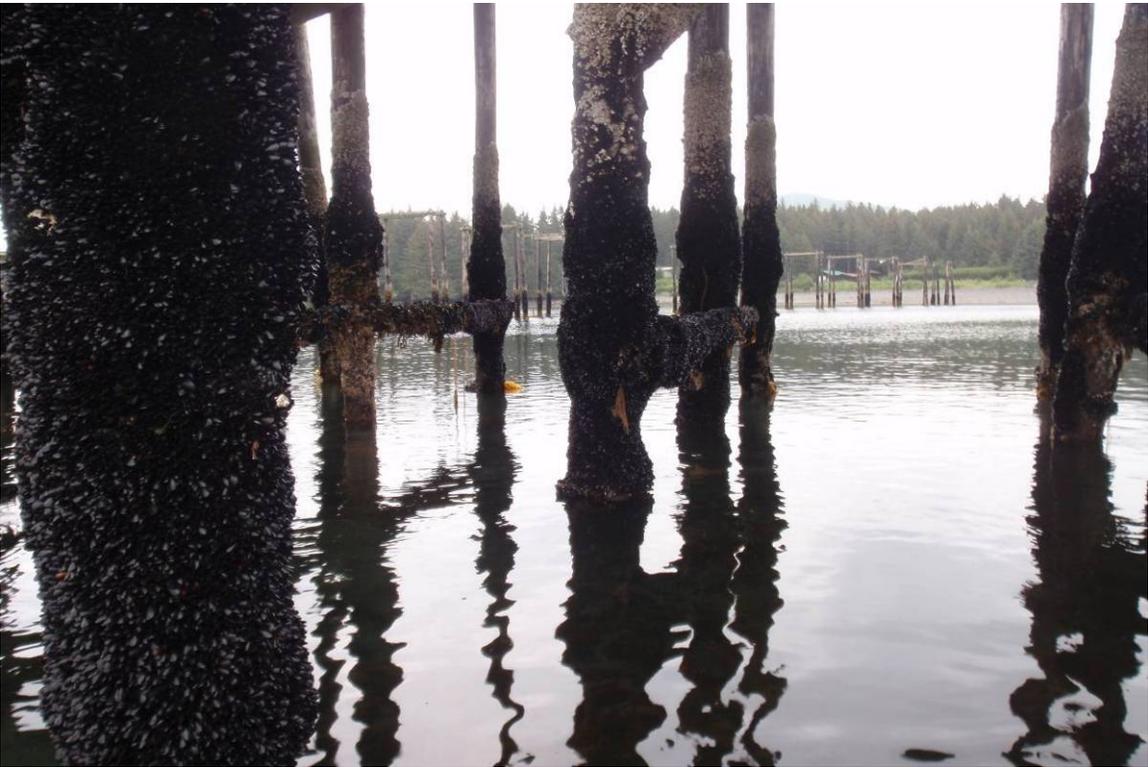
Moderate to severe deterioration of the cross bracing was observed. The deterioration is most severe near the shoreline where the structure is not protected from the timber wave screen. This deterioration consisted of broken or missing sections of the cross bracing and in some locations the cross bracing has become detached from the piles. The cross bracing located on the section of the pier that is protected by the wave screen had less severe

deterioration consisting of random disconnected braces and moderate decay. Refer to Photograph 10.

Photograph 10. View Typical Cross Bracing Deterioration

Lateral support of the bents near the shore has been comprised by the deterioration and damage of the cross bracing. The cross bracing should be repaired or replaced to restore lateral support to the structure.

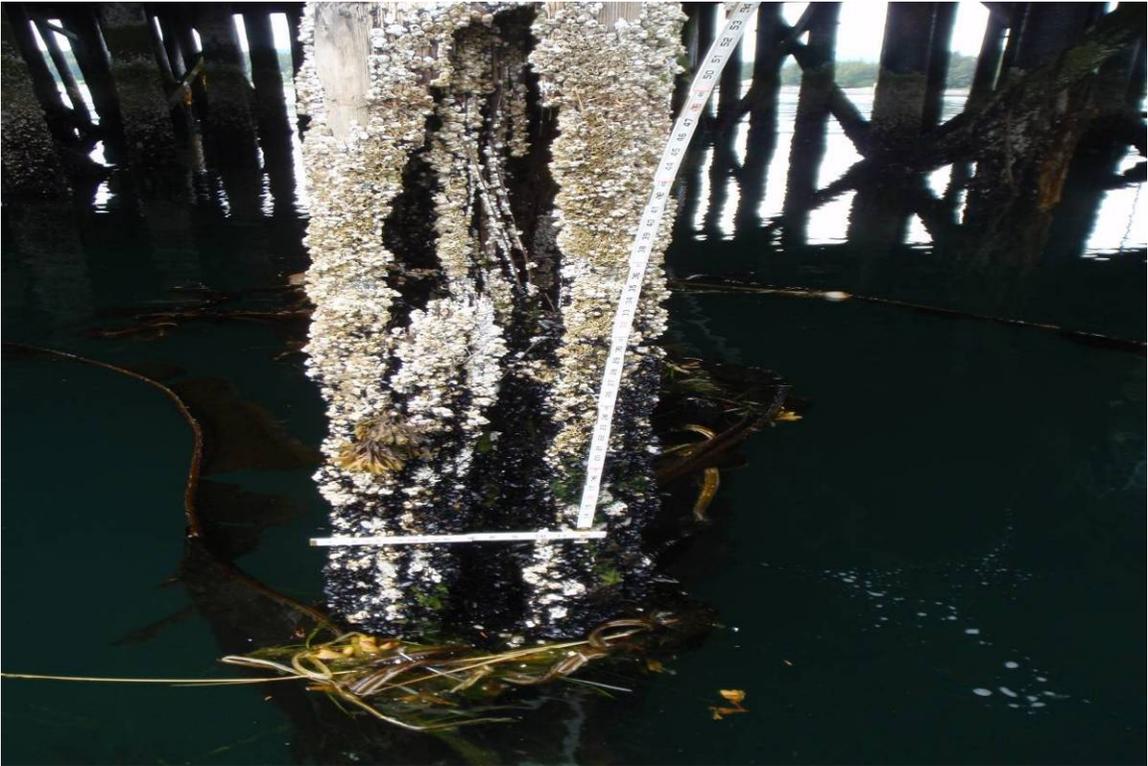
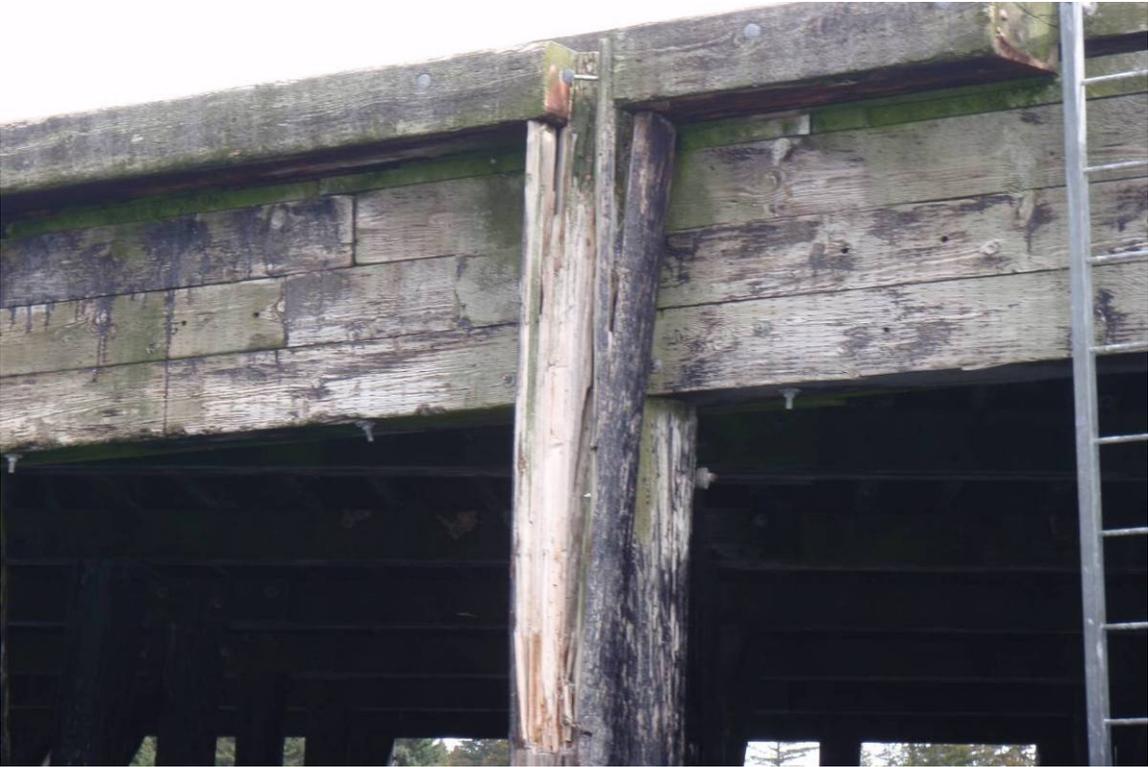
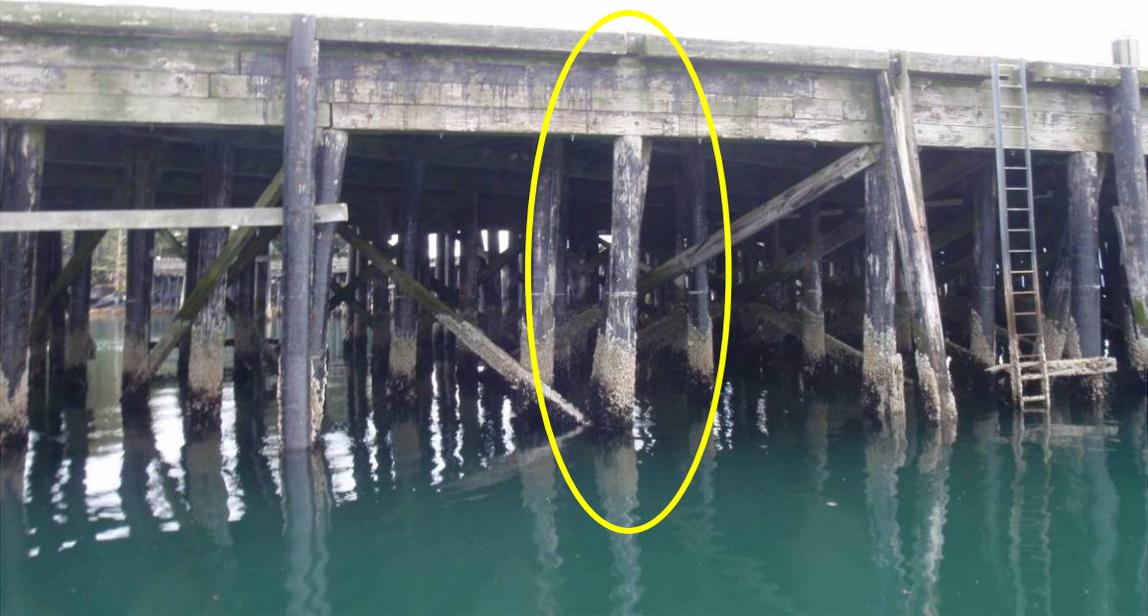
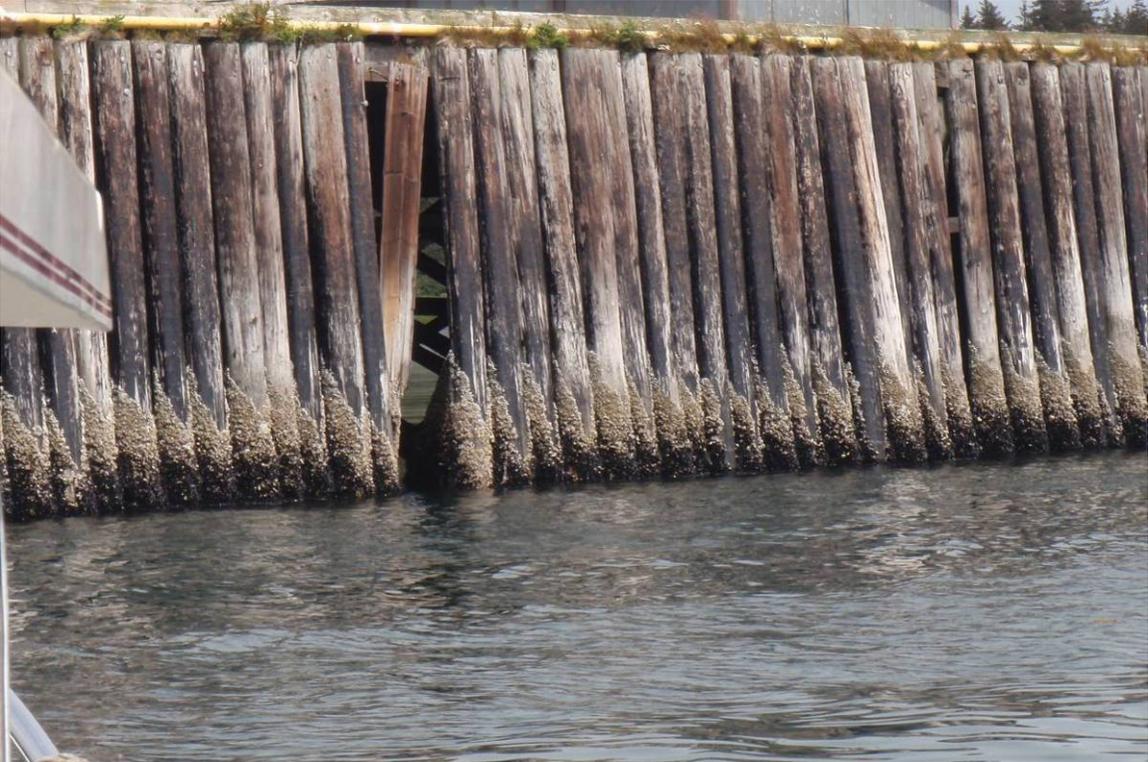
The timber fender system has areas of impact damage and decay. There are a number of fender piles that are missing or damaged. The timber wave screen has several missing and deteriorated timber piles; however, the overall effectiveness of the system has not been compromised. It continues to function as a protective, dampening system for the pier. Refer to Photographs 11 through 16.

The fender system is in need of repair. For the vessels that call on the port, the fender system is undersized; resulting in excessive lateral loading, impact damage, and premature failure of the fender system. Just replacing or repairing the existing damage will only provide a

Photograph 11. Pile 35-J, Timber Fender Deterioration

Photograph 12. Timber Fender N Broken

Photograph 13. Timber Fender O Missing

Photograph 14. Wave Screen Missing Pile

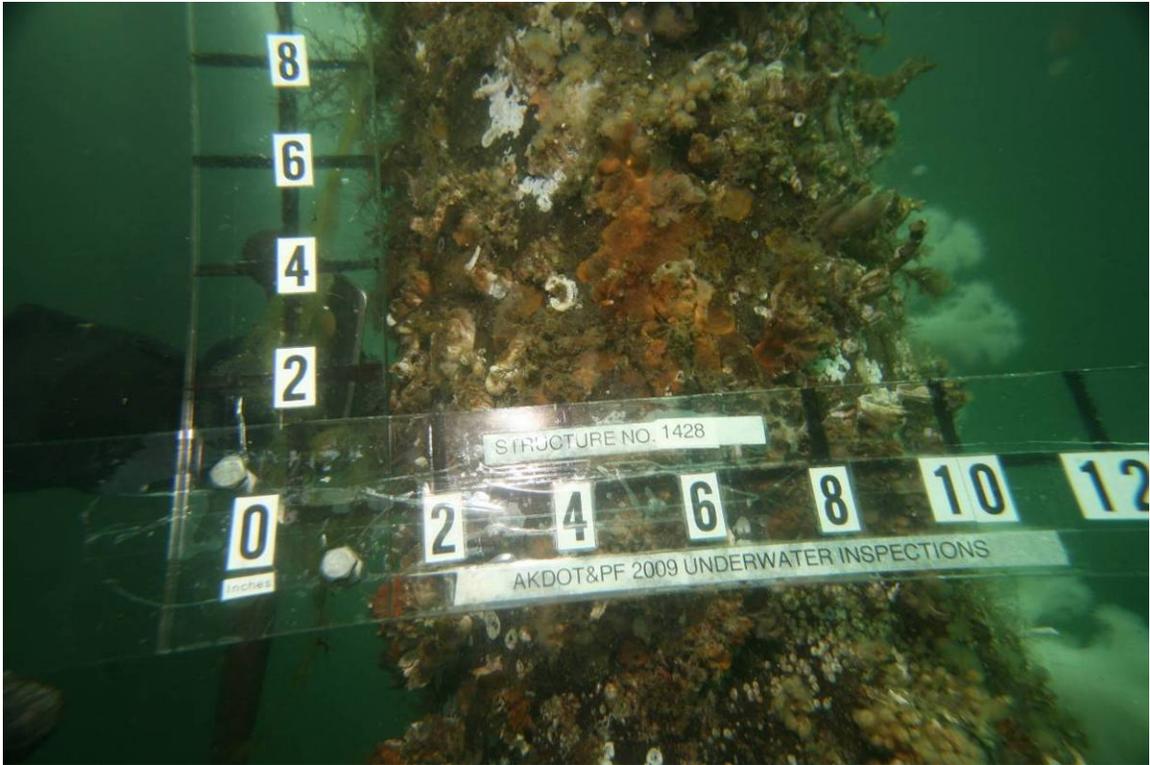
Photograph 15. – Typical Marine Growth
