# Wales - Wales Clinic Repair and Renovation

Project will involve the repair and renovation of electrical, mechanical, and structural defects which are noted in inspection of building.

## MECHANICAL FINDINGS

APPENDIX A – PHOTO LOGS

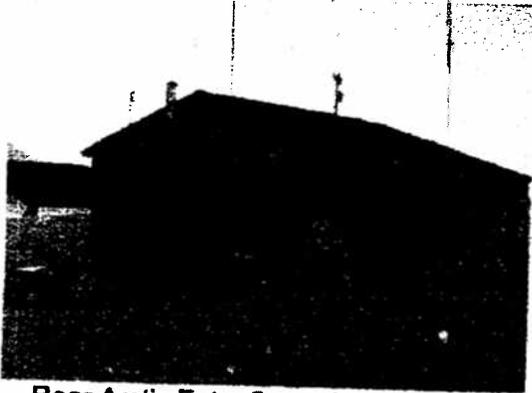
Rear Arctic Entry Snow Accumulation

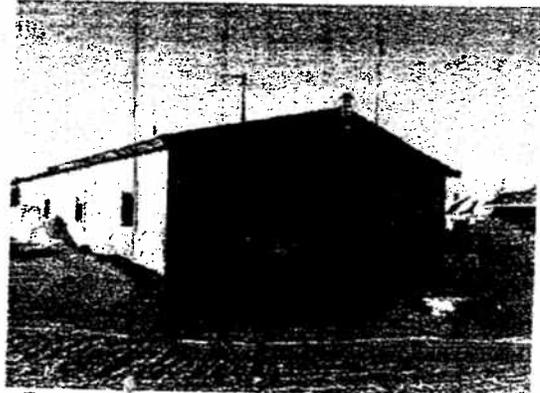
The present fuel oil tank is a 55 gallon drum that is strapped down to the rear deck of the facility. This fuel oil tank is not an approved tank for the storage of Class II flammable liquid (such as fuel oil). The construction of the present tank does not comply with NFPA 30 for fuel distribution and is a code violation (IFC 3404.2.7).

Rear Entry – Fuel Drum & Arctic Box

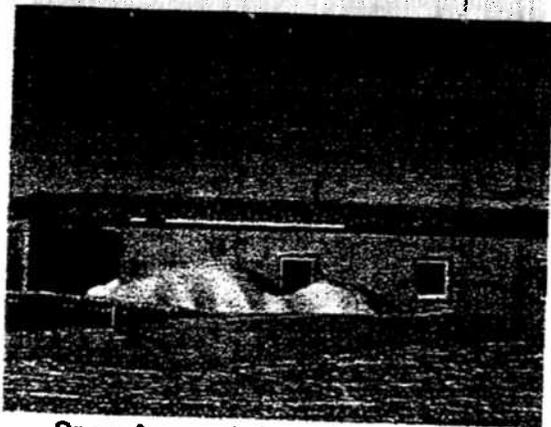
Snow Accumulation – S Wall
