Alaska Center for Children and Adults - ACCA Facility Upgrade and Expansion

FACILITY UPGRADE AND EXPANSION FAIRBANKS, ALASKA

Bettisworth North Architects and Planners has been requested by the Foraker Group to perform a facility assessment of the two buildings mentioned above. The assessment will focus on the existing conditions and identify deficiencies affecting the facility operations, durability, and code compliance. This assessment has been organized to present the existing conditions, report the observed problems, and document the proposed upgrades. Options for renovating and providing additional area have also been created in concept form and included in this report. This report, included in the following pages, shall assist both ACCA and the Foraker Group in planning facility improvement projects or plan for new additions to accommodate a growth in the ACCA program and related space needs.

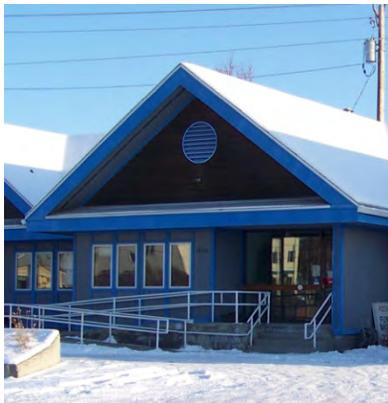
Entry Stairs and Ramp

1. The stairs are not uniform in height, 6-1/4" – 8-3/4" and do not meet code. IBC requires all stair risers to be uniform within 3/8 inch.

Main entry ramp and stair are not protected from snow. IBC requires ramp access be kept free of water, snow, and ice.

1. Entry ramp and stairs must be replaced with new concrete ramp to meet ADA accessibility codes. Stairs must be constructed in a manner so that all riser heights are uniform to meet City of Fairbanks building codes.
2. Ramp must be constructed with a rise-to-run ratio of 1:12 maximum per ANSI 2003.
3. Railings for ramp and stairs must be mounted at a height of between 34 and 36 inches per ANSI 2003.
4. Parking striping must be added to the parking lot to indicate appropriate parking and access aisles, per ADA/ANSI.
5. Refuse dumpster is required to be screened, per Fairbanks Landscape Ordinance.

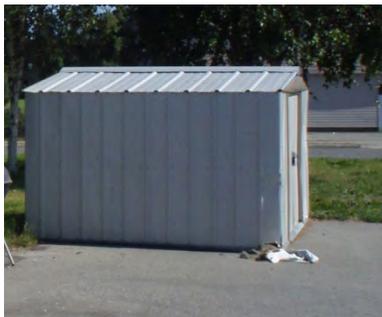
Storage Shed

2. Residential style prefabricated metal storage shed on southeast corner of lot is in poor condition as a result of damage from snow removal equipment.

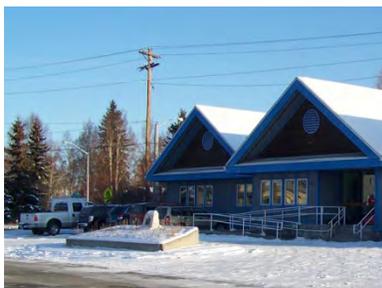
ACCA Parking, Monument Planter

3. Monument planter creates a difficult entry for vehicles and pedestrians. Originally conceived as a pull through dropoff, it adds a level of congestion to the front of the building.

1. The addition of sidewalks serving the parking lot would greatly improve access to building.
2. We recommend removing monument planter to improve safety and access of vehicle and pedestrian routes to the building.
3. Landscaping between building and parking would soften the look at the entry and could help reduce heat gain in the summer months by shading the west windows.
4. Building signage at the front entry would improve wayfinding and visibility for the community.
5. Removal of the existing storage shed and providing indoor conditioned storage for holding overflow from equipment loan program would make access to this equipment more convenient, as well as extend the life of the equipment.
6. Replacement of engine block heaters with new GFI type weatherproof units.

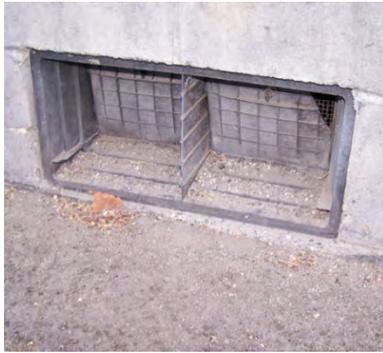
Crawl Space Vent

5. Crawl space vents are in poor condition and are no longer operating as designed, preventing moisture from escaping the crawl space area.

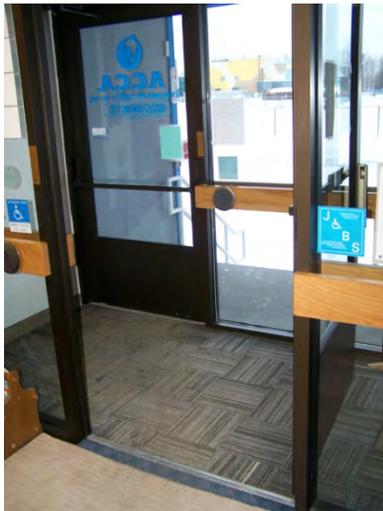
Entry Doors

4. Secondary exterior doors need adjustment to close and seal properly. Some of these doors are racked or twisted and other are in need of adjustment at the hinges. At the time of the survey, several were leaking conditioned air to the exterior.

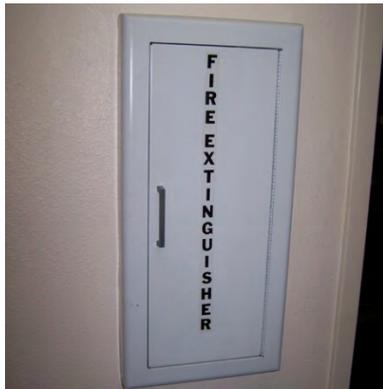
Fire Extinguisher Cabinet

1. Fire extinguishers are present and appropriately spaced. IFC requires that extinguishers be located to limit the overall travel distance to any extinguisher to 75 ft. The extinguishers do need to be inspected and have updated registration. This should be done as part of the annual maintenance schedule.

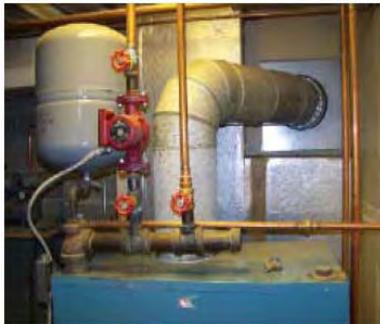
Distribution Piping

1. The hydronic piping within the boiler room and the visible distribution piping outside of the boiler room is not insulated, resulting in uncontrolled heating of the spaces and excessive energy use. This condition is a burn hazard for persons working around the piping. All piping should be insulated with 1" fiberglass insulation with an exterior vapor barrier to reduce undesired heat loss and lessen the burn hazard.

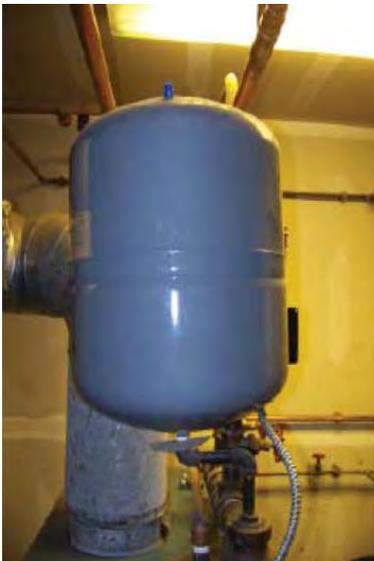
Expansion Tank

5. The expansion tank is not supported. This situation stresses the piping and can cause leaking or a piping failure. The tank should be supported from an appropriate location on the ceiling to relieve the stresses. The tank is likely past its useful life.

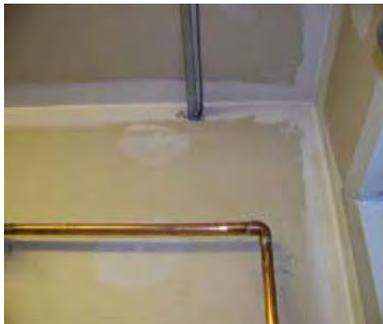
Absence of Seismic Bracing

2. The boiler is not seismically braced. Seismic bracing is required to prevent equipment from moving in seismic events. Movement can damage equipment or injure persons. Provide appropriate seismic restraint for the boiler. (IBC)

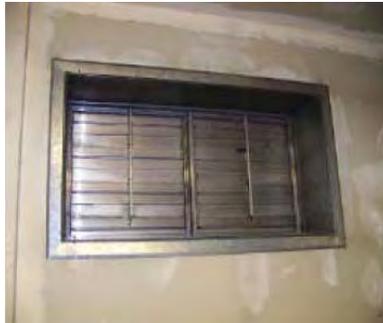
Relief Air Damper

1. The relief air damper is not weighted, making it difficult or impossible for the damper to function properly and resulting in an over-pressurized building. An over-pressurized building forces conditioned air out of the building envelope, wasting energy.

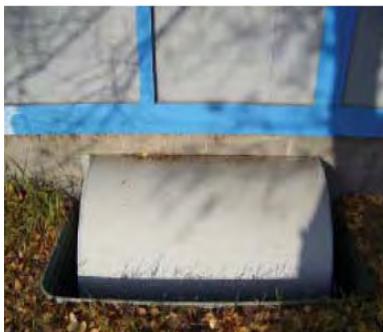
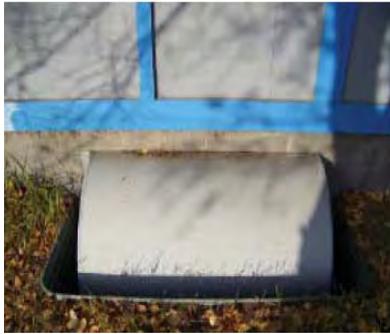
Relief Air Exterior Well

6. The relief air opens into a small well outside of the building and has a hood installed, presumably to prevent rain from entering through the damper. However, since the hood does not cover the entire well it is possible for snow to fill in the gaps and restrict or block the path for air to be relieved. The hood should be removed and replaced with a larger hood that covers the entire well. The location of the hood will also need to be raised out of the well so it can extend over all edges. The hood should be checked periodically during winter months to ensure that snow drifts have not covered the opening.

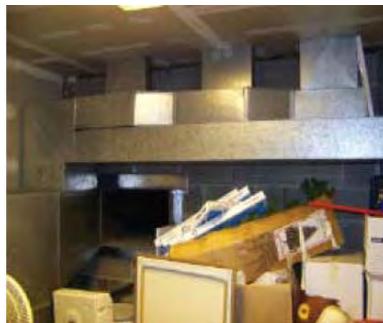
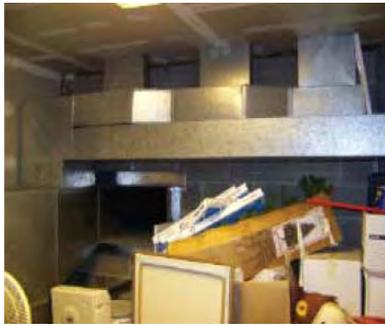
Combustible Materials in Mech. Room

1. Combustible materials are stored in the boiler room. To minimize the fire hazard, combustibles are not allowed in spaces where oil fired appliances are installed. All combustible materials, including paper, cardboard, wood and plastics should be removed from the boiler room and stored elsewhere. (IFC)

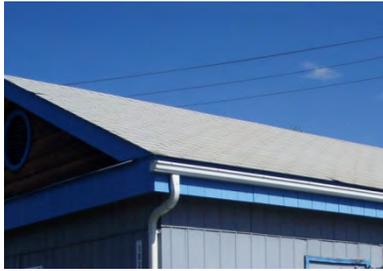
Building B Roof on Vent Side

1. Roof: Shingles are delaminating and becoming discolored. We estimate that the roof has 3-5 years of life left before needing to be replaced. Roof structure is 2x4 truss with 2" of spray urethane foam and blown in fiberglass insulation. Truss construction does not allow for a energy heel at the eave, reducing the effectiveness of added insulation at the exterior of the attic.

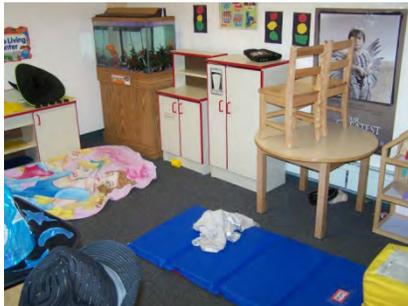
Building B Play Room

1. The interior is in poor condition, suffering from the result of poor craftsmanship in many areas throughout the facility. The addition of the ATCO unit section of the building and interior ramp creates an awkward transition between sections.

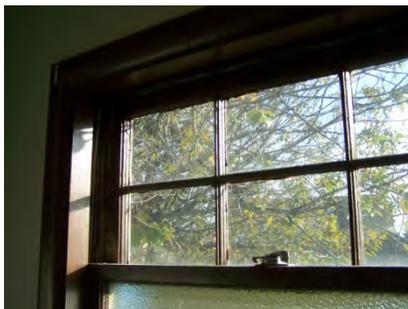
Building B Original Window

2. Windows are in poor condition throughout the facility. There has been an attempt to rectify this with insulated glazing on the interior at one location.

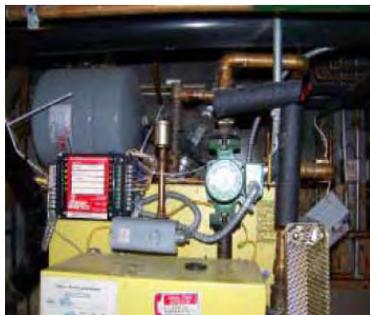
Boiler Piping

1. The boiler piping is extremely compact, making maintenance and repair work difficult. Future renovations and upgrades should address this situation by rerouting the piping within the ample space available.

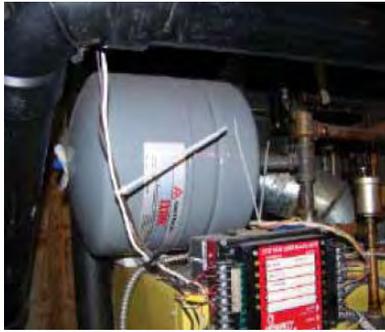
Expansion Tank

5. The expansion tank is not supported. This situation stresses the piping and can cause leaking or a piping failure. The tank should be supported from an appropriate location on the ceiling to relieve the stresses.

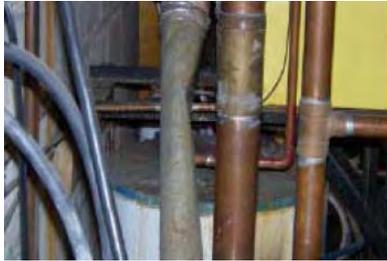
Dryer Exhaust Vent

1. The dryer exhaust vent is noticeably crushed after the flexible run. The crushed section of the dryer vent should be replaced immediately. This situation increases the pressure in the duct and poses a potential fire hazard for the building.
2. The flexible duct on the dryer exhaust is excessively long and has several unnecessary bends. The flexible portion of the dryer exhaust duct should be shortened by cutting it so it does not have extra bends in the run.

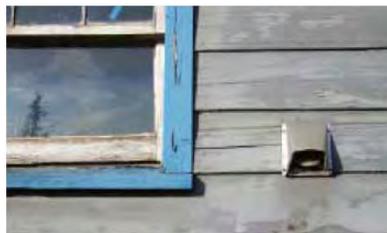
Dryer Vent Proximity to Window

1. Dryer exhaust vent is located within 3 feet of an operable window. The dryer exhaust vent needs to be relocated so it is not within 3 feet of any operable window, louver or air intake. There appeared to be plenty of space on the exterior wall to accommodate this. (IMC)

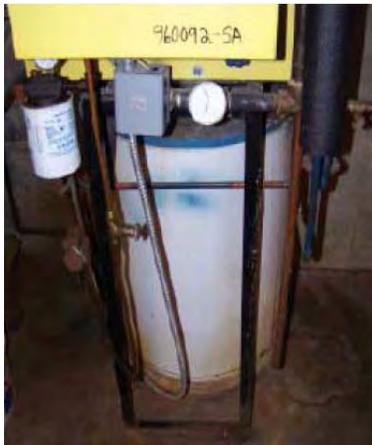
Uninsulated Heat Exchanger

1. The heat exchanger is not insulated, allowing uncontrolled heat to escape into the basement.
2. The water heater shows signs of wear and should be replaced soon.
3. Domestic hot water lines need to be insulated.
