**Agency: Commerce, Community and Economic Development****Grants to Named Recipients (AS 37.05.316)****Grant Recipient: Pioneers of Alaska 19 Cordova Igloo****Federal Tax ID: 920100496****Project Title:****Project Type: Maintenance and Repairs**

# Pioneers of Alaska Igloo #19 - Igloo Building Preservation and Rehabilitation

This Condition Assessment Report with Recommendations for Treatment is intended to expand the Pioneer’s report and provide guidance following The Secretary of the Interior’s Standards for the Treatment of Historic Properties. The November 2011 inspection of the building included the site, crawl space, primary and secondary rooms, attic areas and the exterior elevations.

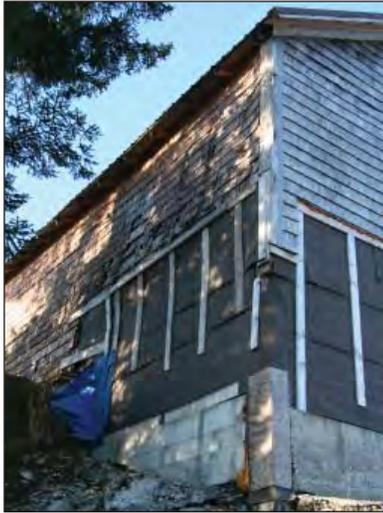
▲  
Foundation and wall stabilization efforts undertaken by the Pioneers in October of 2011. The wall logs had deteriorated severely in the south east corner of the building due to Cordova's prevailing wind driven rain.

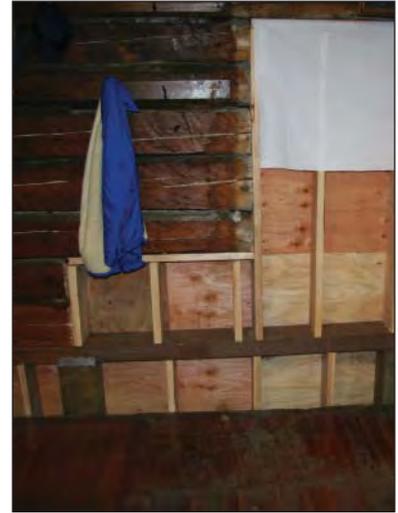
▲ Stabilization efforts undertaken by the Pioneers in October of 2011 to mitigate severely deteriorated wall logs.

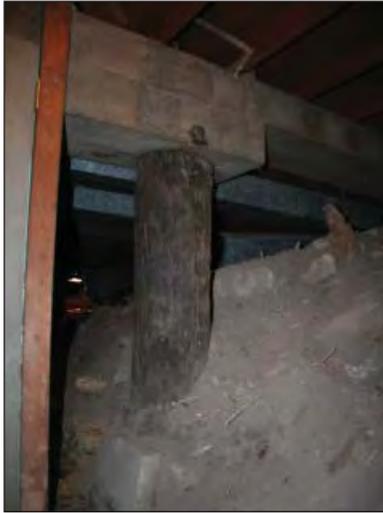
▲  
A column near the junction of the original 1928 section and the 1937 frame addition. This column has a concrete footing but it is not known if the two are connected.

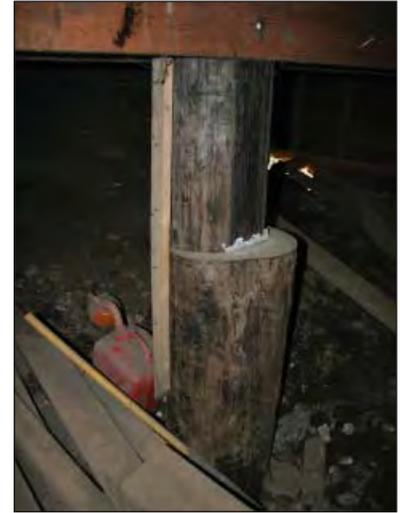
▲ A spliced column under the 1937 frame addition. The lower portions of many columns were replaced due to rot.

Most of the piles have received new bases presumably after it was discovered the portions in the ground had deteriorated. The original piles were cut level several feet above grade and a concrete footing was poured beneath. A new pile, often larger in diameter, was cut to fit and fastened with light gauge Simpson anchors. Some of the pilings may be pinned to the concrete pad.

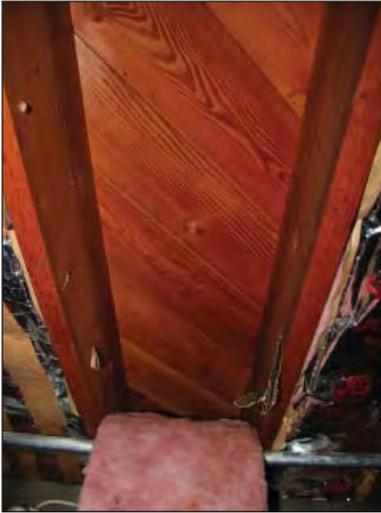
▲  
The floor joist cavities below the 1937 addition are insulated with fiberglass but reveal the original diagonal subfloor.

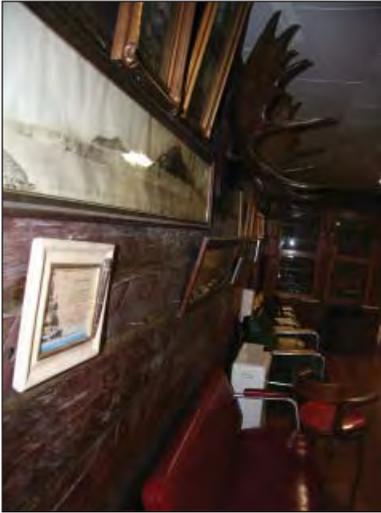
▲  
The south elevation of the original 1928 section's log wall cants inward approximately 3".

elevation which has likely been leaking for years. The wall logs on the south elevation appear to be hinging at the mid line, perhaps due to deterioration of a wall log or insufficient support. The north and west elevations appear plumb and in sound condition.

3. Consider consulting with a structural engineer to determine if additional means are required to stabilize the walls. This effort may include incorporating additional, concealed mechanical fasteners to provide support. Prior to a site visit by the structural engineer, consider removing the siding from the affected areas of deteriorations to allow the engineer to inspect

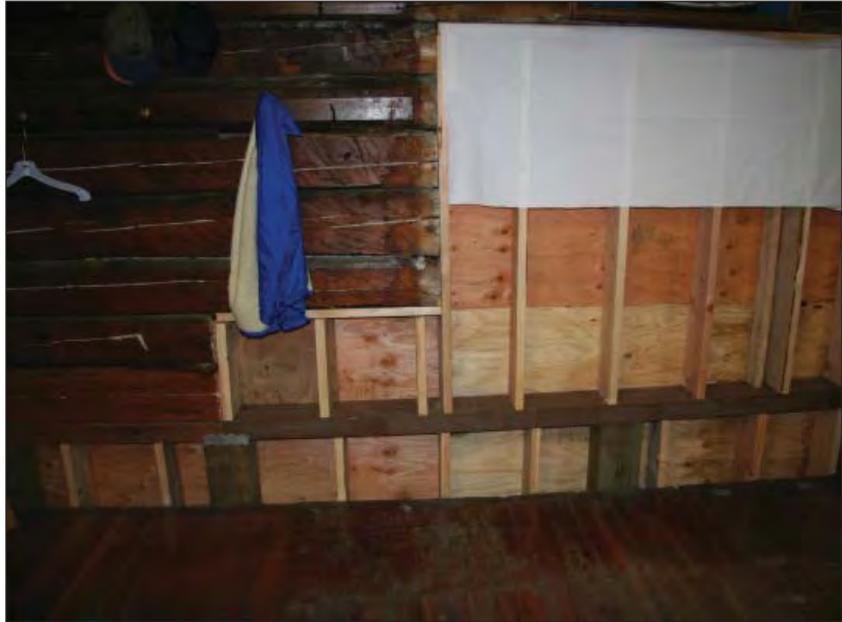
►  
The Pioneers successfully stabilized the deteriorated log walls in October of 2011. The rotten wall logs were removed and are temporarily supported by dimensional lumber.

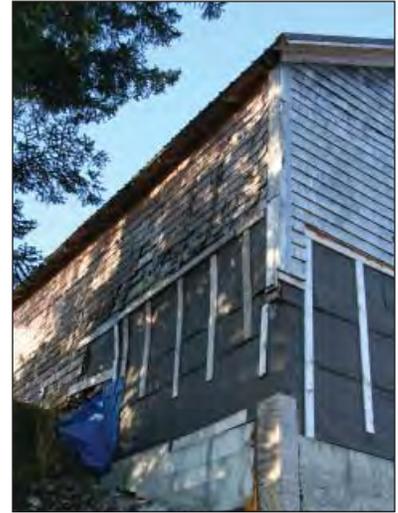
▲ The southeast corner of the Pioneer Igloo is temporarily clad in building paper to weatherize the stabilization efforts.

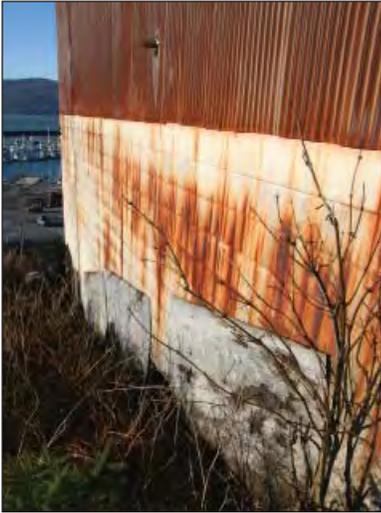
▲ A detail of the south elevation illustrating the rusted siding which was original painted “Kennecott red” from surplus paints donated by the mining company.

The corrugated metal siding has rusted and some of the fasteners have failed. The red paint originally applied in 1937 has not been maintained and is visible in few locations. The paint and gaskets on the fasteners likely contain lead.

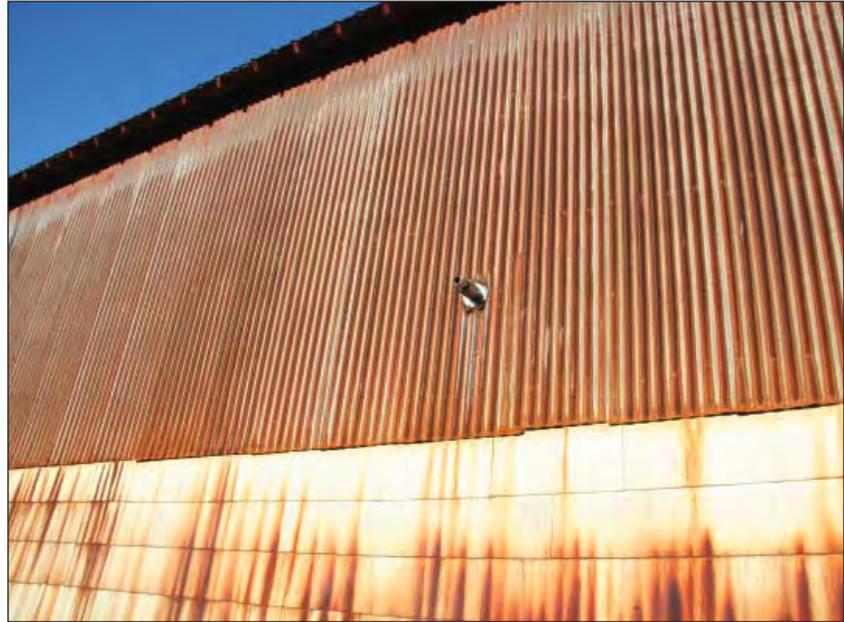
► The skirting around the 1937 frame addition is clad in an asbestos containing material (ACM). The shingles were tested in 2011 and revealed a 25% asbestos content.

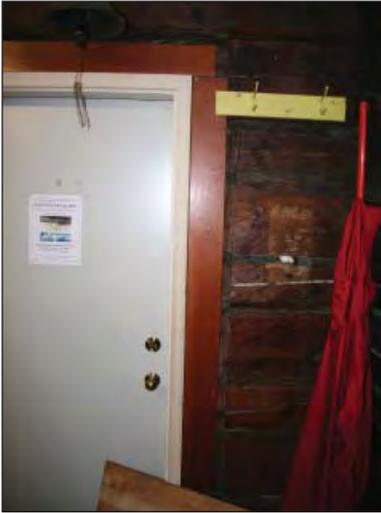
▲  
A log patch to the right of the primary door at the northeast corner of the original 1928 section reveals the original door's width. In-kind replacement of the door may include restoring the width.

The doors in general are in fair to good condition. The primary entrance door and opening have been altered. The infill at the exterior is comprised of dimensional lumber and at the interior, efforts were made to match the log appearance, but the vertical joint remains exposed. The metal rated door was likely changed following the deterioration of the original door or a code inspection. The interior doors are in good condition but some may not be original to the building.

1. Research historic photographs to determine the original configuration of the primary entrance door. Consider having a door manufactured to match the original configuration while meeting the code requirements. This effort should include returning the door to its original width.
2. Restore existing door in crawl space of the 1937 addition and retain for possible reuse at the women's restroom. Or if future plans include removing the storage cabinet in the northwest corner of the log section, this door may be used at the women's room.
3. Replace the four-panel wood door at the oil shed. This effort may include improving access to the shed if it is retained in

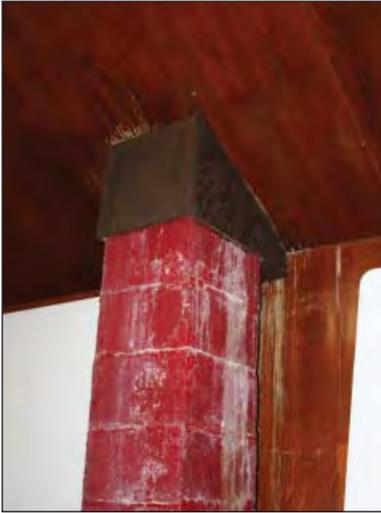
▲  
The roof penetration of the concrete masonry unit (CMU) chimney associated with the boiler in the crawl space of the 1937 frame addition failed and has caused damage to the interior sheathing.

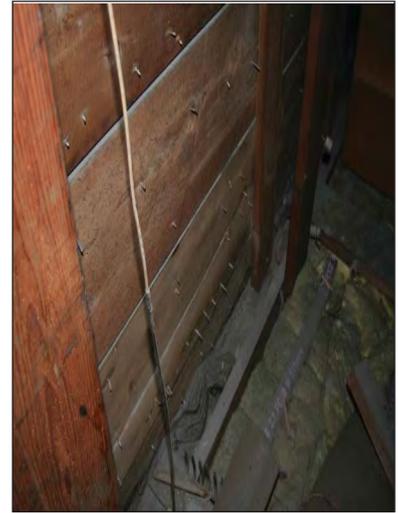
▲ A wire splice wrapped in electrical tape at the east elevation of the original 1928 section attic.

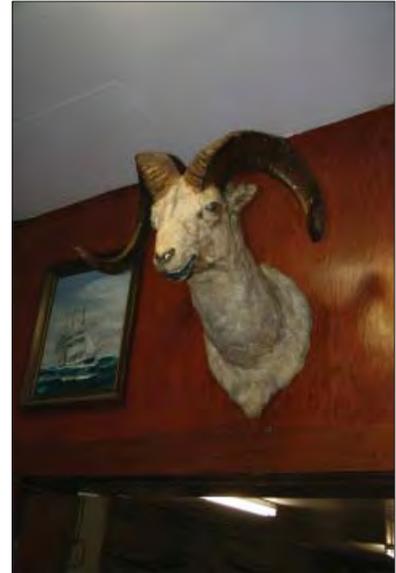
▲ The sheep mount is visible in many historic Pioneer photographs and may have been preserved using toxic materials.
