Kenai Peninsula Borough - Anchor Point Fire and Emergency Medical Service Area Sewer System Replacement

PRELIMINARY REPORT

Subject: Spruce Acres Subdivision Lot 23
Anchor Point Fire Station
Septic System Investigation and Recommendations
2 pages + Attachments

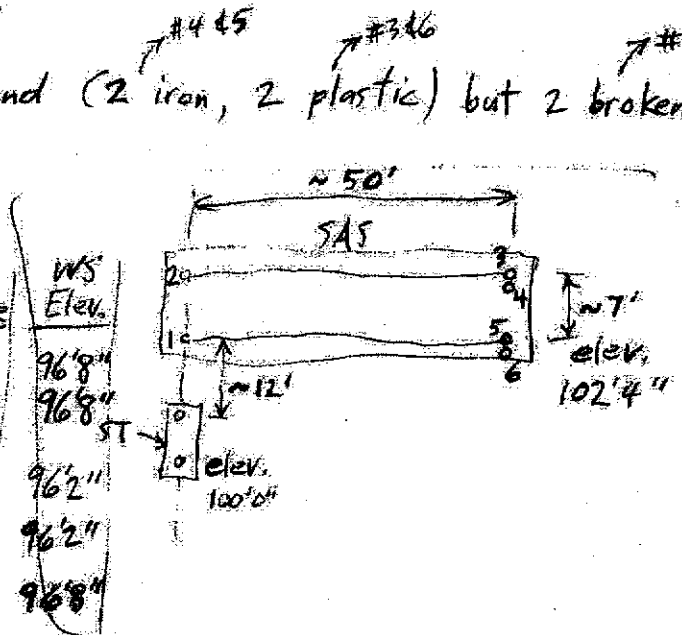
- upstream ST MT broken off at ground
- 2 MTs for SAS at upstream end
- 4 MTs for SAS at downstream end (2 iron, 2 plastic) but 2 broken off

Bottom Depth from Surface	WS Elev.
ST MT #1	5'2"	8'6"	96'8"
ST MT #2	5'2"	8'6"	96'8"
SAS MT #1	1'6"	5'4"	96'2"
' #2	1'6"	5'4"	96'2"
' #3	3'4"	9'	96'8"
' #4	9"	6'6"	95'10"
' #5	13"	6'6"	95'10"
' #6	3'6"	9'	96'8"

- ditch observed parallel to SAS to north (no water)
- no standing water observed on surface onsite
- ST & MT #1 & 2 roughly level ground
- MT #3 → 6: ground ~ 2'4" higher than at ST
