# Kodiak Regional Aquaculture Association - Pillar Creek Hatchery Upgrades

# PILLAR CREEK HATCHERY INSPECTION REPORT

Alaska Department of Fish and Game

March 2012

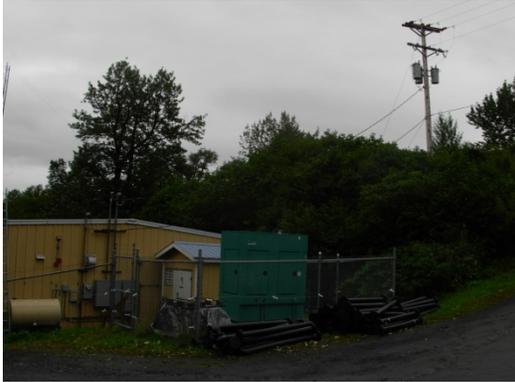
Service mast and aerial cables: Two 2 inch rigid steel conduits with four no. 3/0 conductors each provide the service from the aerial cable above the roof to the meter equipment mounted on the exterior of the building. The masts, conductors, and aerial cable appear to be in good condition and adequately sized for the loads, although the conduits are corroded.

Service equipment and generator

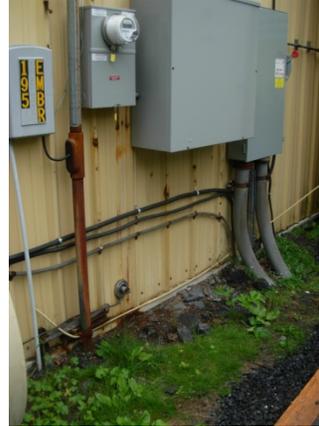
The utility metering equipment consists of an enclosure with three current transformers (CT's) inside wired to a separate enclosure with meter socket and meter. The CT's are configured with a 100:5 ratio, yielding a multiplier of 20. The meter indicated a peak demand in August of 1.246, resulting in a peak load of 24.9 KW. This equipment is in good condition with some corrosion on the conduits.

The corrosion on the conduits is caused by the nearby exhaust from the Toyo stove inside the office. This exhaust should be further directed away from the side of the building to reduce further corrosion.

A single 3 inch rigid steel conduit with 8 no. 3/0 conductors extends from the metering equipment to a fused disconnect (it appears to be rated for 400 amperes) in a NEMA 3R enclosure, also mounted on the exterior of the building. This equipment is also in moderately good condition with some corrosion on the load-side conduits.

Service meter and main disconnect

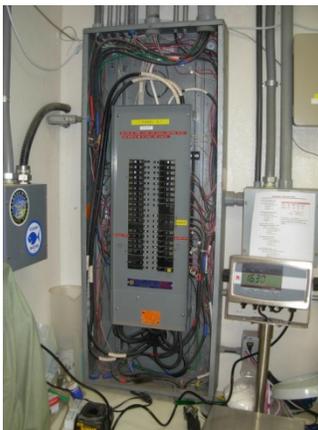
Panel A is located inside the office. It is rated at 400 amperes. It is full with two spare circuit breakers. This panel was installed with the original facility and is in fair condition. The circuit breakers should be replaced in the next five years and an additional panel installed to provide more circuit capacity. The panels need to be positioned to allow working space clearances in compliance with the National Electrical Code (NEC).

Panel A

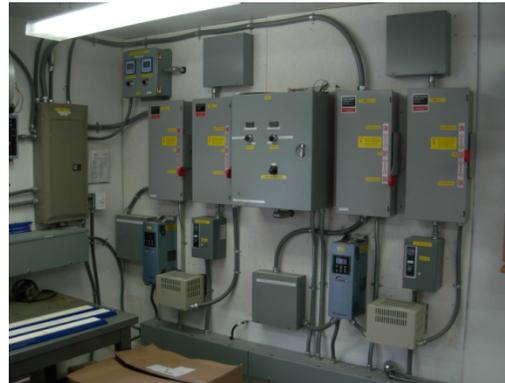
Panel B is located inside the Compressor/Oxygen Building. It is a load center type appliance with a service life of approximately 15 years. It is currently in good condition yielding most of its service life.

Compressor/Oxygen Building Panel B and Well Pump Controls

Two well pumps (7.5 HP) are fed from Panel B with 50 ampere circuit breakers and no. 6 conductors to the controls. The controls consist of double pole switches on the "line" and "load" side of the controls with a variable frequency drive (VFD) and a motor starter in between. The motor starter on each provides redundancy to the VFD in the event of a component failure. These controls are a few years old and are in moderately good condition. It appears that they have approximately ten years of service life remaining. The circuits are in good condition.

The two oxygen generators are fed from Panel B with no. 10 conductors on 50 ampere circuit breakers. The no. 10 conductors are rated for 30 amperes, only. The units are rated to demand a 21 ampere load. Thus, the circuit breakers need to be replaced with 30 ampere rated type, or the conductors replaced with no. 8 AWG copper.

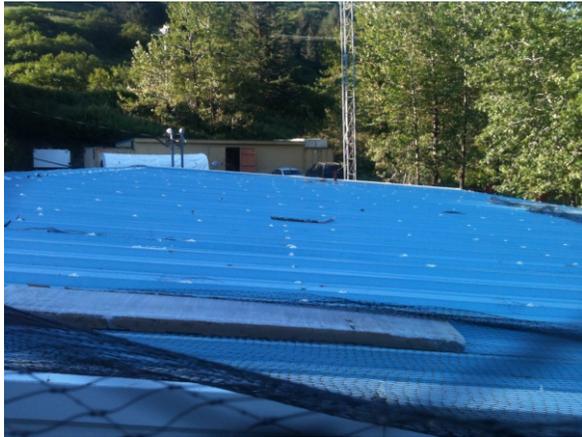
**Roofing:** Existing metal roofing appears to be 24 gage, exposed fastener panels installed over conventional 8 or 10 inch roof purlins. Fiberglass insulation is installed in the conventional metal building method draped over the purlins. The original drawings note the insulation as R-30 but we could not confirm that thickness. The roofing leaks and has caused water damage inside the

building. The conventional metal building techniques used in the original construction do not appear sufficient to prevent condensation from occurring in the cool wet hatchery environment, causing further damage. The existing exposed roof fasteners were each touched up with sealant in the recent past, but that is a merely stopgap measure. The finish is past its useful life. The metal could be painted to gain a few years of additional usefulness, but replacement must still be scheduled. It is recommended that replacement roofing be installed in a thermal break configuration to reduce the potential for condensation within the building interior.

**Metal roof deck.**

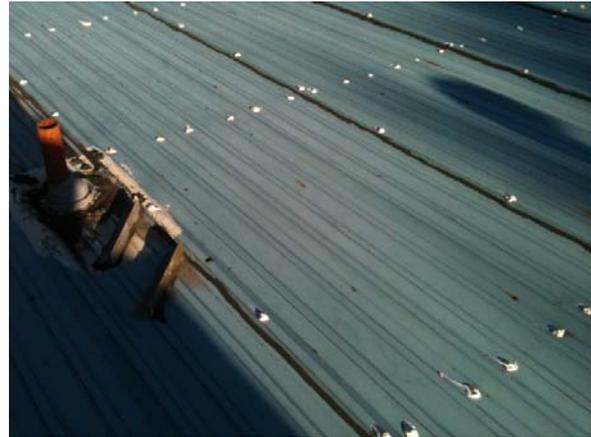
**Sealant at metal fasteners.**

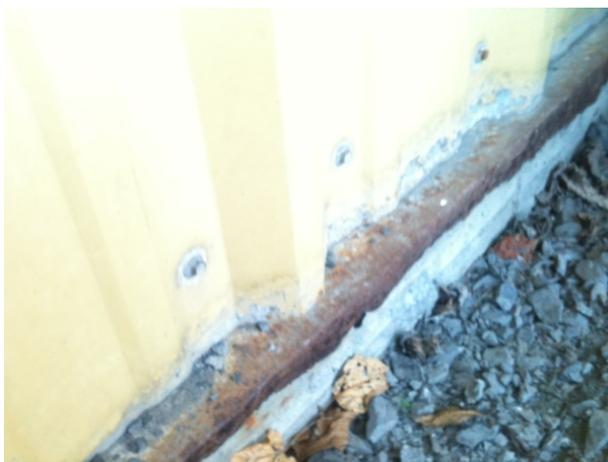
***Metal Siding:*** metal siding is exposed fastener, 26 gage siding installed to conventional horizontal metal building siding girts. Vertical metal studs are installed on the inside face of the siding to 8' high as backing for interior finishes, with fiberglass insulation (approximately R19) in the stud space. Above the 8 foot high level the conventional metal building insulation and white vapor barrier is exposed. The metal siding is in fair condition. The drip flash at the base of the walls is completely deteriorated away in spots. Metal siding edges and fasteners are corroding. The siding should not be assumed to have a useful life beyond an additional 5 years. It should be budgeted for replacement, which could be done in association with roof and door replacement. New siding should be installed in a thermal break configuration to reduce potential for condensation.

**Above: Deteriorated sill flashing**

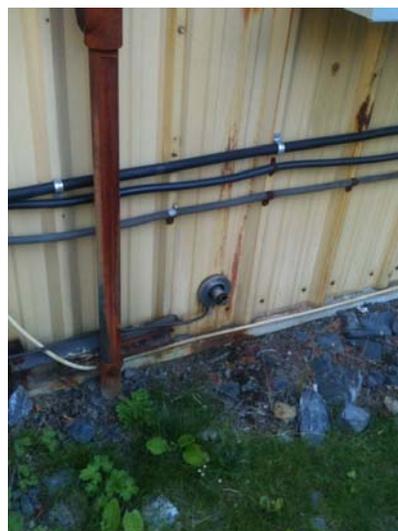
**Right: Deteriorated wall panels.**

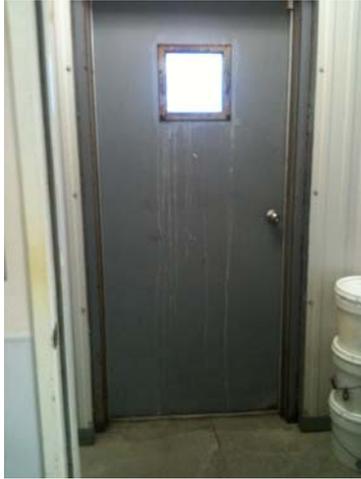
**Doors:** Doors are painted steel, insulated, in metal and wood jambs. Doors are rusting out, hardware is worn out, and frames are beginning to rust badly. Doors frames and hardware should be replaced.

**Door**

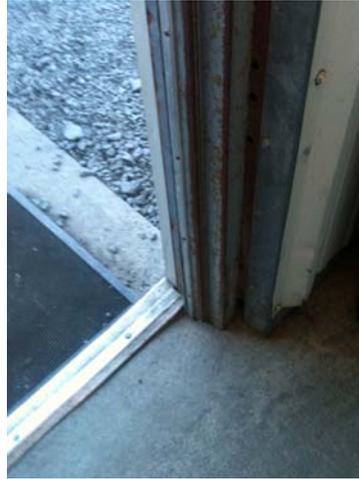
**Door frame**

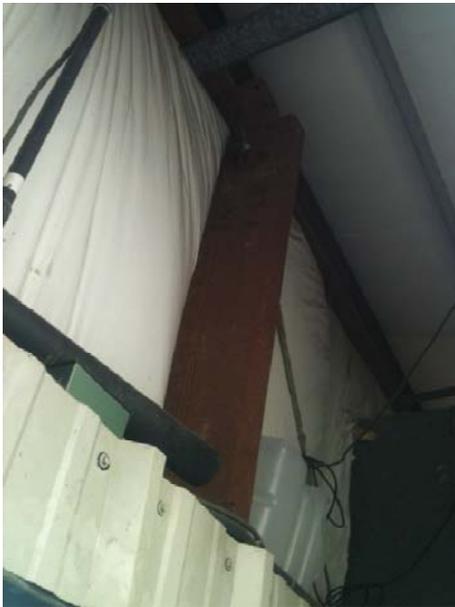
**Structural Steel:** structural steel, including the red iron rigid frames, wall girts and roof purlins are corroded due to condensation. Rust should be treated and the structural steel painted to contain corrosion.

**Typical interior wall to roof connection.**

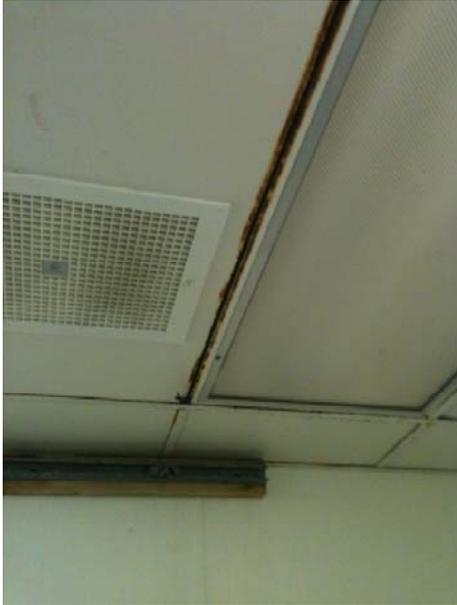
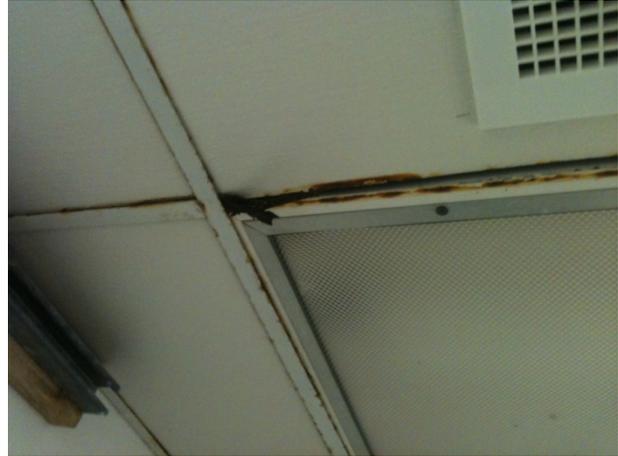
**Ceilings:** Most of the ceilings are conventional suspended grid ceilings. Grid members, clips, light fixtures, and hanger wires exhibit heavy corrosion in many locations. The original panels, where they exist, are often saturated with water. The ceiling suspension system does not meet current seismic requirements. They should be removed with consideration given to eliminating them entirely, resulting in high bay spaces which increase air movement and reduce condensation. If suspended ceilings are replaced they should be specifically designed for wet environments and be seismically braced.

**Water damaged ceiling tiles.**

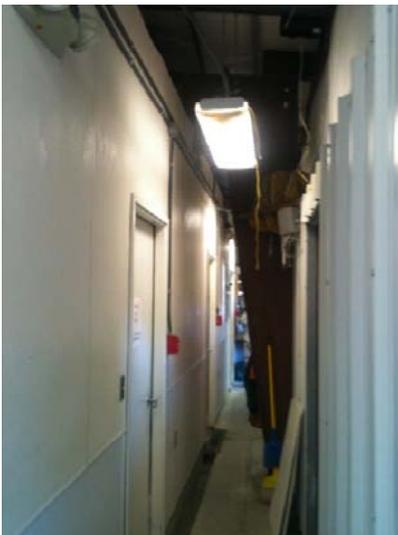
**Walls:** Interior walls consist of fiberglass reinforced panels (FRP) glued to conventional gypsum drywall over metal studs. The walls appear to be saturated with water in places or to have been saturated in the past. No mold was observed but it may exist in concealed locations. Consideration should be given to replacing interior partitions with full height walls made of mold resistant drywall with FRP adhered as a finish installed over galvanized metal studs. As an option, a factory laminated FRP panel could be selected. All walls should be installed over concrete curbs.

**Interior walls**

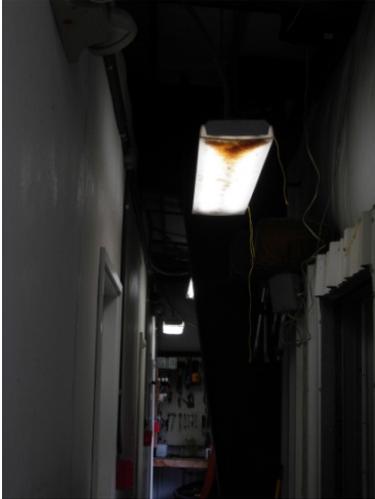
Hatchery: Suspended linear fluorescent with T12 lamps and wraparound acrylic lenses, and some incandescent. These luminaires are also in poor condition. These should be replaced with new strips utilizing T5 or T8 lamps, or with pendant type with LEDs. The controls for these fixtures should also be replaced with new wall switches.

Lighting in corridor

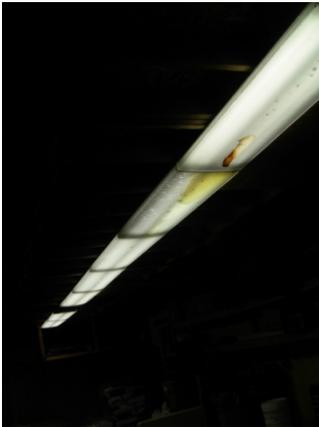
**Lighting:** Surface mounted industrial strips with reflectors and T12 lamps in the containers and surface mounted linear type with wraparound lenses and T12 lamps in the main area. These luminaires are in poor condition. Replace with similar fixtures using T5 or T8 lamps. Position the fixtures to primarily illuminate work areas with the spill light illuminating the storage and passage areas. Provide occupancy sensor type control for most of the luminaires with some controlled by a manual wall switch. Provide emergency battery packs with select fixtures.

Light fixtures

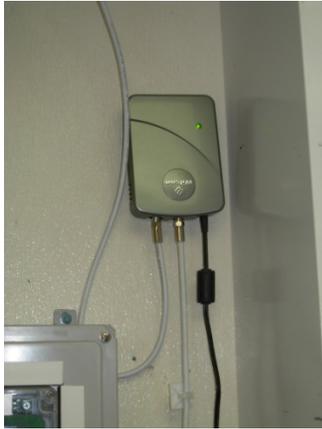
Communications is accomplished with a cell/broadband modem connected to provide limited internet service. The system is slow with little capacity. Landline service is provided in this location for telephone, but does not include the capability for internet service. The network inside the office is facilitated with a wireless router.

**Cellular Signal reader**

Given the nature of the topography at this site, access to satellite internet communications might be difficult, but it should be further explored. Otherwise, when the demand for better communications becomes desirable, more investigation should be made toward upgrading the cell/broadband system with differently positioned antennas and more robust equipment.

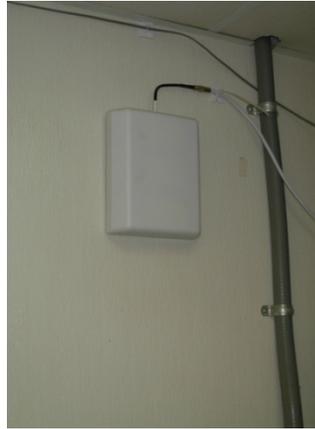
**Cellular antenna**

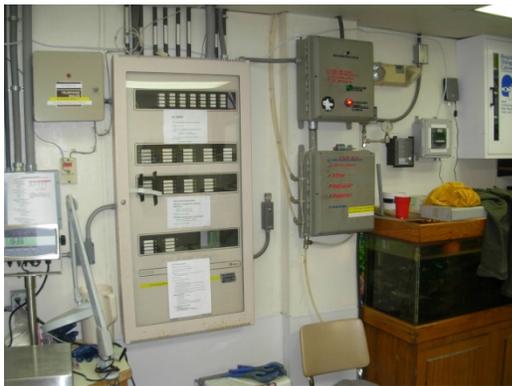
The alarm panel appears to have been installed with the original facility and has exceeded its service life. Considering the importance of the alarms, it is appropriate to consider a system replacement in the near future. An addressable system using discrete devices should be considered. Such a system may be single loops of circuits to address modules located near the devices, or individual circuits from the panel to each device as currently configured.

**Alarm panel**

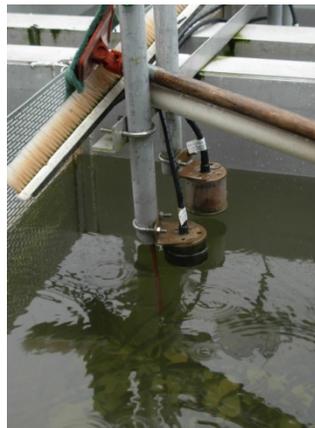
The alarm system consists of a conventional, zoned type fire alarm panel monitoring numerous discrete contact closures for alarm conditions. Primarily small float switches are positioned to indicate Hi or Lo water conditions in the active raceways. Each switch is connected as an identifiable zone. There appear to be 32 zones in use at this time with a general alarm signaled to the staff via pagers, using the communication system.

**Raceway level switches**
