January 9, 2013

PND 122085

Re: Yakutat Seafoods Wash House  
Structural Condition Assessment

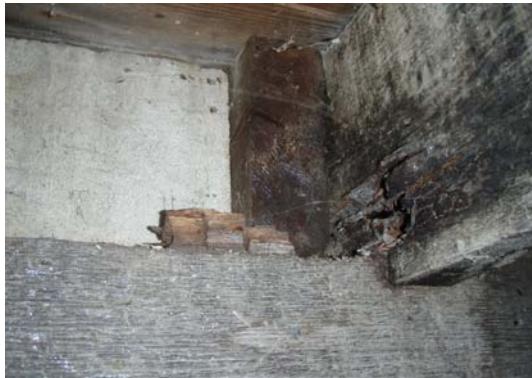
- 3) Floor joists are rotten at supports with significant crushing. Some joists have fungal growths on them.
- 4) Timber floor deck has fungal growth on the underside.

Rotten end of floor joist – Note crushing.

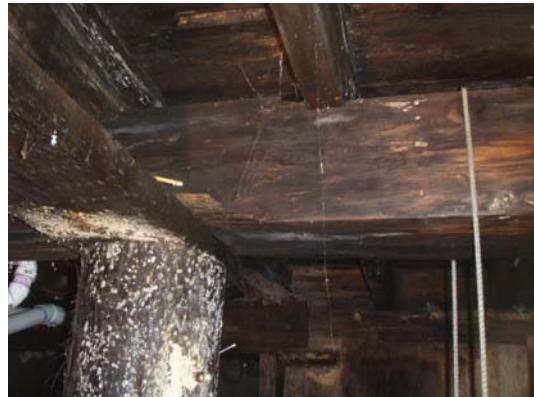
- 1) Timber piles are saturated and have fungus on the surface.
- 2) Timber pile caps have failed in compression and one is cracked vertically. Although the creosote treatment protects the outer surfaces of the timbers the interior are rotten and crumble when probed.

Cracked and crushed pile cap

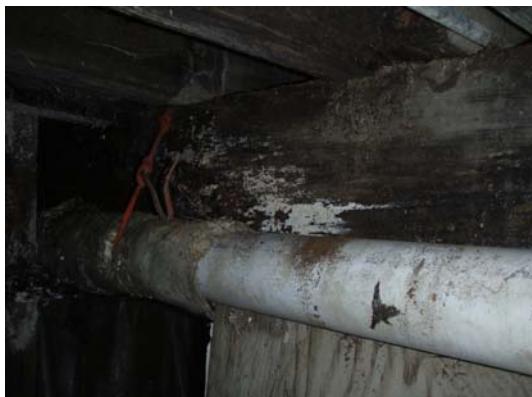
Fungus on pile cap

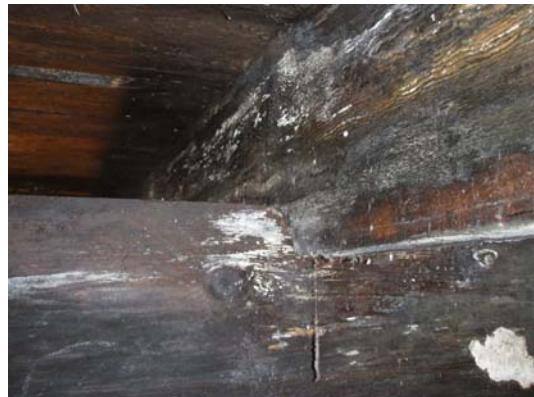
Crushed joist, fungus on joist and cap

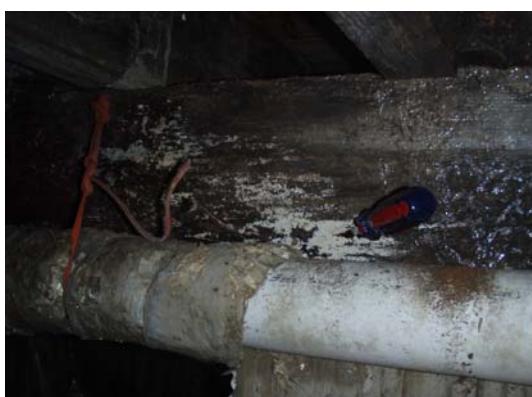
Rotten pile cap penetrated by screwdriver

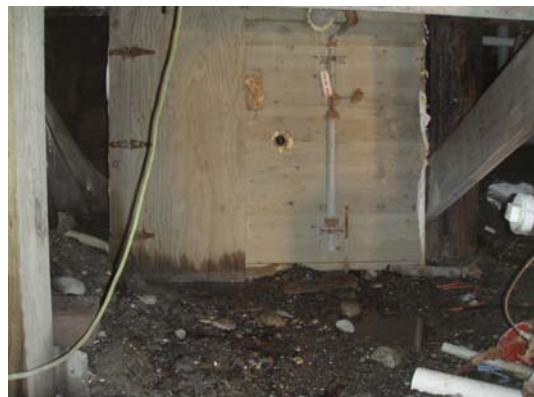
Exterior of sprinkler riser room

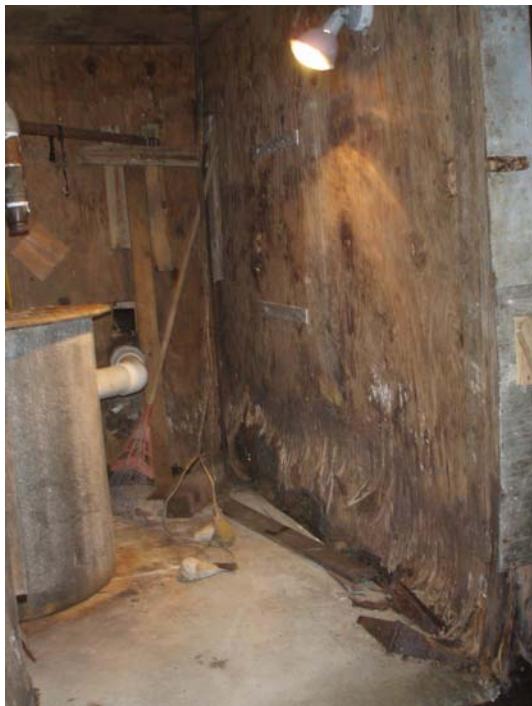
- 8) The compressor in the sprinkler room no longer functions. A small electric heater keeps the space relatively dry.
- 9) The timber supporting the sewage pump room slab is rotten and is failing.

Failed sheathing at sewage pump station room

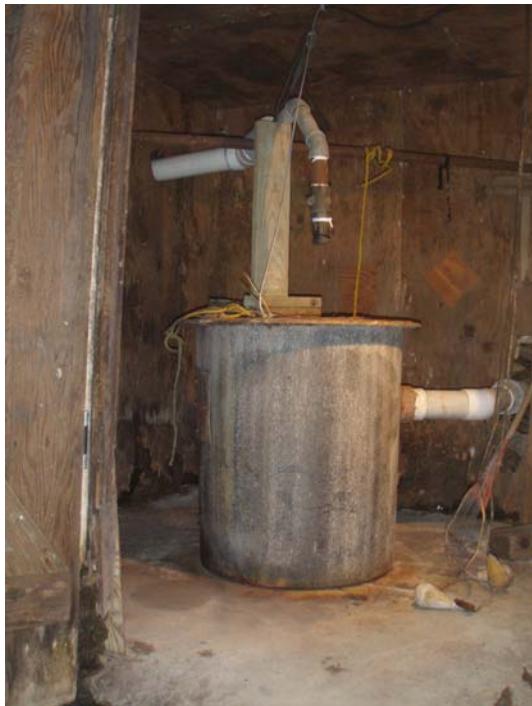
Sewage pump wet well- note float controls on floor

- D) Install a slab over a relatively thick vapor barrier in the crawl space.
- E) Relocate the sewage pump station room to the north side of the crawl space. Vent the room to the exterior. Replace the relatively small wet well with a larger wet well, sized for the volume of sewage anticipated. Have two pumps with appropriate alarms and level controls.

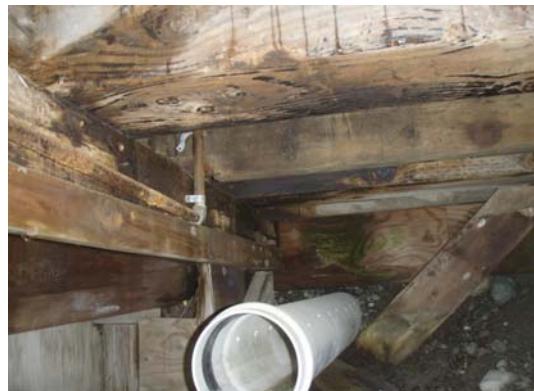
- 5) The ground surface in the crawls space is extremely wet and there is no vapor barrier on it. A foundation drain daylights and empties into the crawl space.

Foundation drain day lighting into crawl space

- A) Remove all debris from the crawl space.
- B) Install a foundation drain around the new crawl space. The drain should be perforated pipe that is surrounded with drain rock encased in a drainage geotextile. The perforated pipe should be extended to the tidewater east of the Wash House.

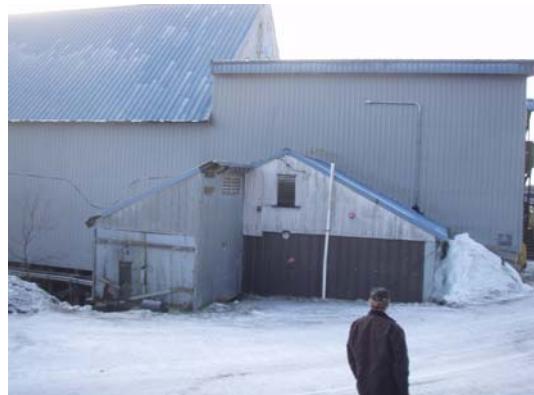
Exterior from north side

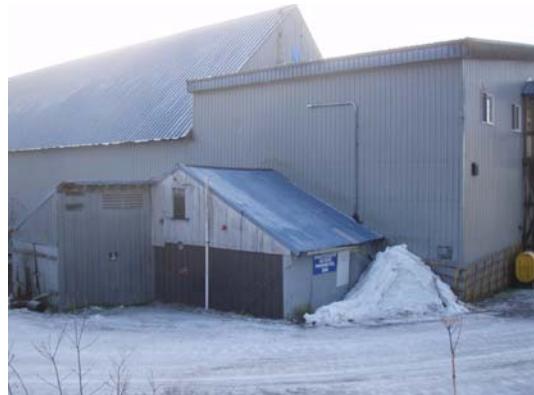
Exterior from north west

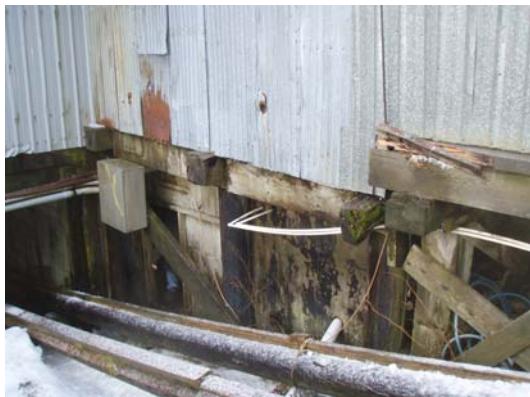
Exterior from north east.

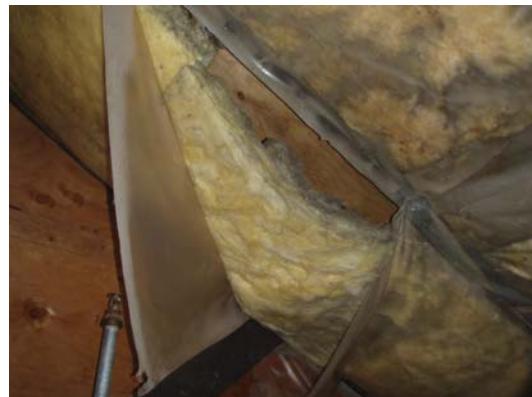
- 12) In the western part of the building one truss appears to have been removed and another has been severed so that it is not supported on one end.
- 13) Insulation and vapor barriers at the roof in the western part of the structure appear damaged. It appears the roof has leaked.

Damaged vapor barrier and insulation

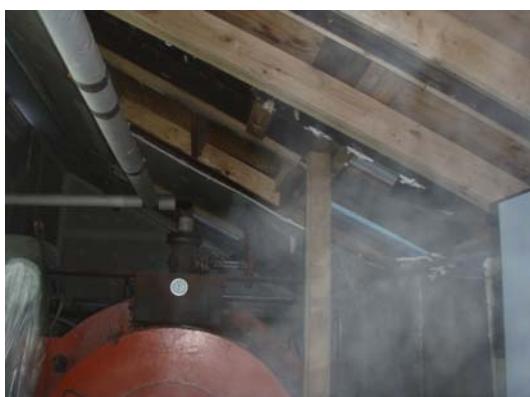
- 11) The roof framing in the eastern part of the building appears to have significant problems. Locations where stacks or flues penetrated the framing were poorly framed with headers not well connected to rafters. Many rafters have been sistered with 2x material.

Suspicious roof framing in east portion of roof

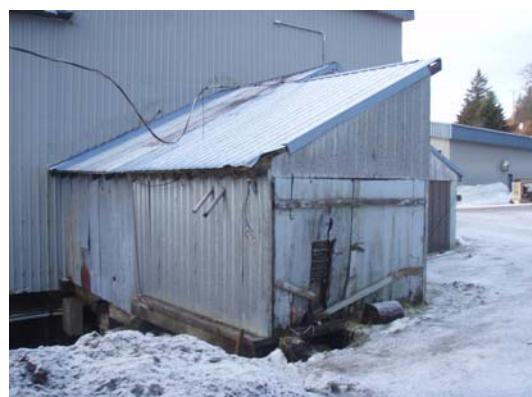
Deteriorated siding

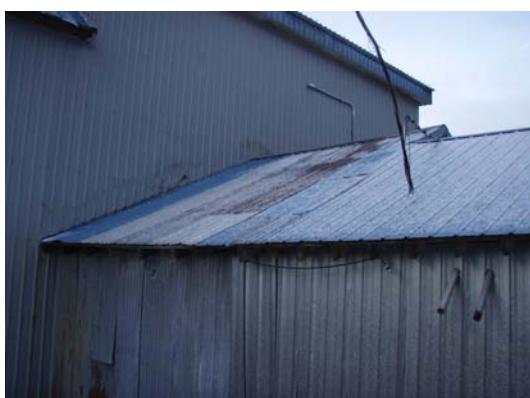
- 14) The corrugated metal roofing appears to be beyond its expected life. In places the coatings are depleted and the roofing is corroded. The roofing has been damaged from falling snow and ice off the adjacent building's higher roof.
- 15) Building metal siding is beyond its expected life. It is damaged in many places.
- 16) Grading north and west of the building causes surface water to drain into the crawl space. Maintenance workers have installed a surface drain on the west side of the structure.
- 17) The north edge of the adjacent building abuts the wash house. West of the wash house earth spills into the main building crawl space. This is approximately 6 feet high and 10 feet long.

Deteriorated roofing east side

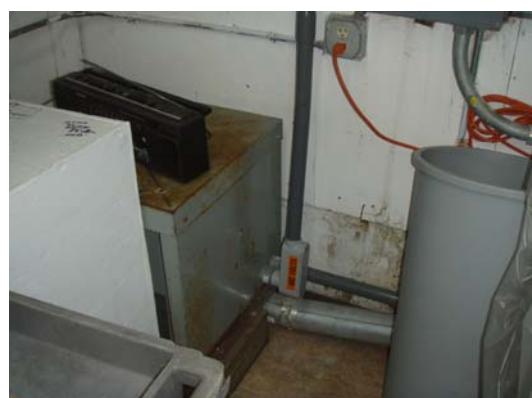
Transformer without proper clearance

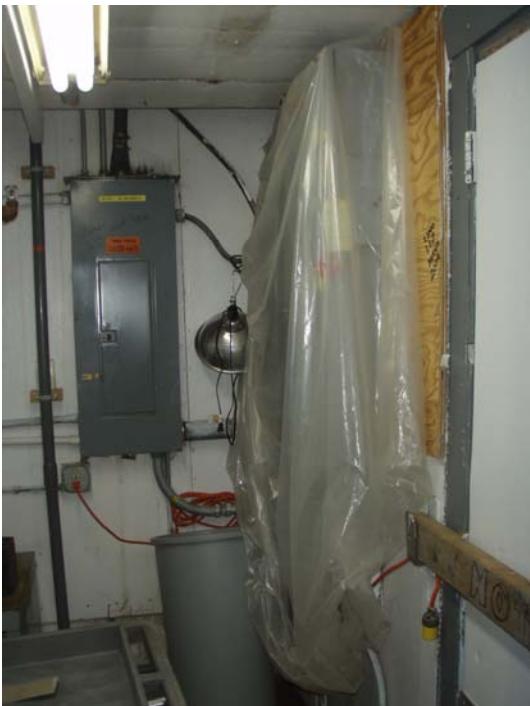
Electrical boxes

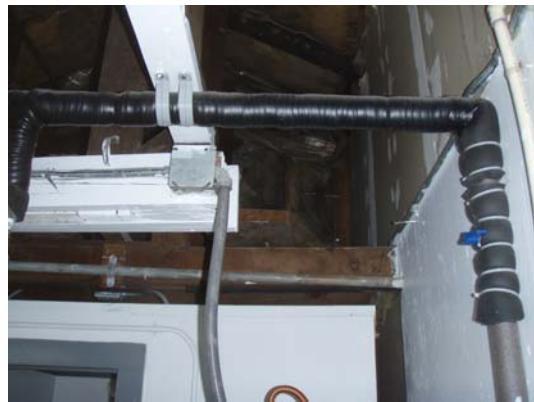
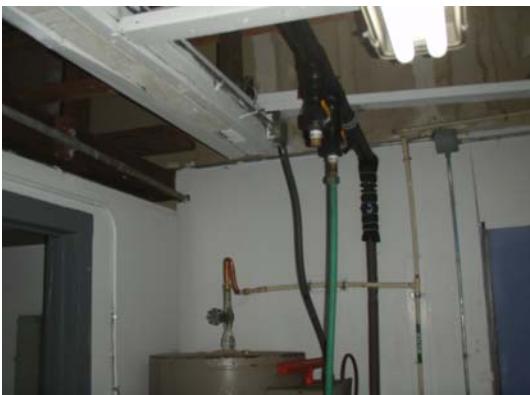
Another view of severed roof truss

Severed roof truss
