Agency: Commerce, Community and Economic Development**Grants to Municipalities (AS 37.05.315)****Grant Recipient: Kodiak****Federal Tax ID: 92-6000083****Project Title:****Project Type: Remodel, Reconstruction and Upgrades**

Kodiak - Monashka Pumphouse Upgrades

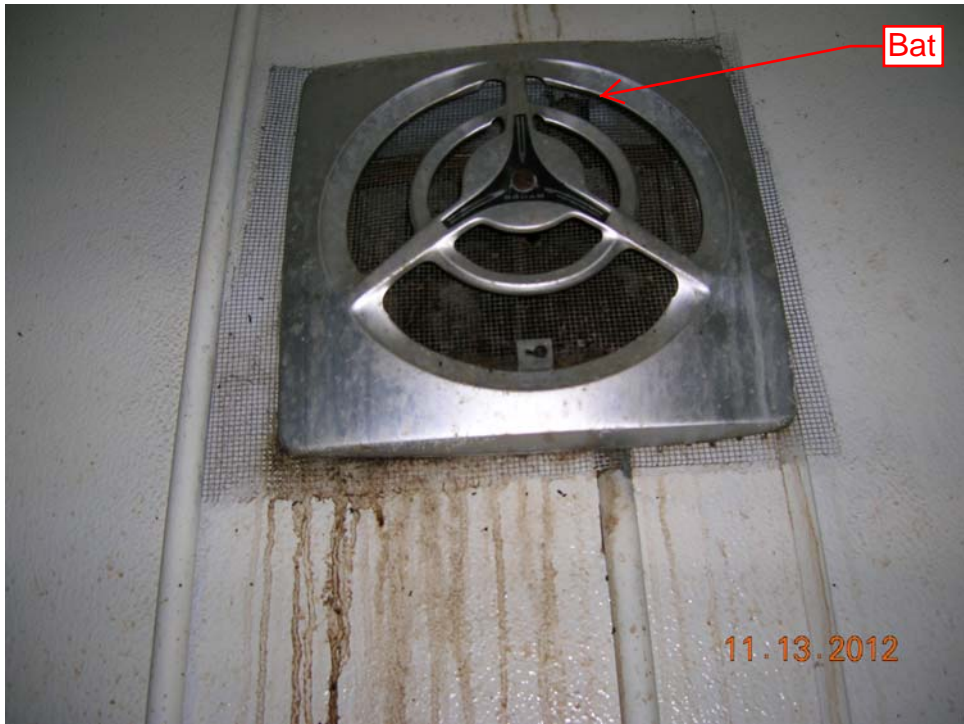
Vent with bat behind the screen

If the building is seismically stable, design work would progress toward upgrading the pumps and capability of the pumps, electrical systems including modern start systems and most likely variable frequency drive pump systems. Building improvements could be planned, particularly the effort to control bat infestation problems. Plans will include improving long distance monitoring and control of the pumps systems to improve response to water system demands. This is particularly of concern during extreme weather events in the winter time. The City has experienced events where power was lost at Monashka and it took crews over 12 hours to get to the pumphouse by road.

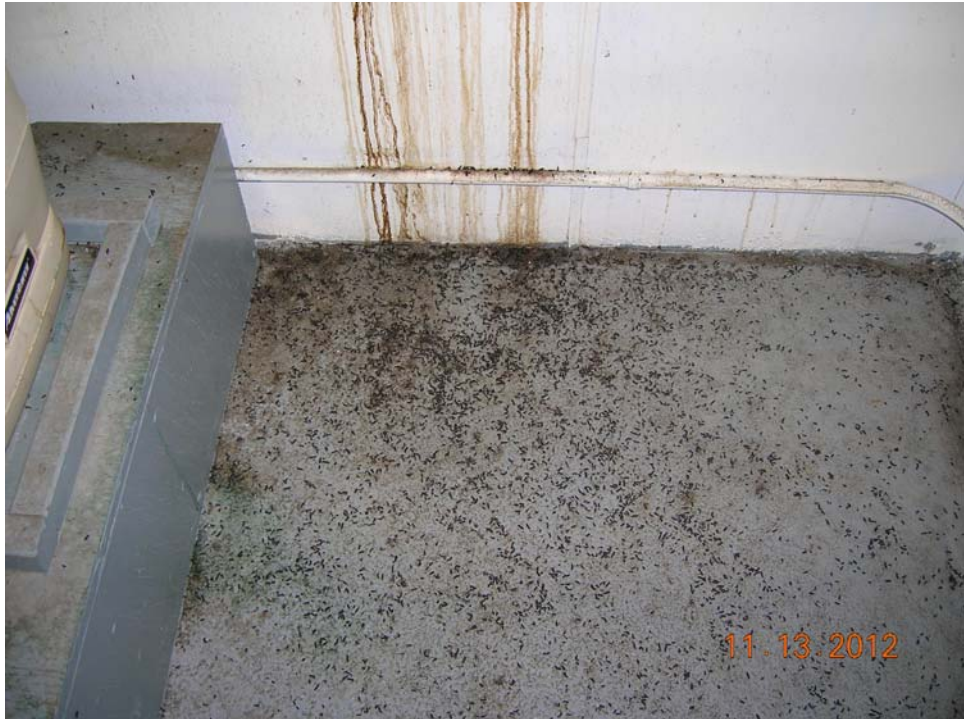
Bat feces

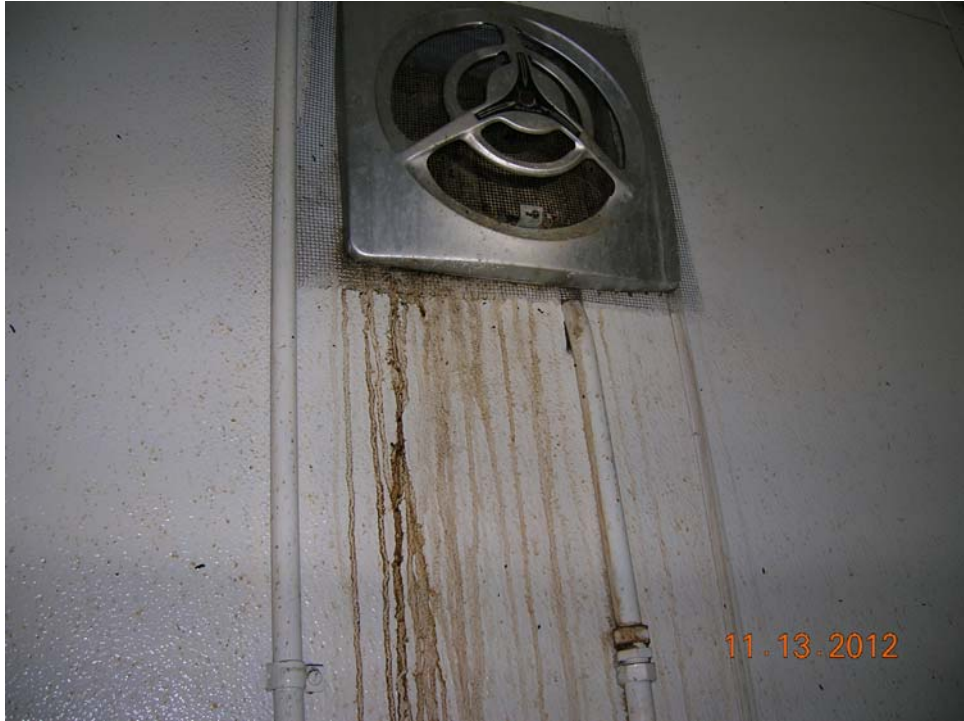
Bat urine running down the wall

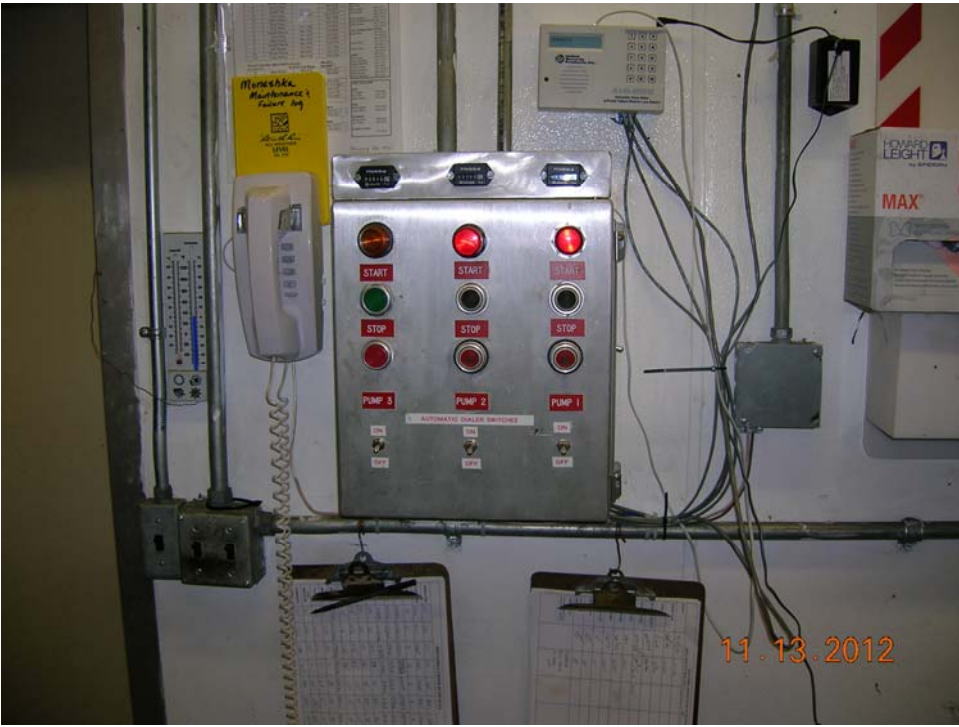
Switch Panel

All of the original electric motor starts have been replaced with soft start systems. However, the last ones were replaced in 1992 and are not being supported with on-the-shelf parts either. As pieces fail, the City has to special order replacement parts at very high cost and time. The starts are Allen Bradley start systems which are one of the major manufacturers of industrial components like this.

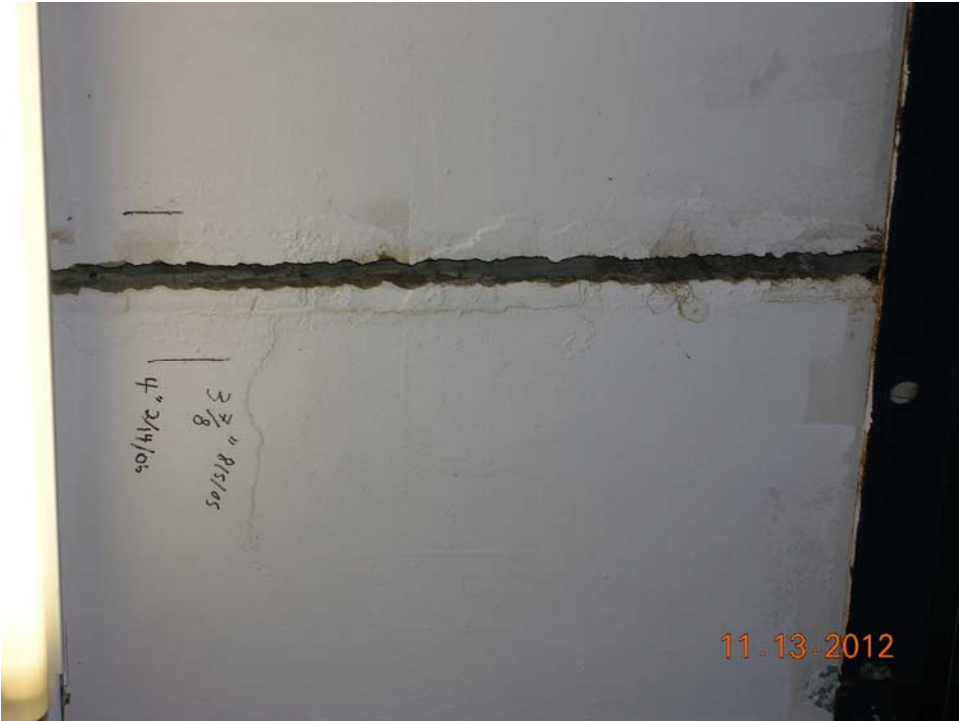
Crack in downstairs ceiling

The pumphouse shows its age more and more. There is separation on some of the wall panel connections and between the two floors of the pumphouse. The City contracted with CH2MHill to do a feasibility study to evaluate the overall condition of the building. Preliminary indications were that the building was in fair condition. However, they are currently undertaking additional investigation of the building's structural & seismic stability. Once this work is completed, the City will have a clearer picture of whether it building can be upgraded or may need complete replacement.

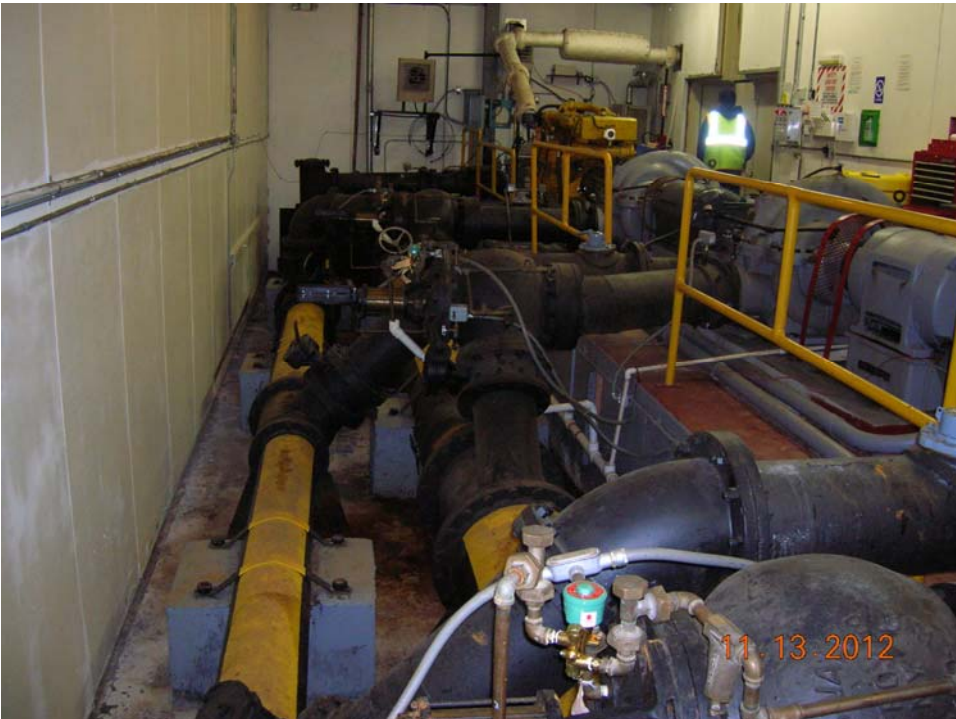
Inside pumphouse

The pumps are 1940 technology and no longer manufactured. They have proven to be very reliable and dependable over the years; however parts must be manufactured on an as needed basis and are extremely costly. The City prefers to have a machine shop build parts which is less costly than having the manufacturer that owns the pumps rights build parts.
