Yakutat - Ocean Cape Dock Major Maintenance

**ENGINEERS REPORT
SITKA SOUND SEAFOOD'S
PROCESSING PLANT
YAKUTAT, ALASKA**

Re: Yakutat Seafoods Process Building
Piling Inspection and Assessment

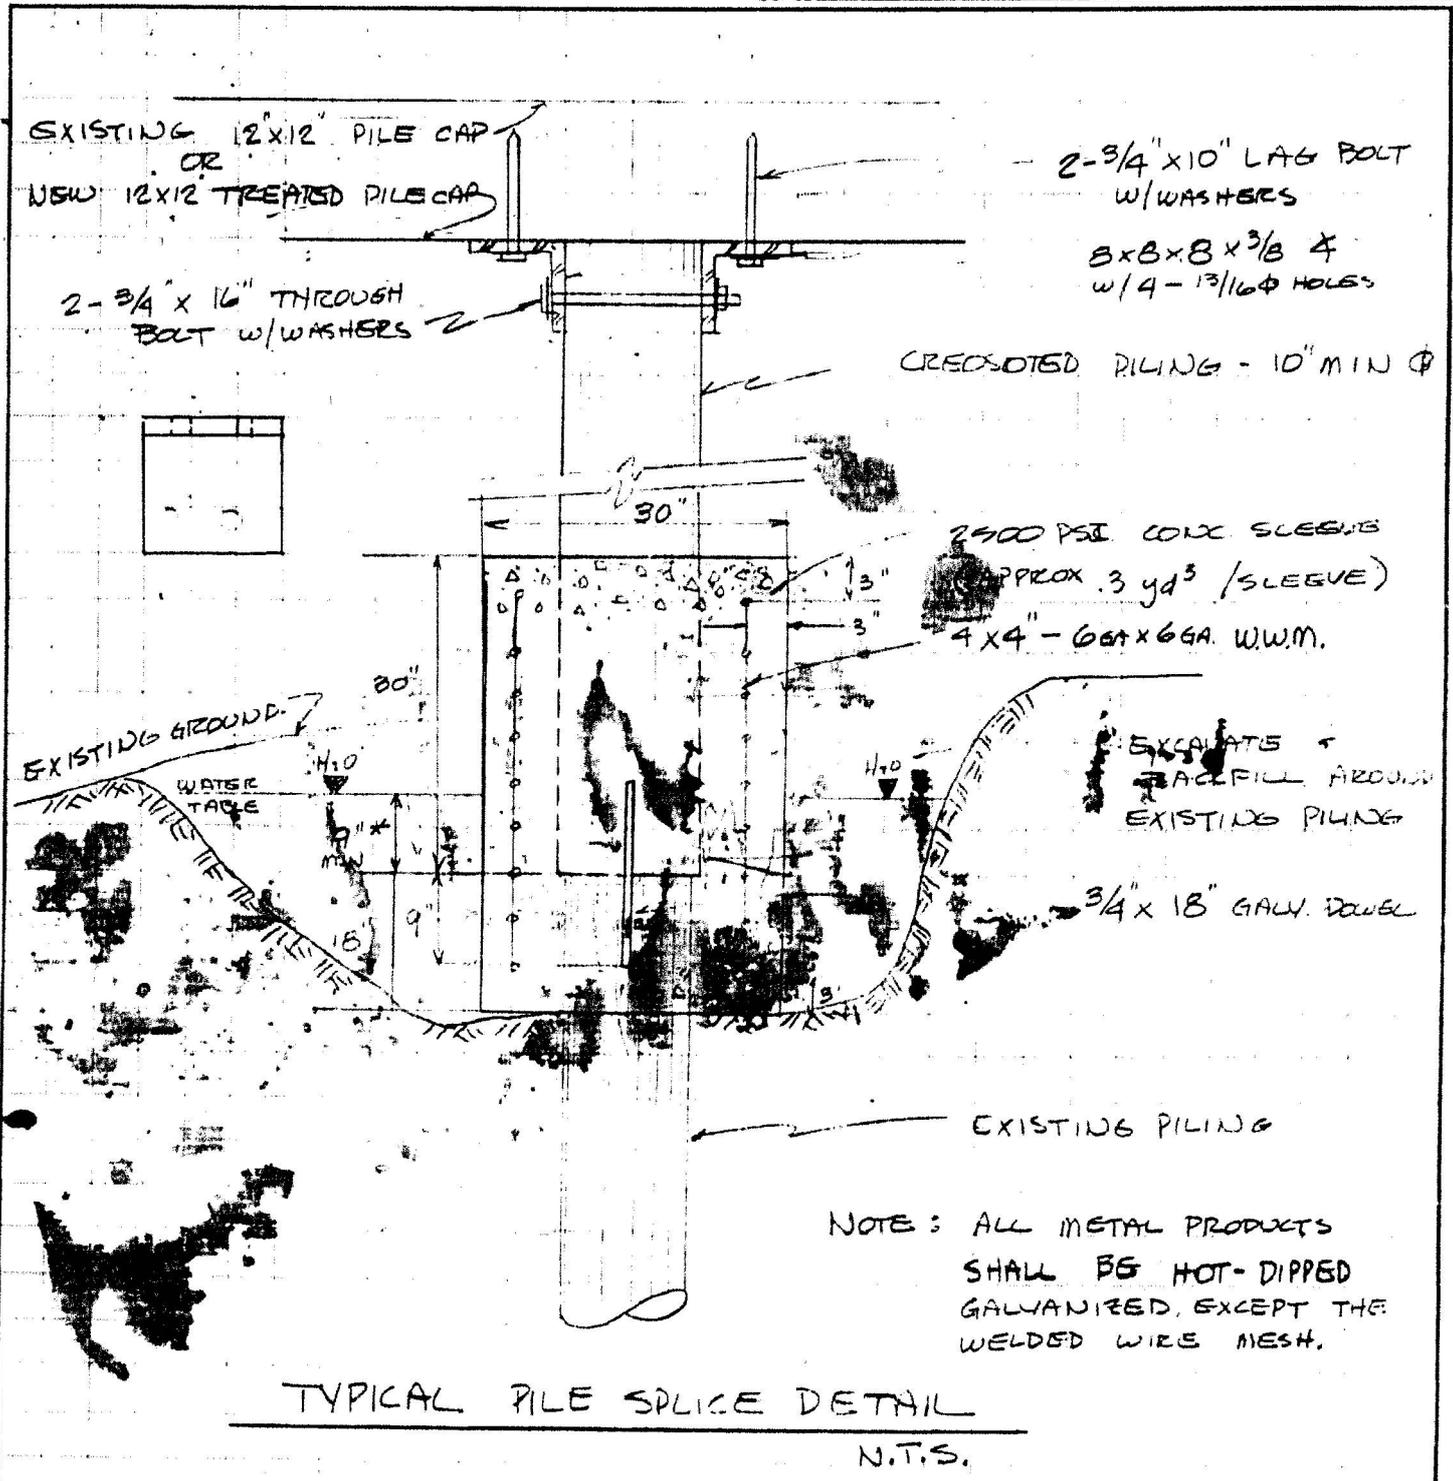
TYPICAL PILE SPLICE DETAIL

* CUT OFF EXISTING PILING A MINIMUM OF 9" BELOW WATER TABLE OR AT A SOLID PORTION OF EXISTING PILING.

All of the remaining piling should be replaced according to the details provided on sheets 5 and 6 of the attached calculation sheets, except the existing creosoted piling. These piling should be attached to the pile caps according to the attachment details on sheet 5.

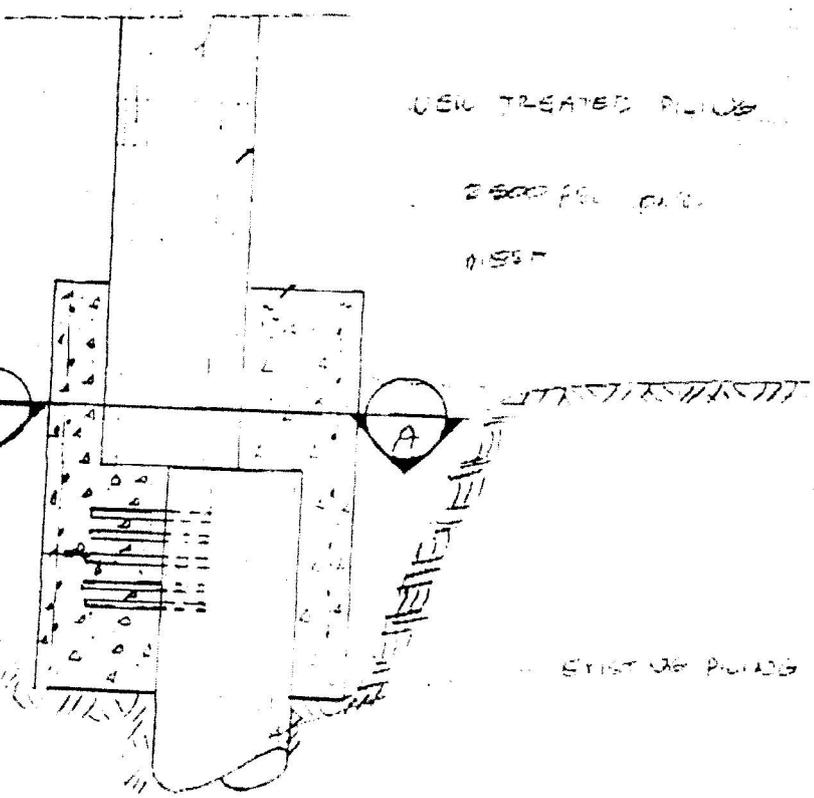
TYPICAL ELEVATION

NEW TREATED PILING CAN BE OUT OF PLUMB BY AS MUCH AS A 1:12 SLOPE

3 #5 bars
run into existing
pile

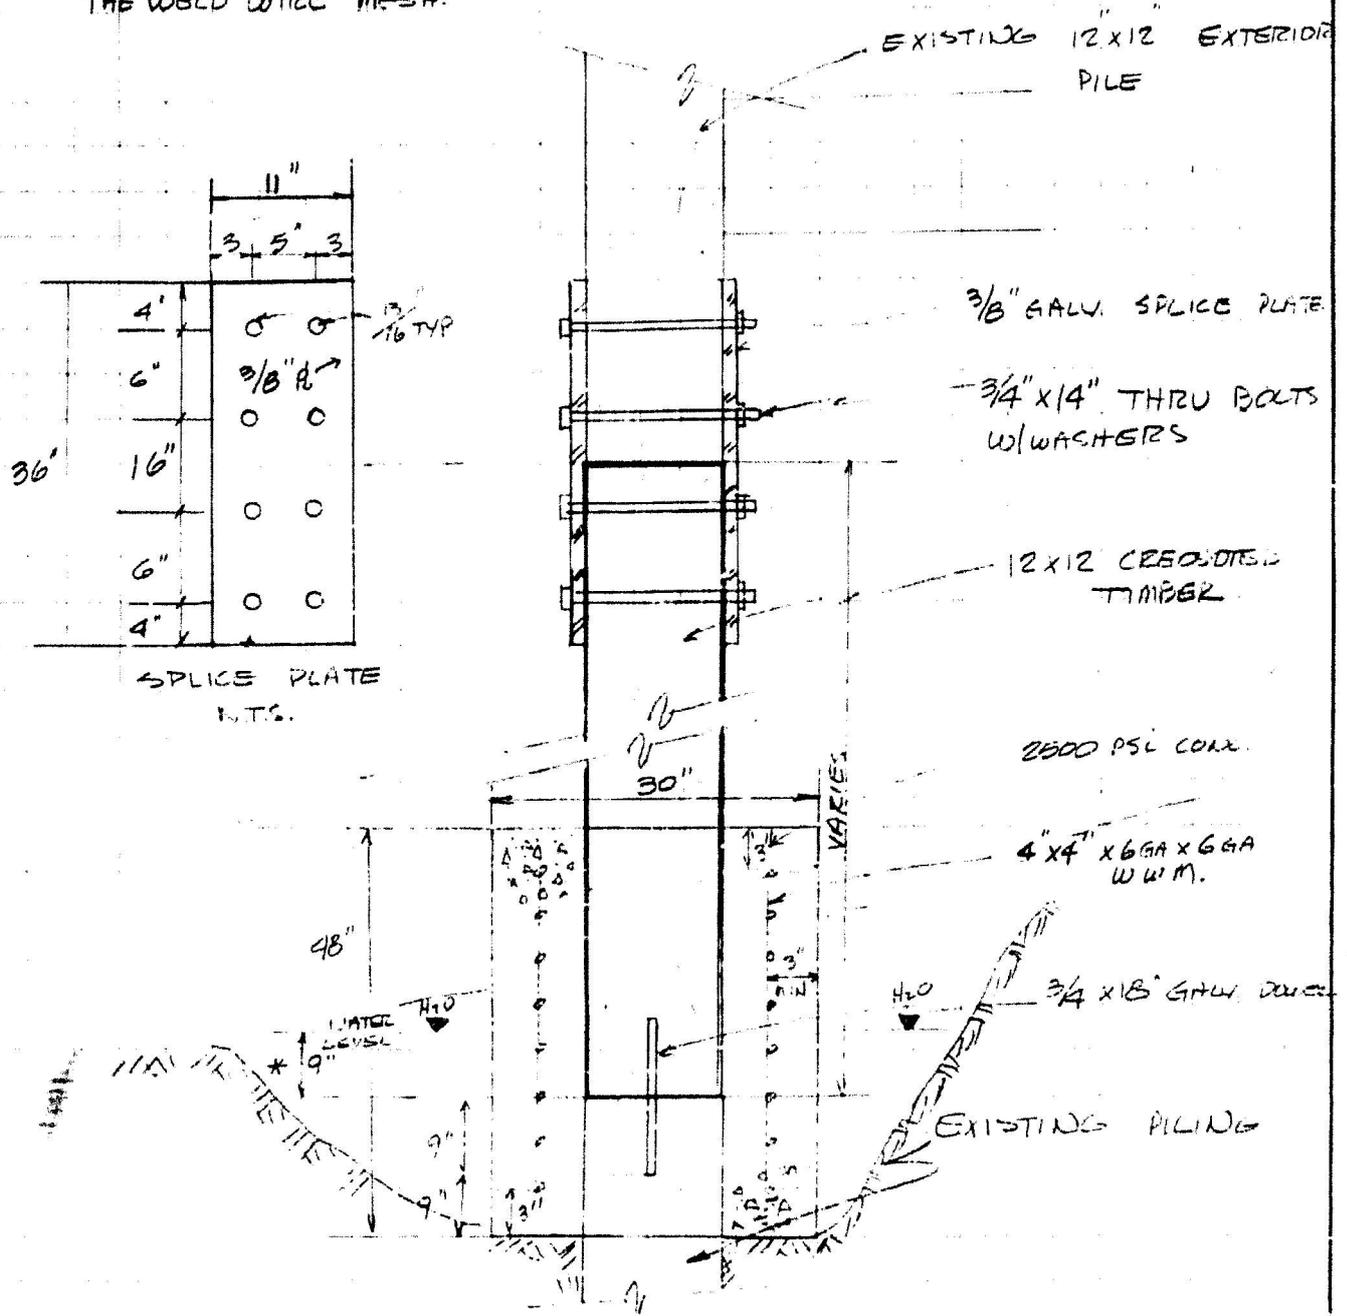
TYPICAL 12x12 EXTERIOR PILE SPLICE DETAIL

* CUT OFF EXISTING PILING A MINIMUM OF 9" BELOW WATER TABLE OR AT
A SOLID PORTION OF EXISTING PILING.

NOTE: ALL METAL PRODUCTS SHALL
BE HOT DIPPED GALVANIZED, EXCEPT
THE WELD WIRE MESH.

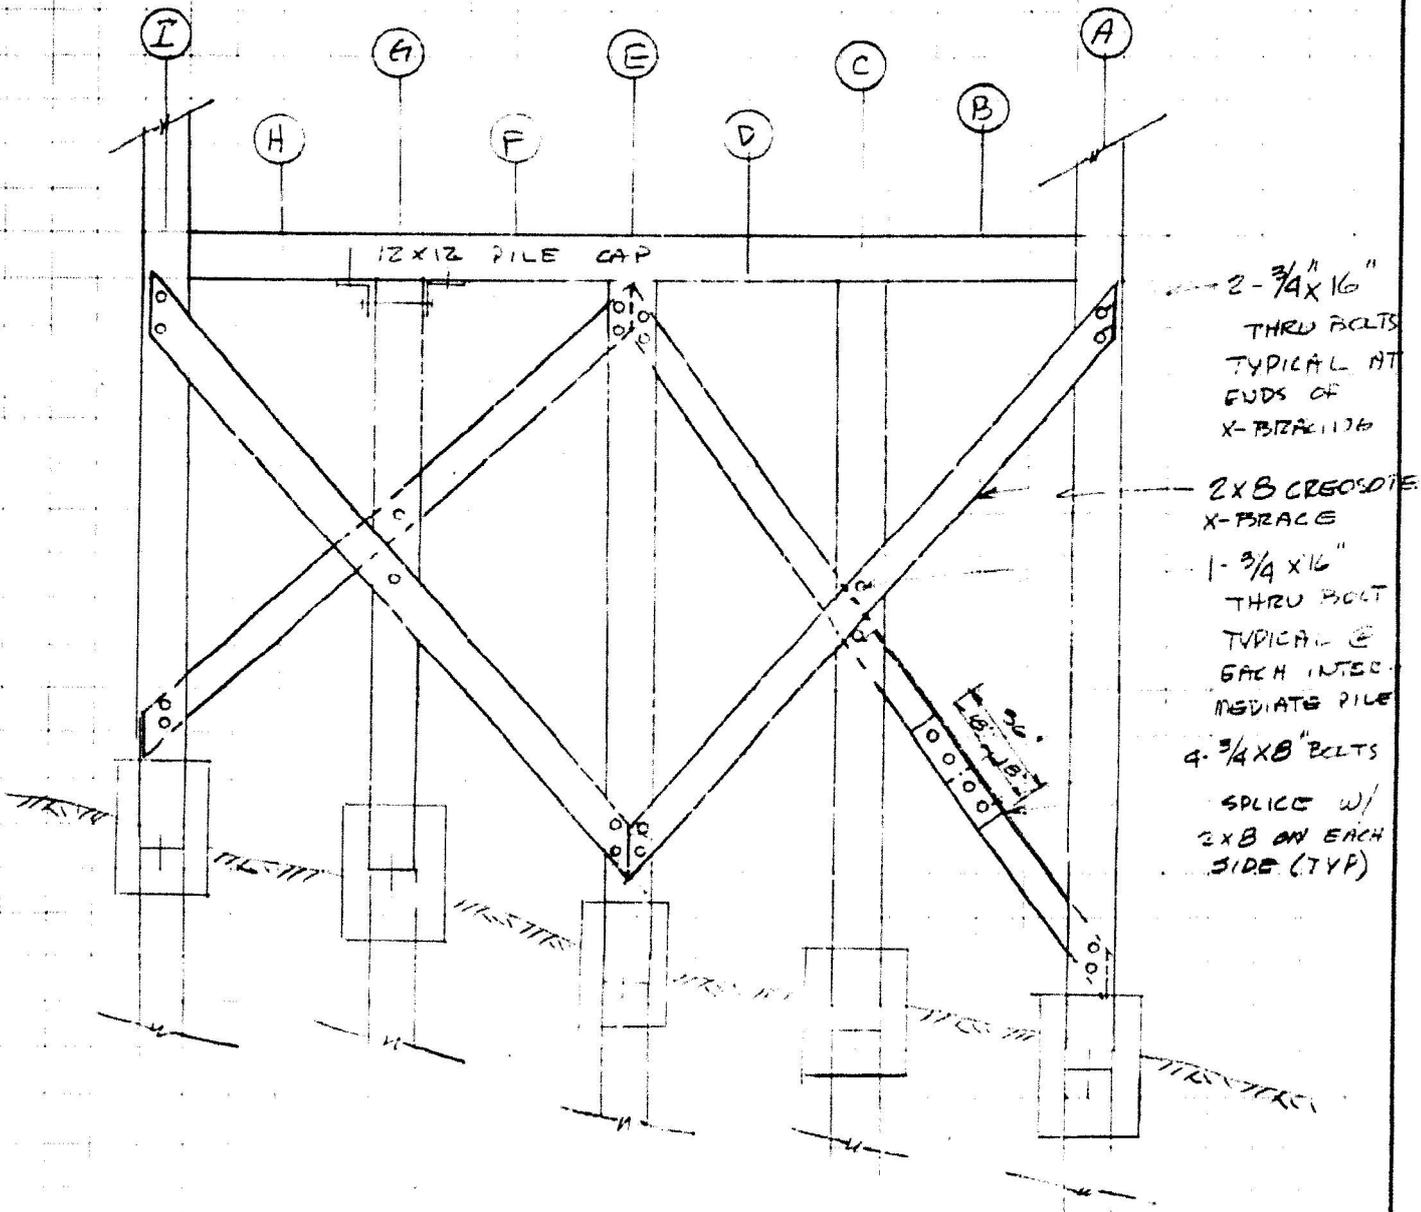
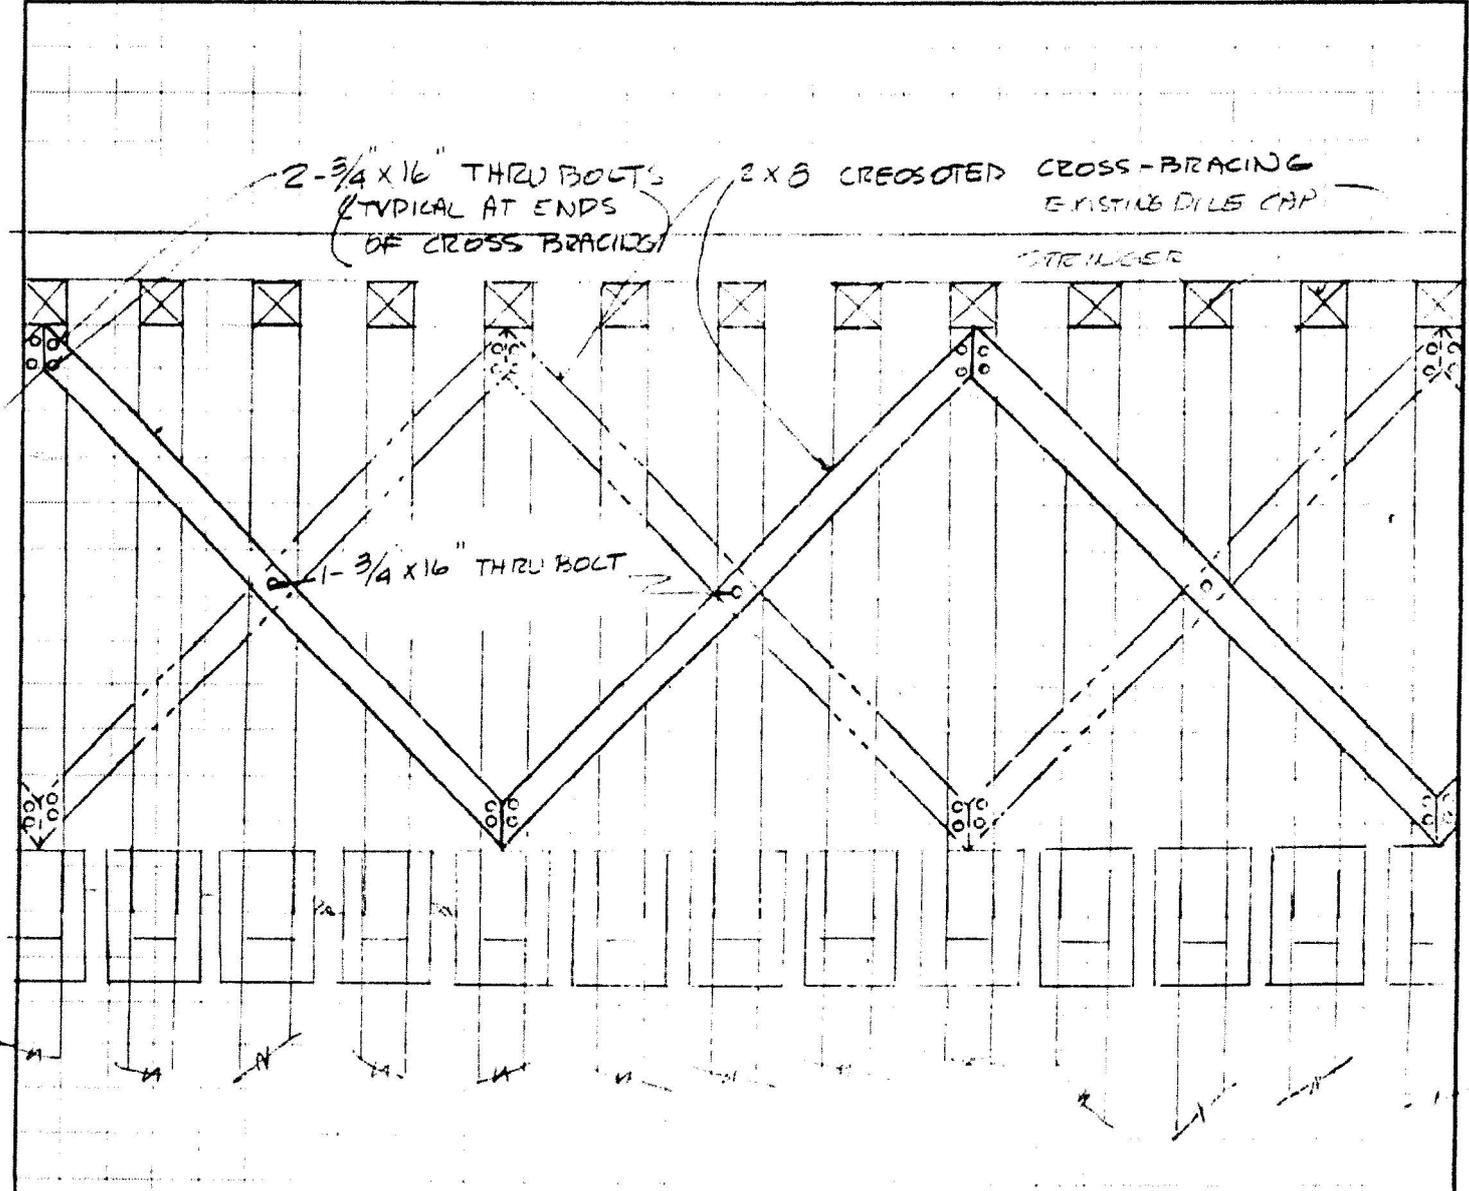
TYPICAL LONGITUDINAL X-BRACING
@ GRID LINES A, E & I U.T.S.

WE WOULD NEED X BRACING THEN $\frac{14}{4.7 \times 1.2} = 4.6$ OR EVERY 4TH ROW OF
PILING.

PROVIDE CROSS BRACING ON GRID LINES:
3, 7, 11, 15, 19, 23, 27, 31, 35, 39, 41, 42, 43 & 44

Cross-bracing, in both the lateral and longitudinal direction as detailed on sheets 8 and

9, shall be installed according to the schedule on those sheets.
