**PROPOSED ACTIVITY:** Cut slopes on both sides of existing airport runway to meet

**AIRPORT RUNWAY EXTENSION**

**OLD HARBOR, ALASKA**

This effort involved a geotechnical investigation consisting of assessing soil and bedrock conditions, for the proposed runway extension. The investigation included the following:

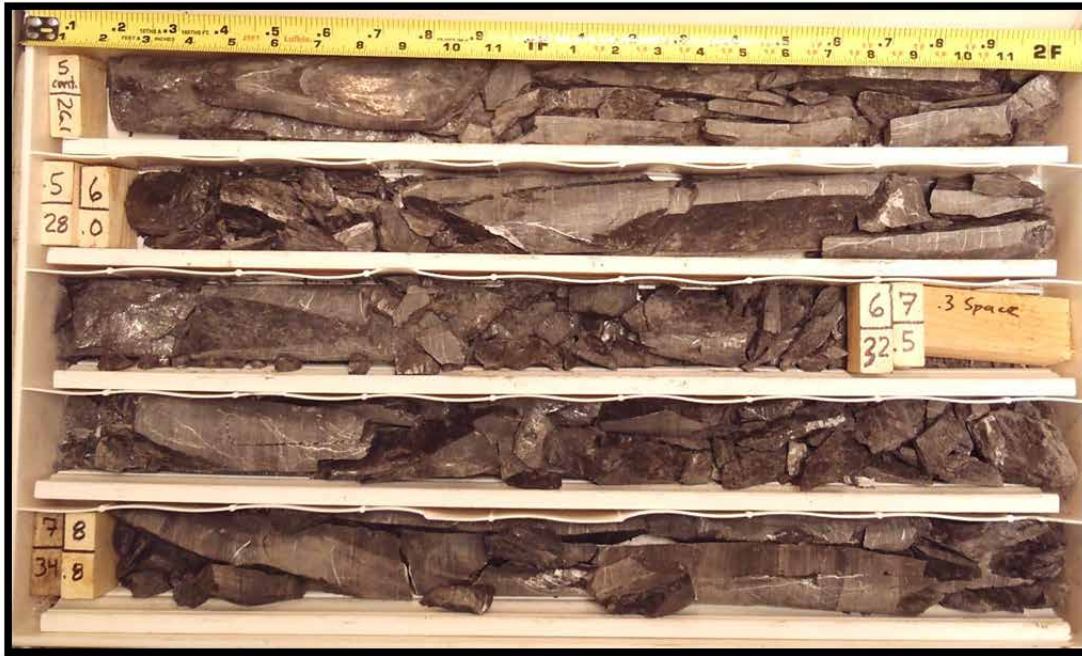
RM12-03, Box 2, 26.1 to 37.2 feet, Dry. Core box highlighting the highly fractured recovery and vertical trending foliation observed within many zones of the phyllite unit

A less fractured, harder rock zone was observed at each boring location, generalized into two main rock units presented on the logs. The two rock units are based on the percentage of phyllite within the graywacke determined by visual inspection. Discontinuity reports detailing the occurrence and characteristics of breaks observed within the core are provided in Appendix B on Drawings B-32 through B-41. Selected photos of the rock core are provided as Figure 2. A complete set of rock core photographs is provided as Appendix E.

Phyllite: The phyllite unit is interpreted as more than 50 percent banded phyllite and generally ranges from medium to hard, slightly to moderately weathered, with frequent zones of soft rock along major bands. The rock generally splits readily along the foliation, with a varying degree of slaty cleavage (graphitic “greasy” feel) along the majority of splits. The rock appears to be more layered, soft to hard, and moderately to highly fractured. RQD within this unit ranged from 0 percent to 83 percent, with an average RQD of 25 percent.

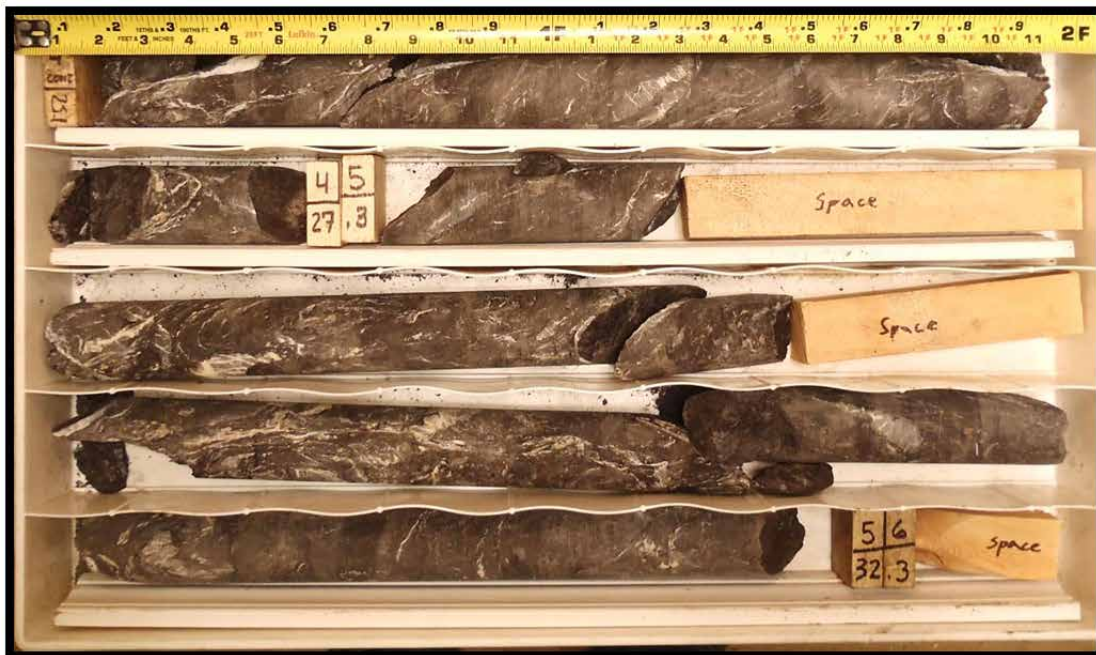
RM12-04, Box 2, 25.1 to 32.3 feet, Dry. Core box highlighting the higher rock quality and visible carbonate veins observed within the phyllitic graywacke unit

Phyllitic Graywacke: The phyllitic graywacke unit is interpreted as very fine sandstone with less than 50 percent by volume phyllite by visual examination. This rock generally splits along the foliation. Rock mass strength for this unit is interpreted to be primarily a function of the foliation and the percentage of the phyllitic material present in the rock mass. This unit tends to be hard, fresh to slightly weathered, less fractured and generally more competent than the phyllite unit. RQD within this unit ranged from 15 percent to 100 percent, with an average RQD of 66 percent.

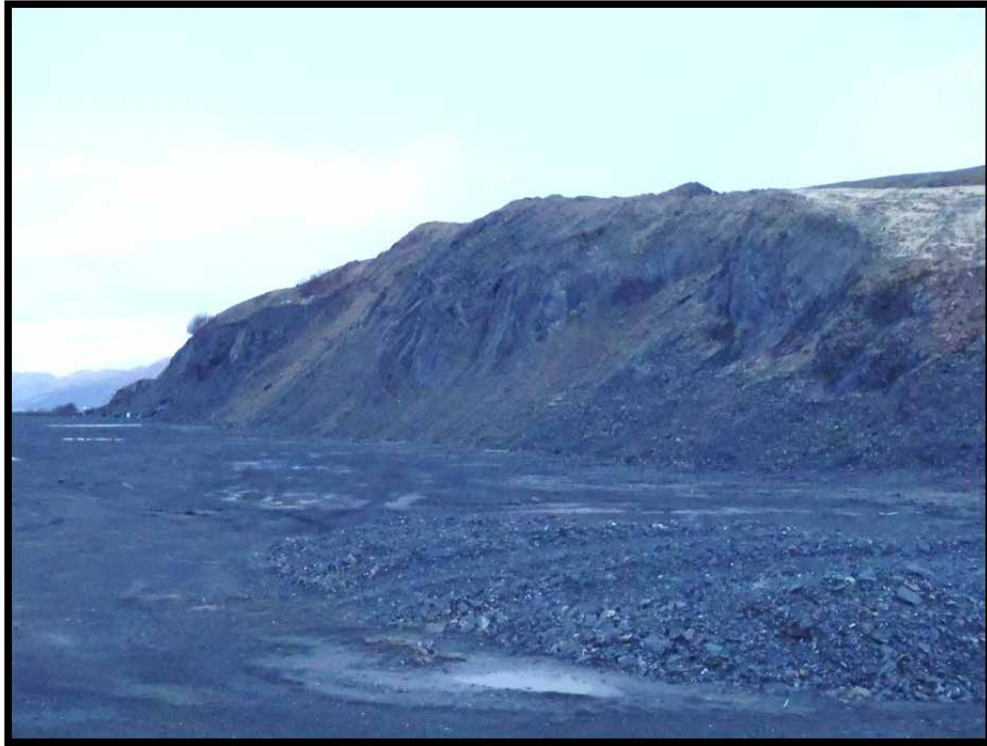
The existing northern runway rock cut, as viewed from the east, 26 October 2012

Bedrock in the cutslopes was interpreted to consist of various grades of interbedded phyllite and graywacke, and appears highly folded and twisted. A well-developed foliation and associated cleavage was observed, trending near vertical. Generally, the rock in the area consisted of closely spaced dark gray phyllite bands and clasts within a gray, very fine-grained graywacke.

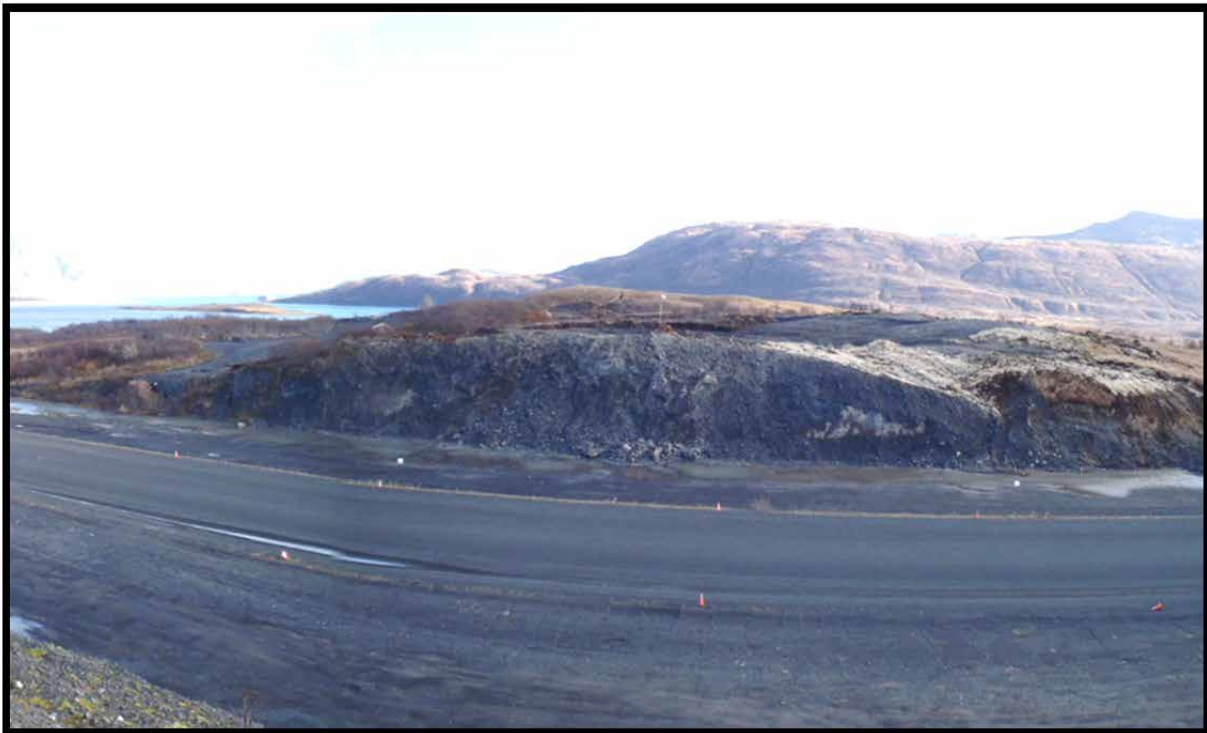
The existing southern runway rock cut, as viewed from the northwest, 26 October 2012

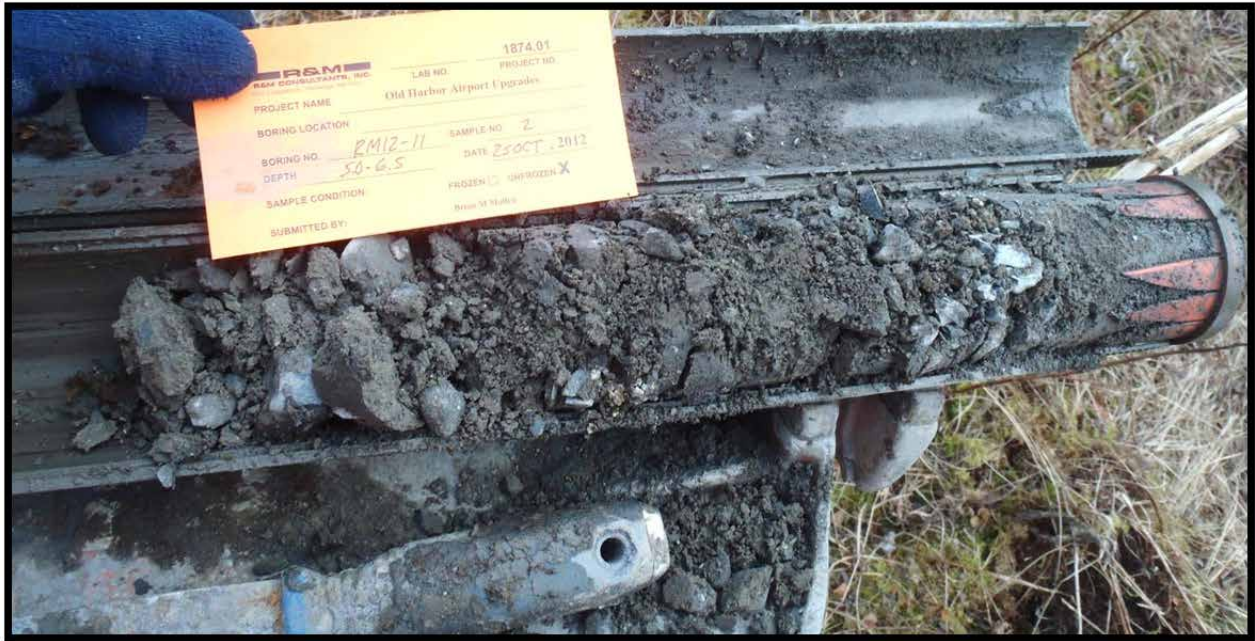
Test boring RM12-11, Sample 2, 5.0 to 6.5 feet, Sample within the glacial till unit

The glacial till unit was observed varying in classification from poorly graded gravel with silt and sand to silty gravel with sand (GP-GM, SM, GM). This unit contained cobbles and boulders in some locations. The consistency of the till unit was typically medium dense but ranged from loose to dense across the onshore investigation area. Tested P200 values ranged from a minimum of 5.7 percent to a maximum of 30 percent, with an average P200 of 17 percent. Tested moisture content within the till unit ranged from a minimum of 4.3 percent at RM12-07 to a maximum of 33 percent at RM12-13, with an average of 9.3 percent. Hydrometer testing within this unit showed P0.02 values ranging from 6.3 to 16 percent. The thickness of the till unit varied from a minimum of 5.5 feet at RM12-08 to a maximum of 18.1 feet at RM12-10.

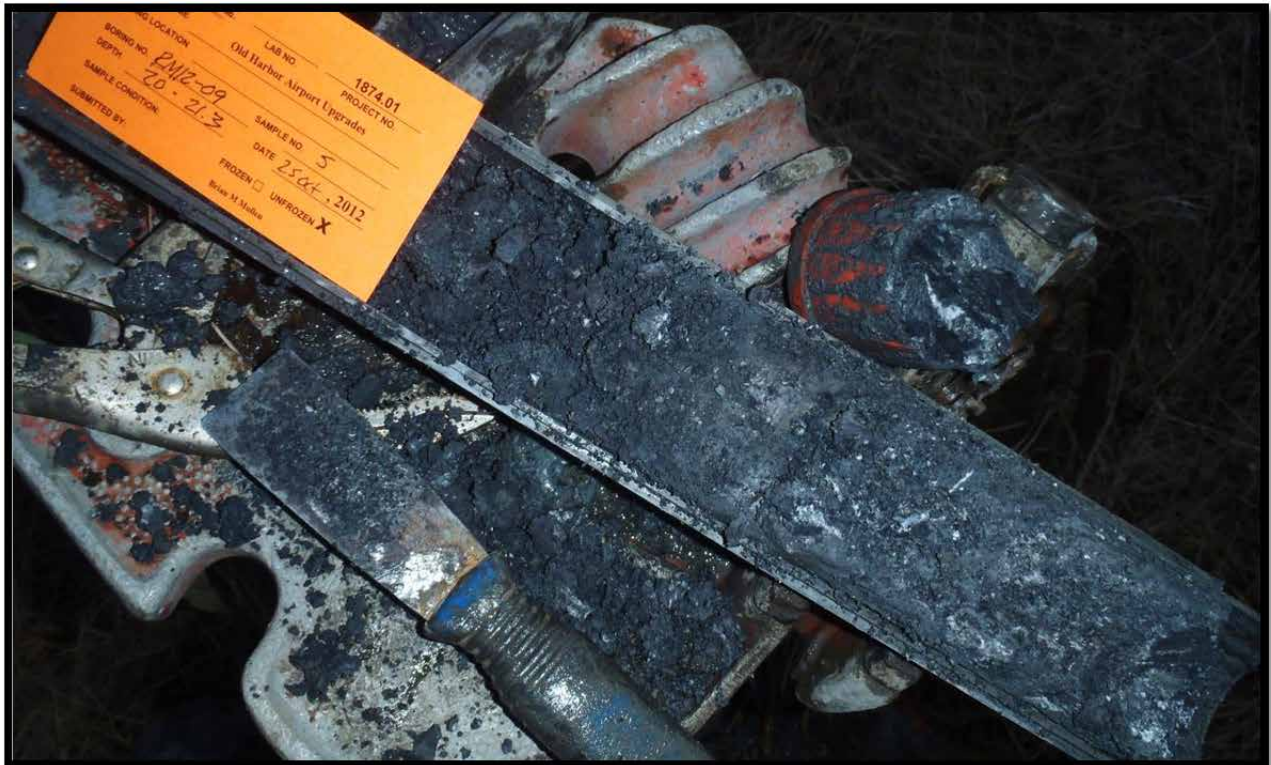
Test Boring RM12-09, Sample 5, 20.0 to 21.3 feet, Sample within the weathered bedrock unit

Bedrock underlying the onshore investigation area was generally interpreted to be a zone of moderately to highly weathered, soft, highly fractured phyllitic rock over harder, less fractured rock. Although the rock could typically be drilled and sampled with auger methods, auger refusal on presumably hard rock was encountered in several of the boring locations before the target depth was achieved. In particular, the harder rock zone is expected at an elevation of 15 feet at the proposed stream diversion cut (RM12-07) and at an elevation of 45 to 65 feet at the proposed runway extension cut at the north extent of the peninsula.

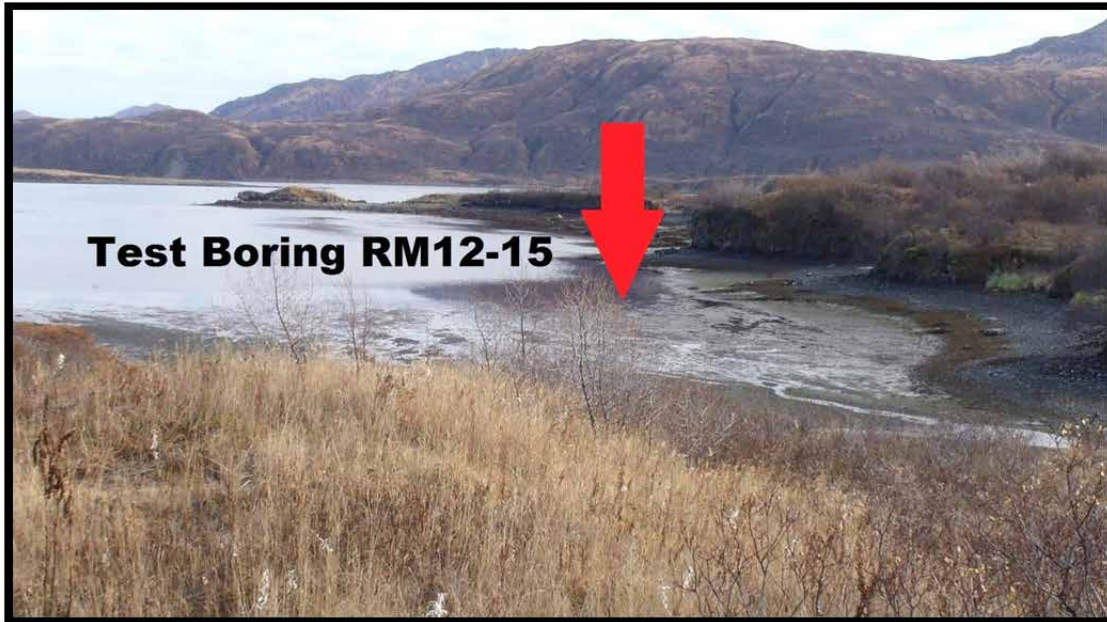
Southern Intertidal Zone, as viewed from the north, 24 October 2012

The offshore investigation areas exhibited a variable thickness of marine soils grading to marine affected glacial till deposits. The soils classified as silty sand with gravel (SM), with tested P200 values ranging from a minimum of 22 percent to a maximum of 32 percent, with an average P200 of 25 percent. The consistency of the soils ranged from loose in the upper five feet to medium dense below. Both atterberg limit tests performed on soils within this unit provided non-plastic results with liquid limits of 23 and 29. Moisture contents observed within the unit ranged from a minimum of 7.0 percent to a maximum of 32 percent. Slight organic content was observed throughout RM12-15 in the south offshore area. Cobbles were interpreted at various depths within RM12-16 in the north offshore area.

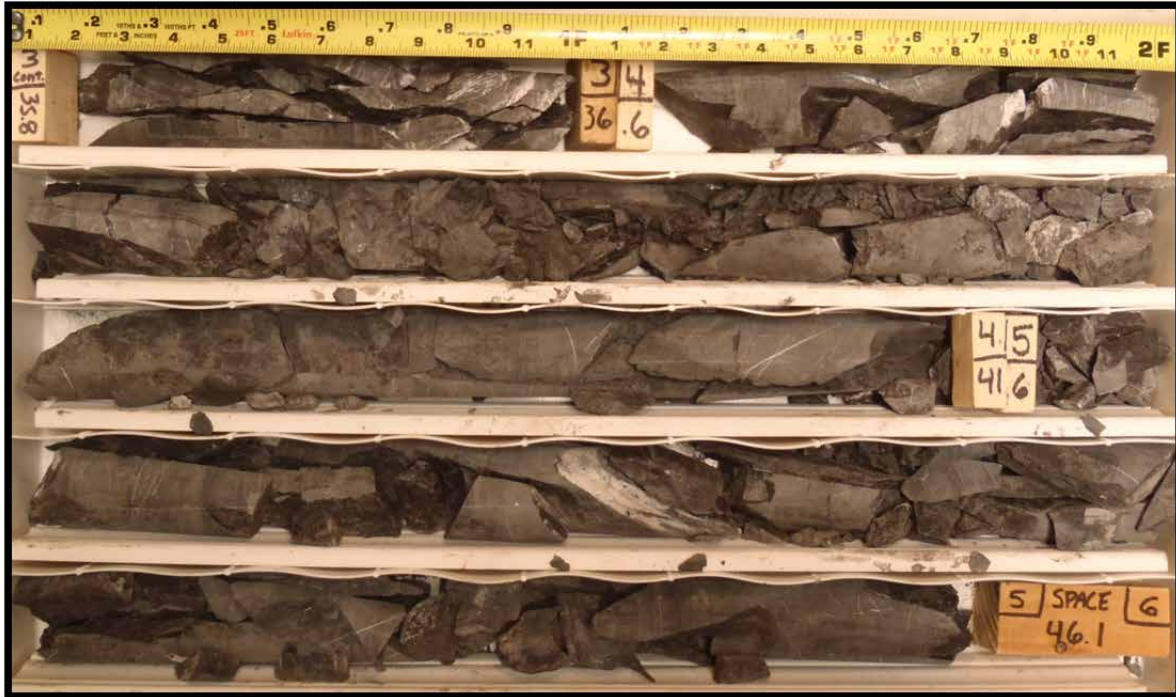
Figure E-01

RM12-01, Box 2, 35.8 to 46.1 feet, Dry.

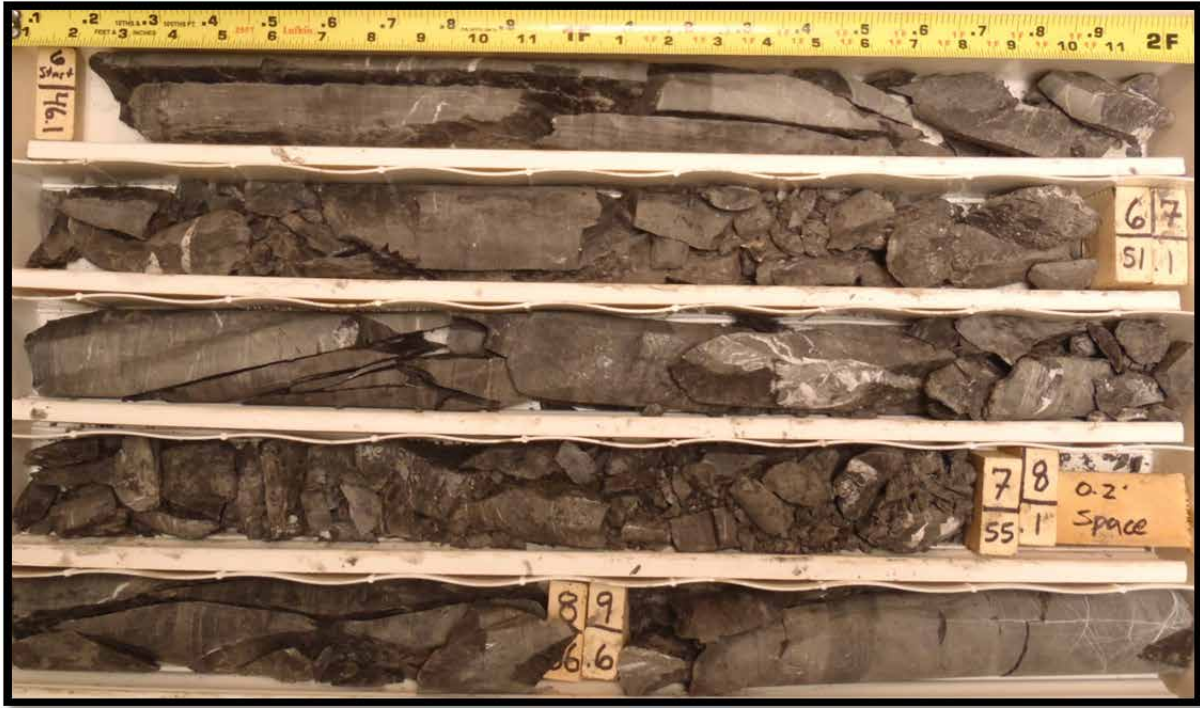
RM12-01, Box 3, 46.1 to 57.4 feet, Dry.

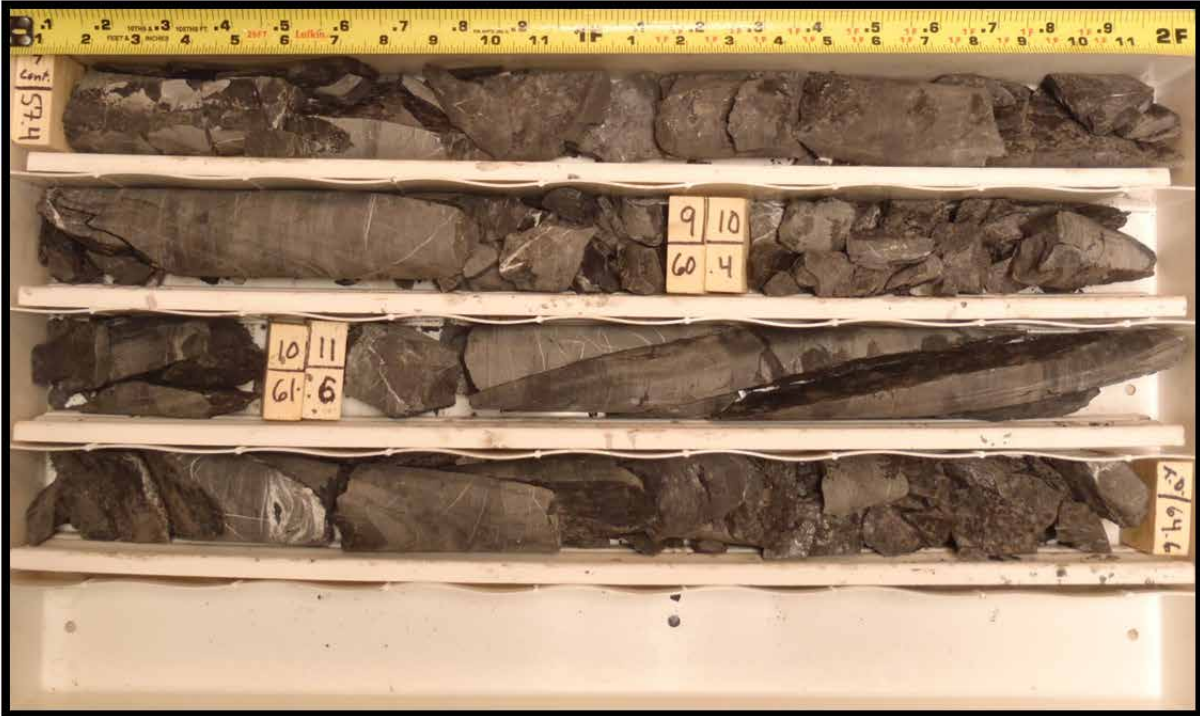
Figure E-02

RM12-01, Box 4, 57.4 to 64.6 feet, Dry.

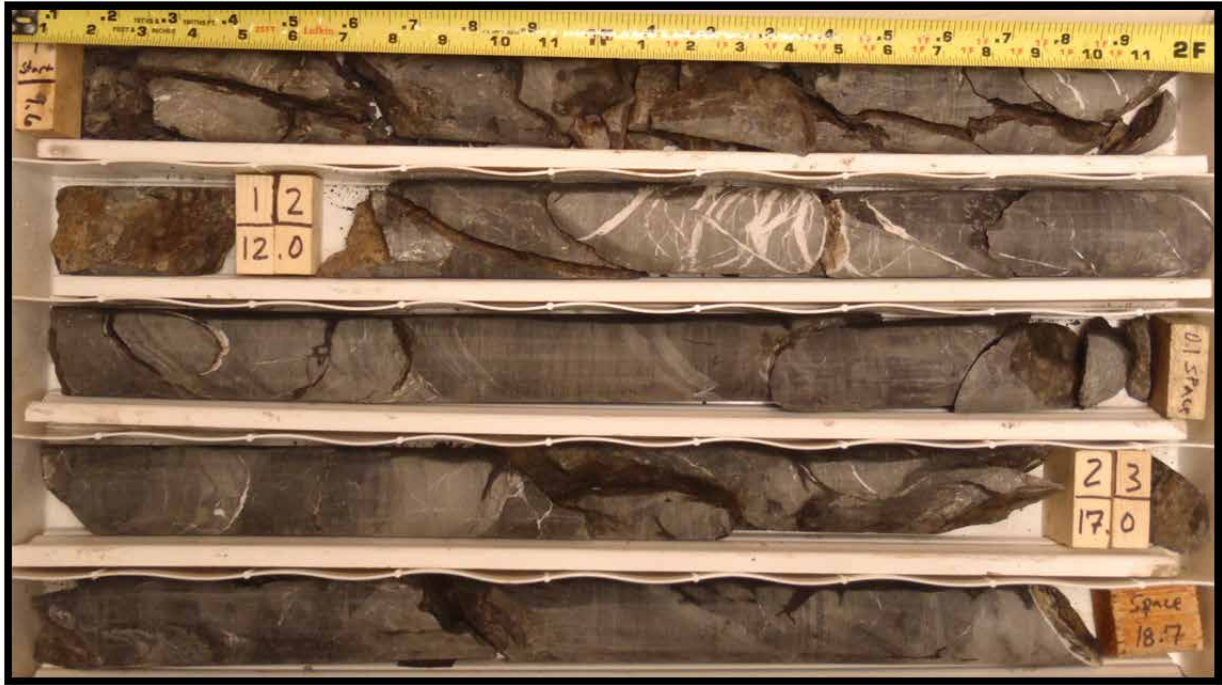
RM12-02, Box 1, 9.6 to 18.7 feet, Dry.

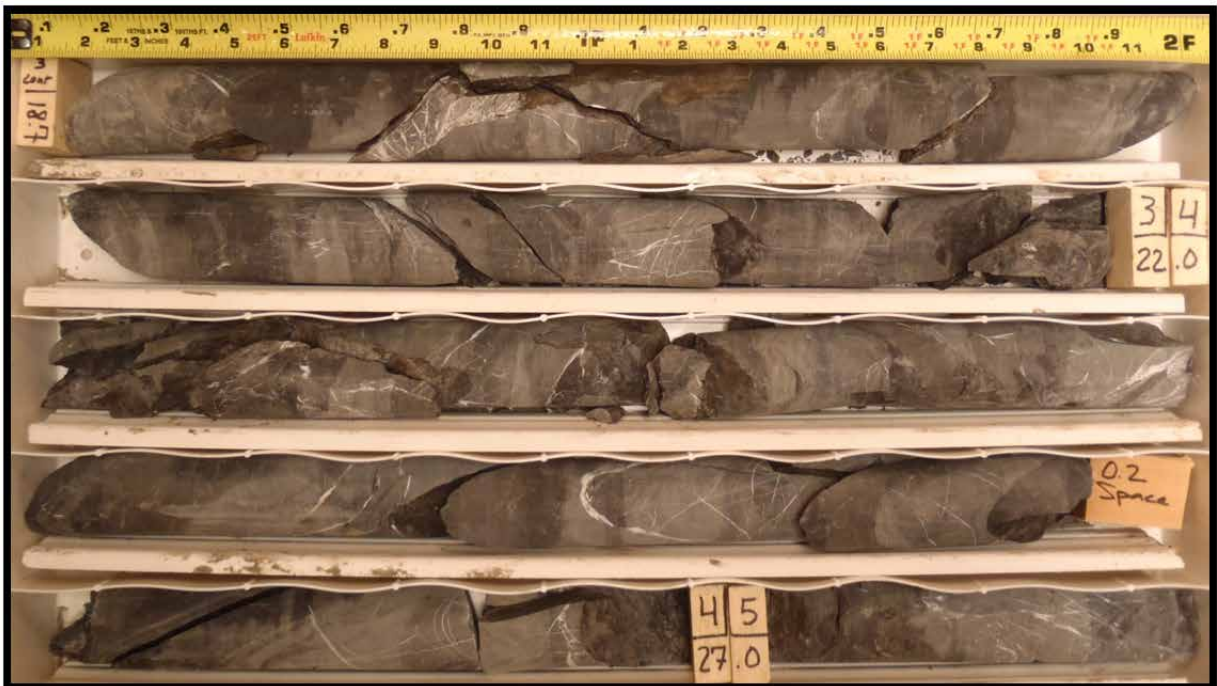
Figure E-03

RM12-02, Box 2, 18.7 to 27.7 feet, Dry.

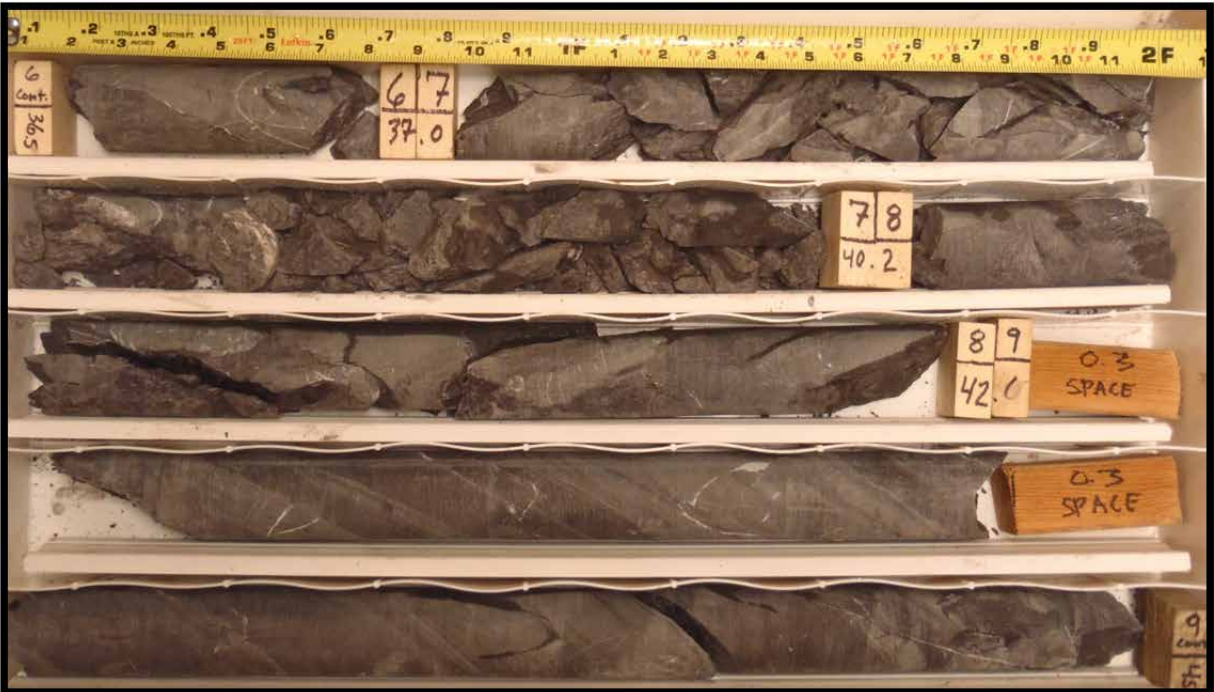
Figure E-04

RM12-02, Box 4, 36.5 to 45.5 feet, Dry.

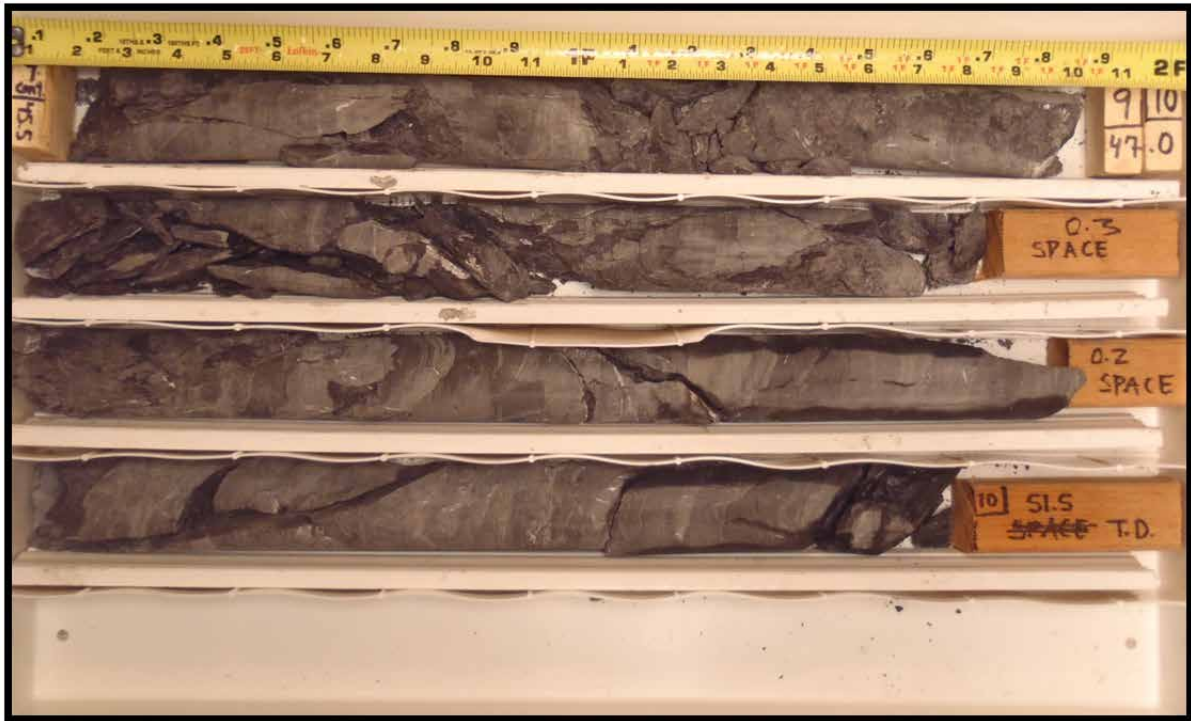
RM12-02, Box 5, 45.5 to 51.5 feet, Dry.

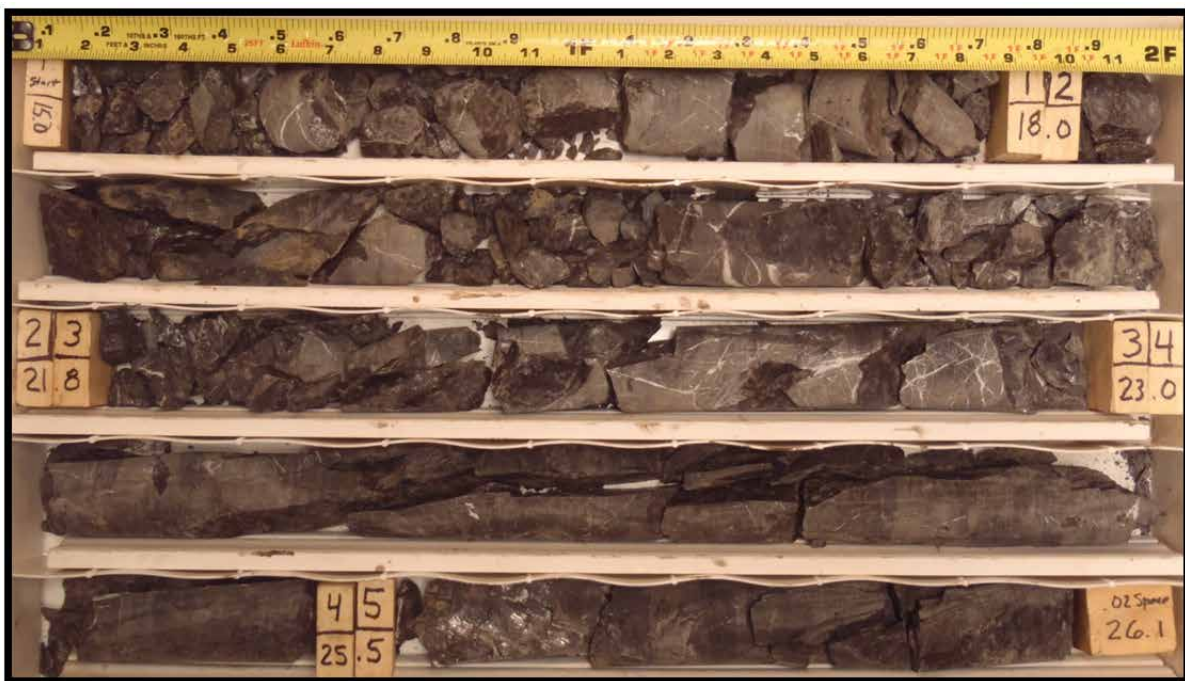
Figure E-05

RM12-03, Box 1, 15.0 to 26.1 feet, Dry.

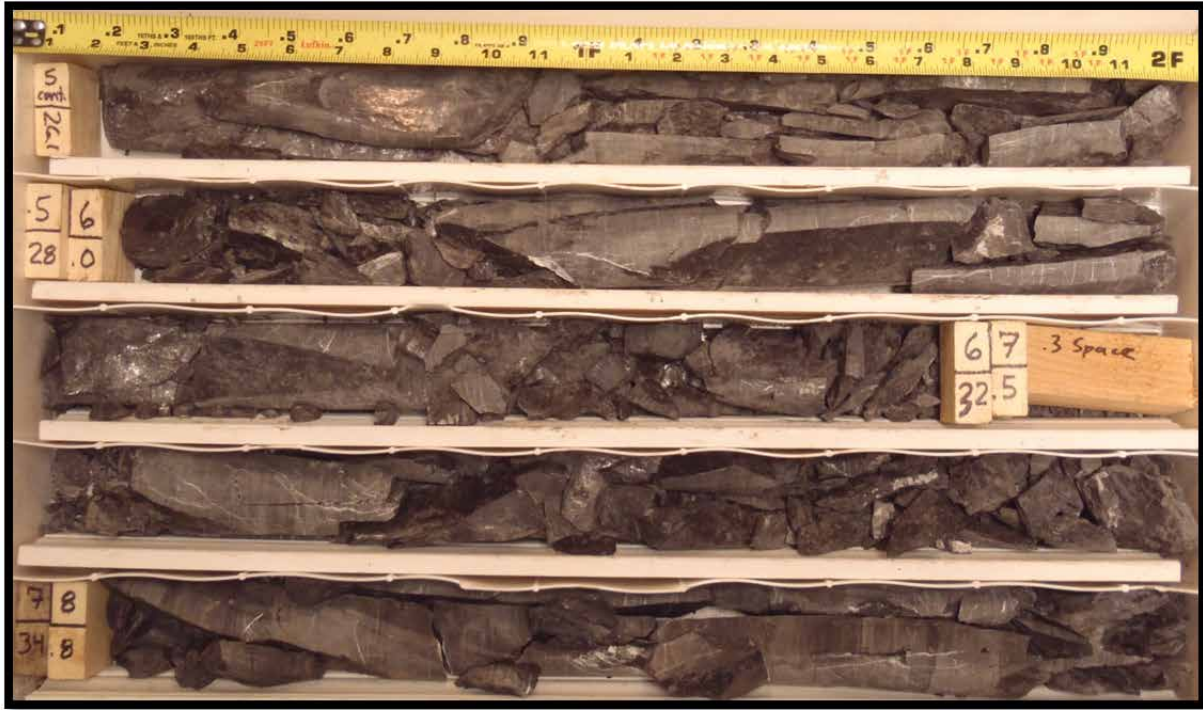
RM12-03, Box 2, 26.1 to 37.2 feet, Dry.

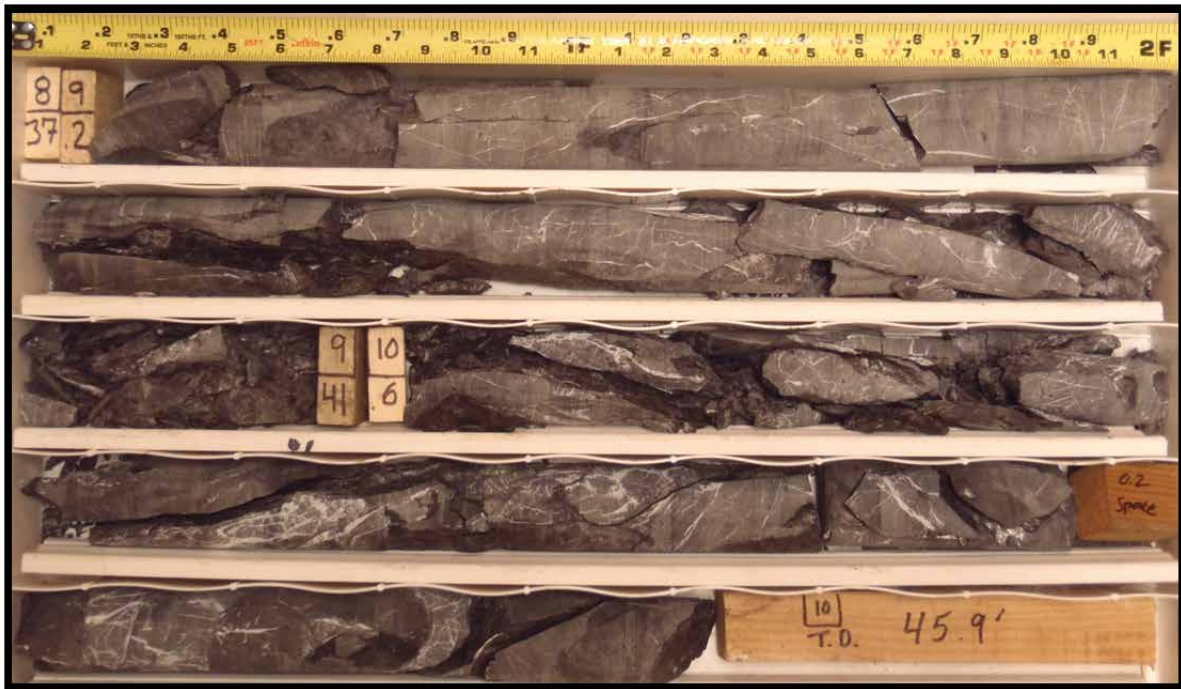
Figure E-06

RM12-03, Box 3, 37.2 to 45.9 feet, Dry.

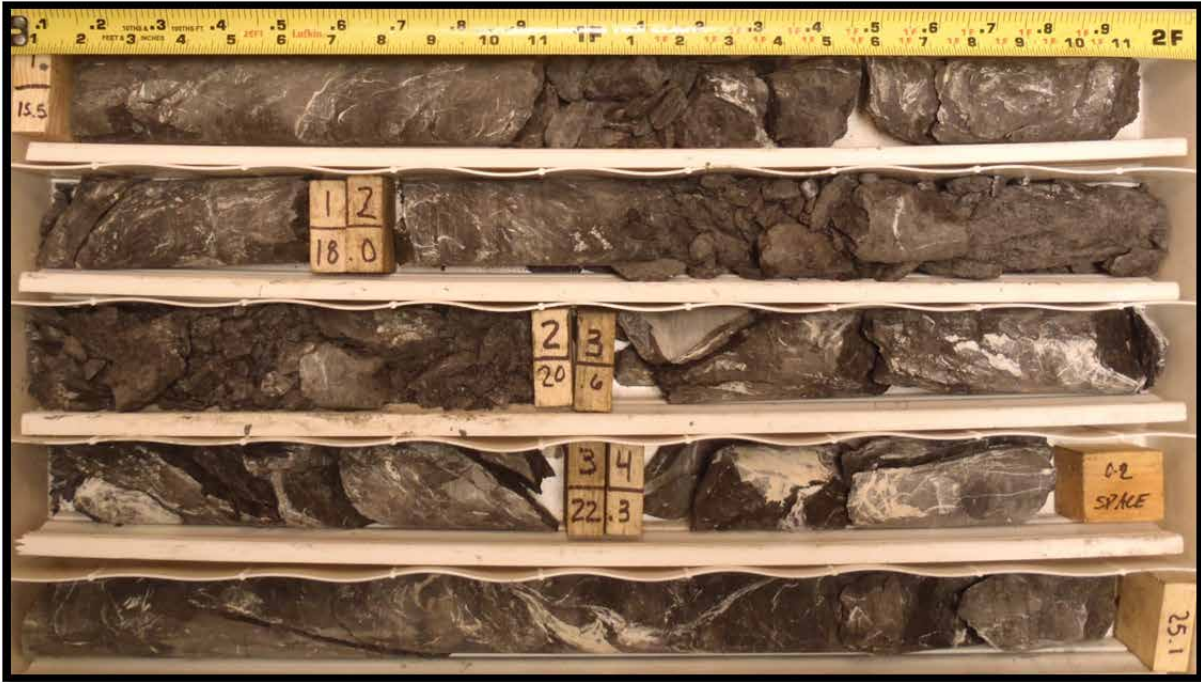
RM12-04, Box 1, 15.5 to 25.1 feet, Dry.

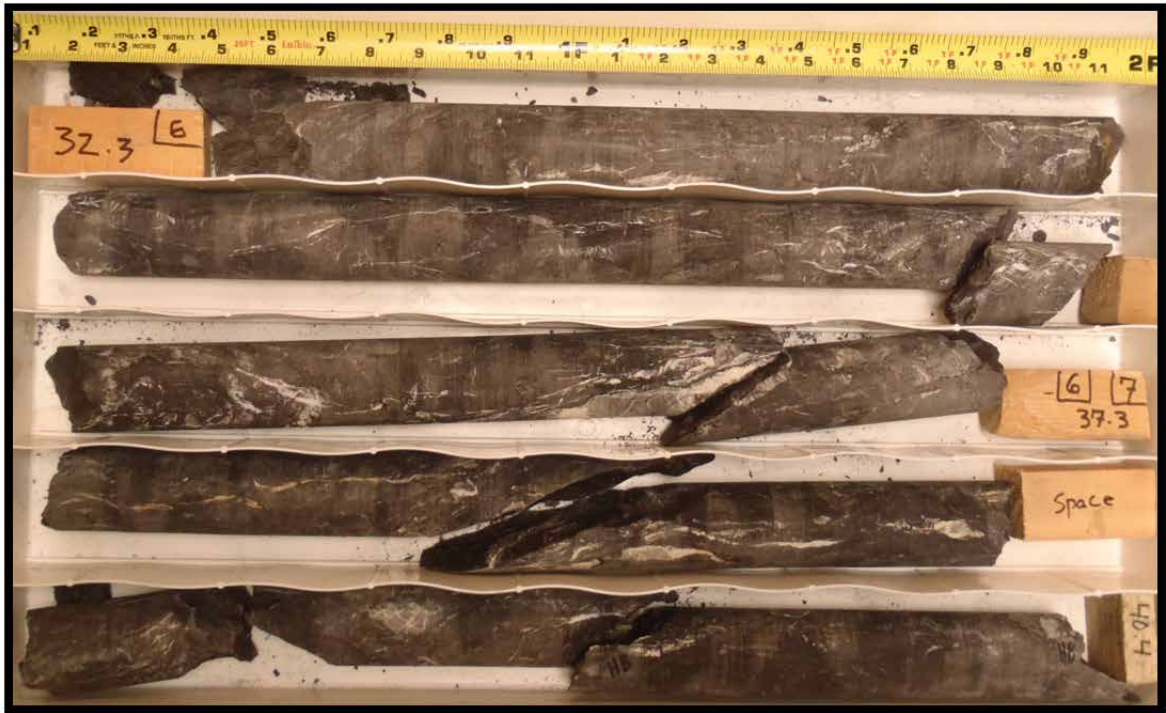
RM12-04, Box 3, 32.3 to 40.4 feet, Dry.

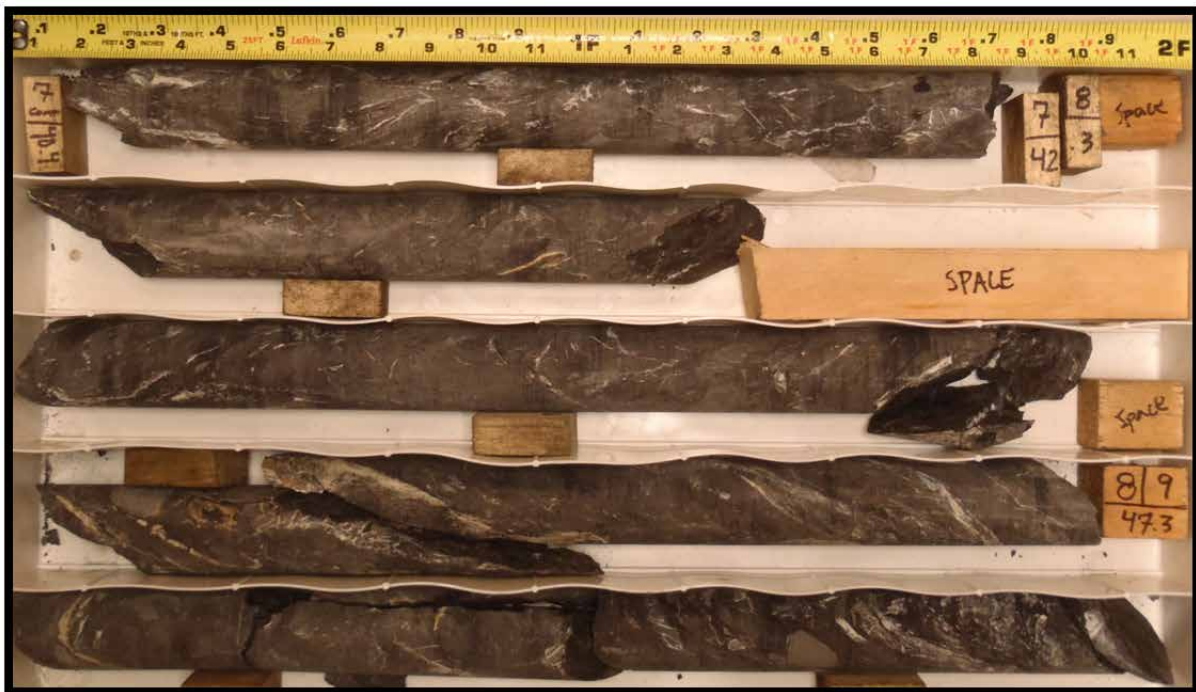
Figure E-08

RM12-04, Box 4, 40.4 to 48.9 feet, Dry.

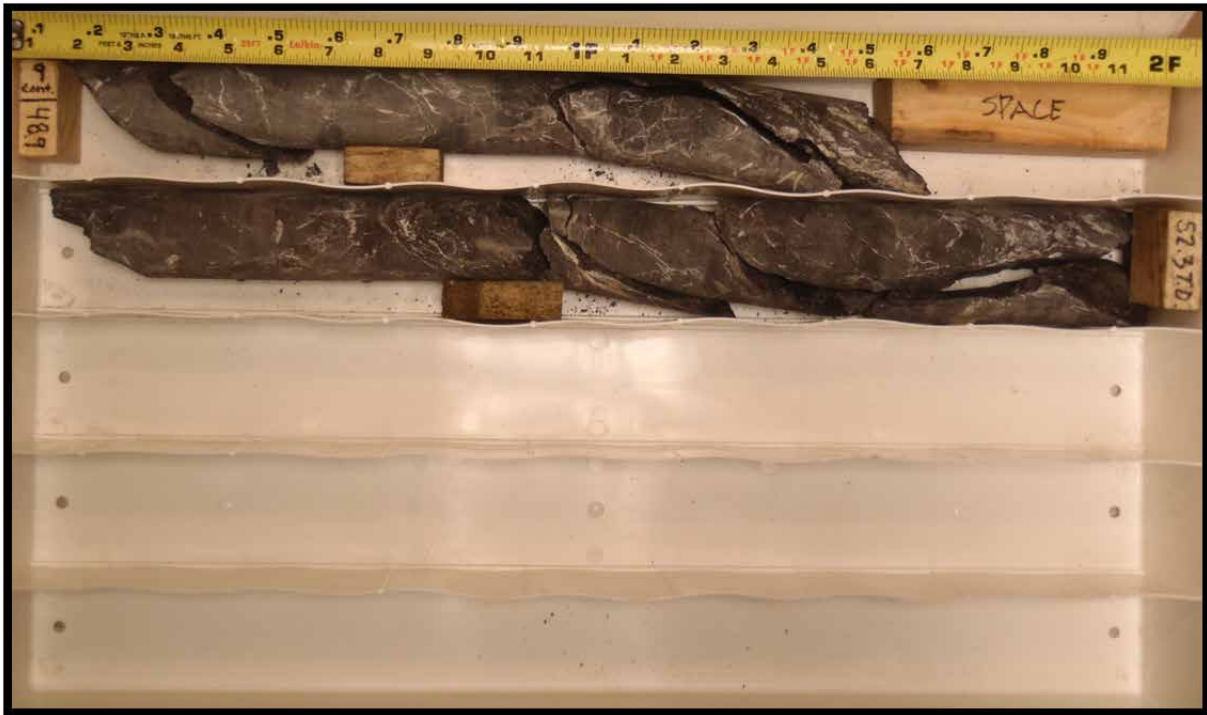
RM12-04, Box 5, 48.9 to 52.3 feet, Dry.

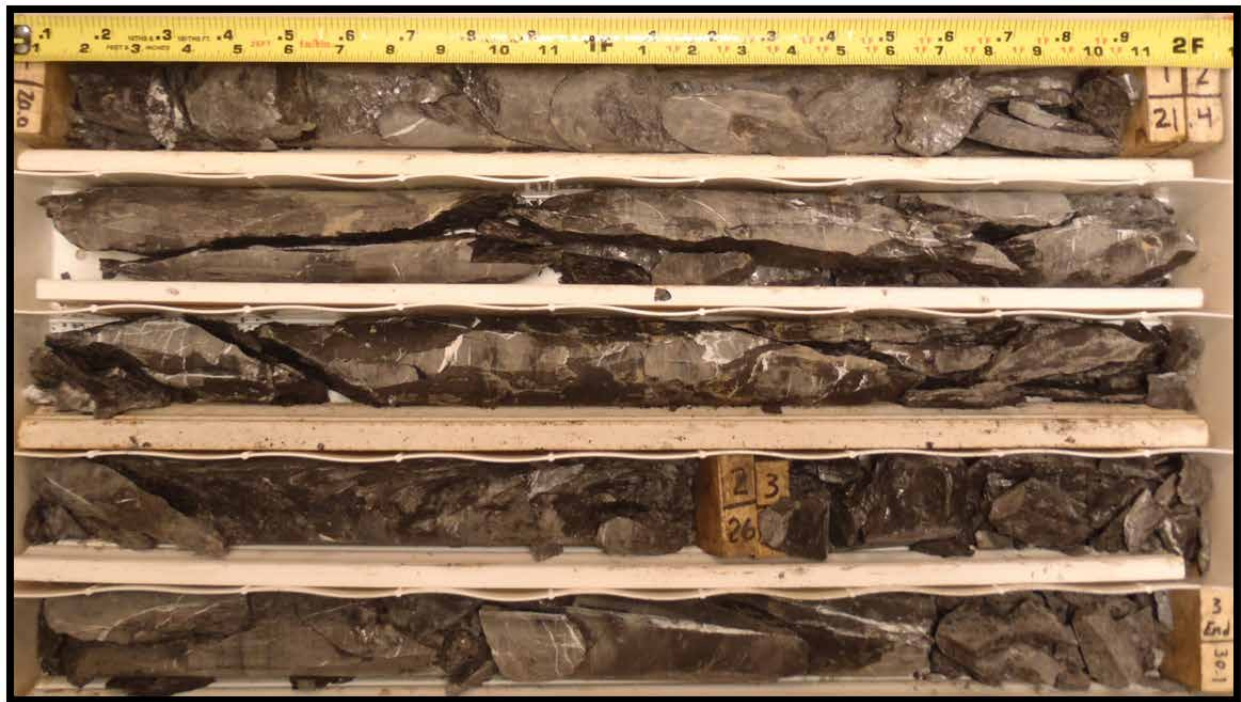
Figure E-09

RM12-05, Box 1, 20.0 to 30.1 feet, Dry.

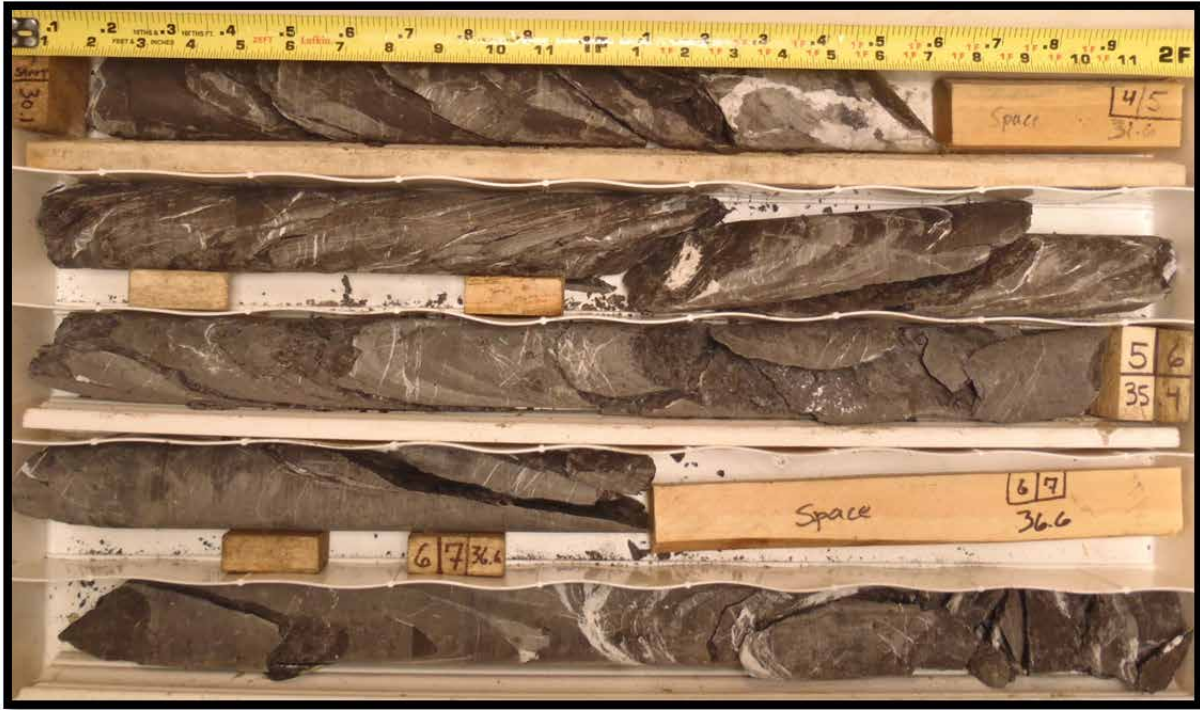
RM12-05, Box 2, 30.1 to 38.6 feet, Dry.

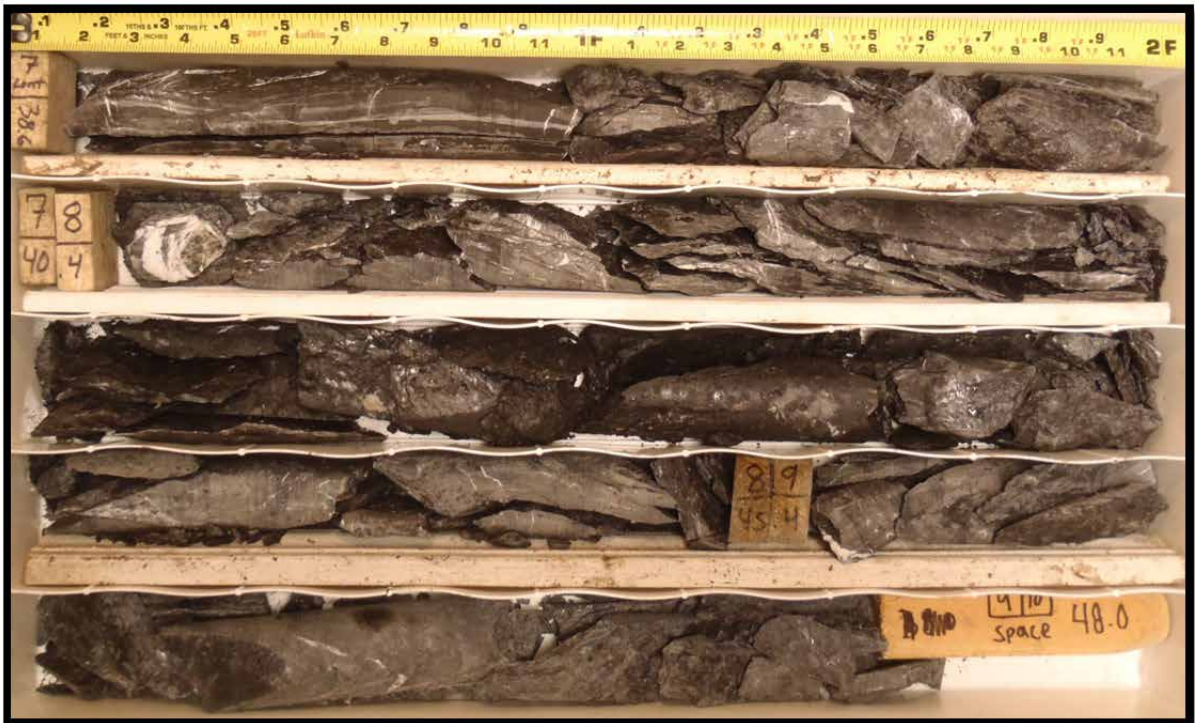
RM12-05, Box 3, 38.6 to 48.0 feet, Dry.

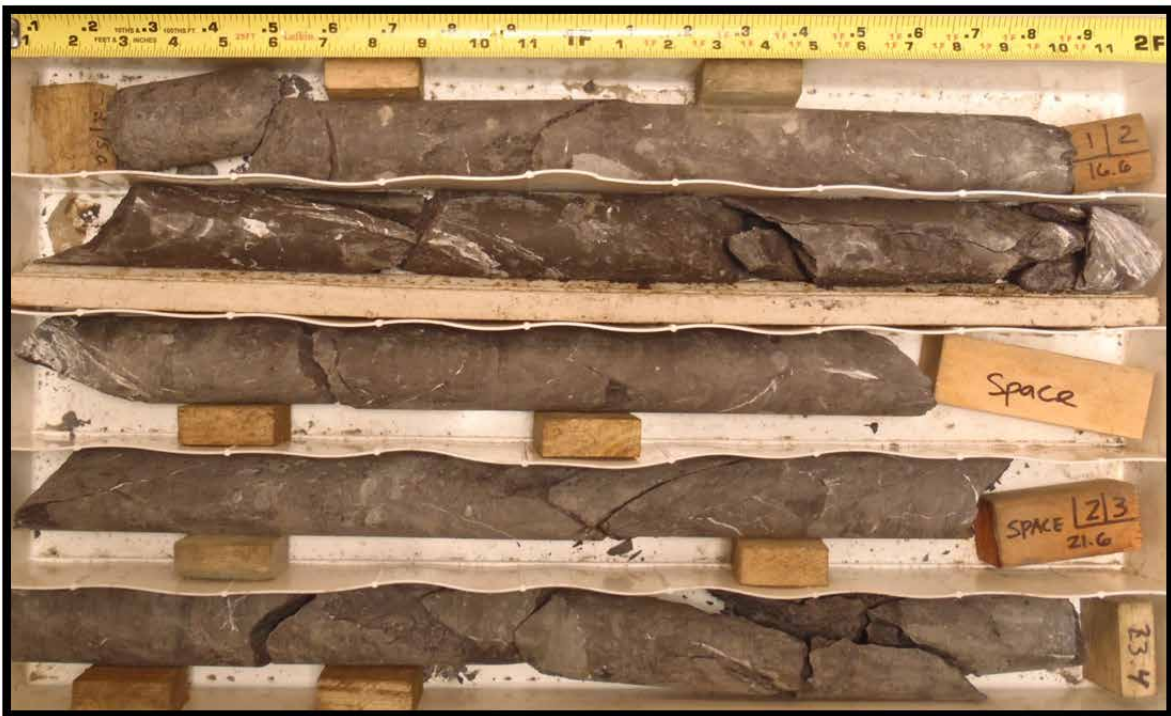
Figure E-11

RM12-06, Box 1, 15.0 to 23.4 feet, Dry.

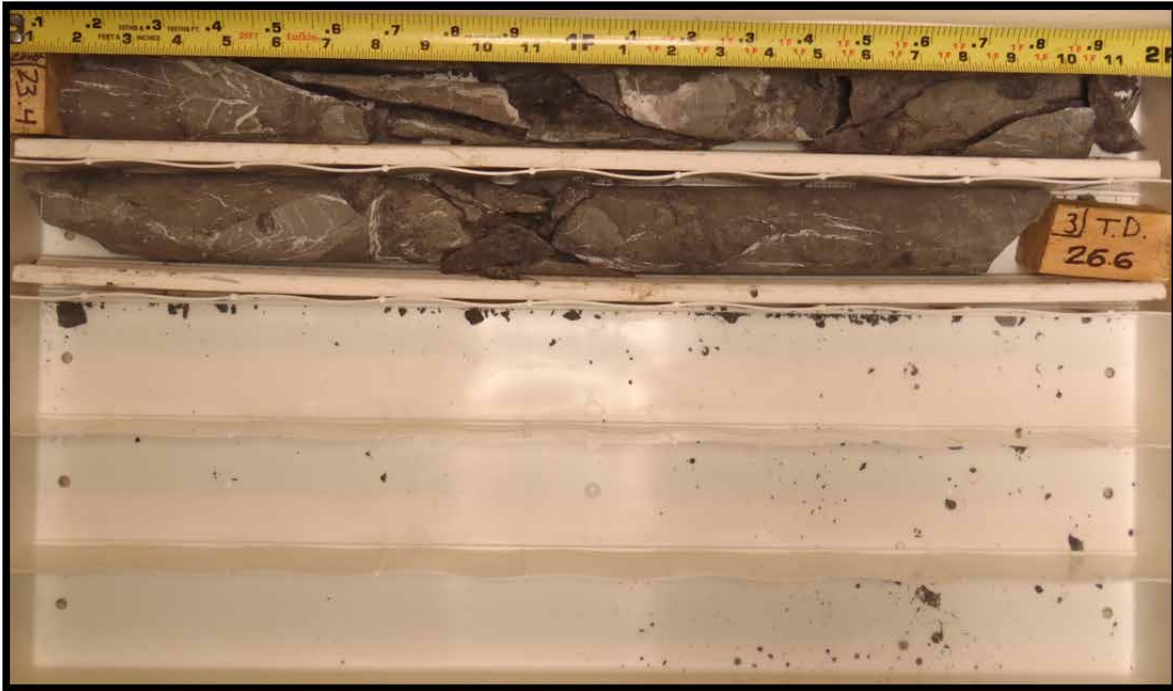
Figure E-12

RM12-06, Box 2, 23.4 to 26.6 feet, Dry.
