Grant Recipient: Kodiak Historical Society

Kodiak Historical Society - Phase III Refurbishment of the Baranof Museum Historical Building

Project Title: National Historic Landmark Exterior Restoration – Phase III

National Historic Landmark Exterior Restoration Phase III
Kodiak Historical Society / Baranov Museum, Kodiak, Alaska
February 2010

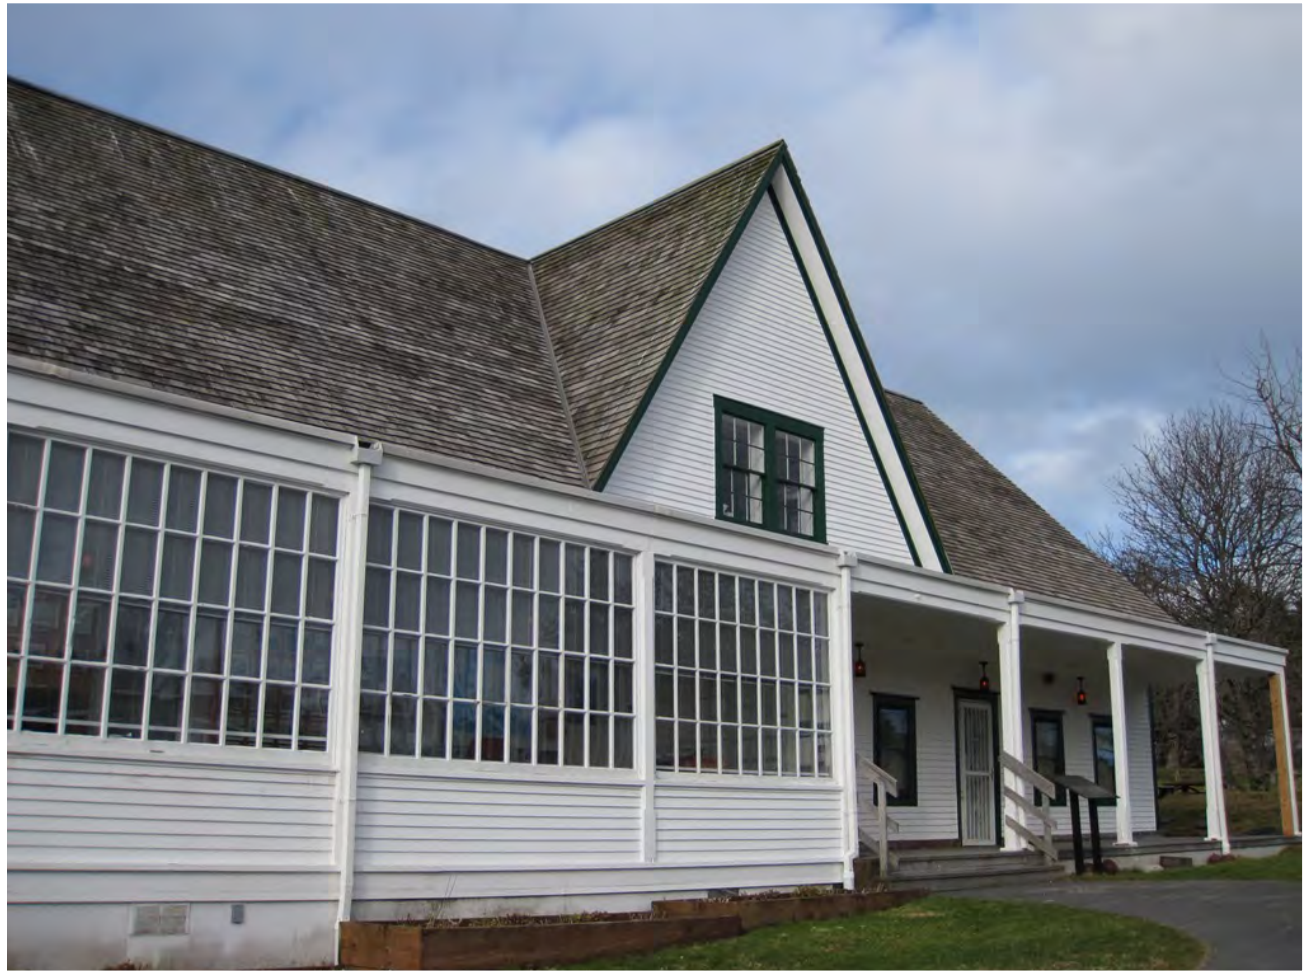
Photo 1. The southern elevation of the Baranov Museum is the focus of this project. Visitors to the museum enter into the front sunroom. This area presents a challenge for window restoration as the historic windows here include more than 120 individual panes of glass.

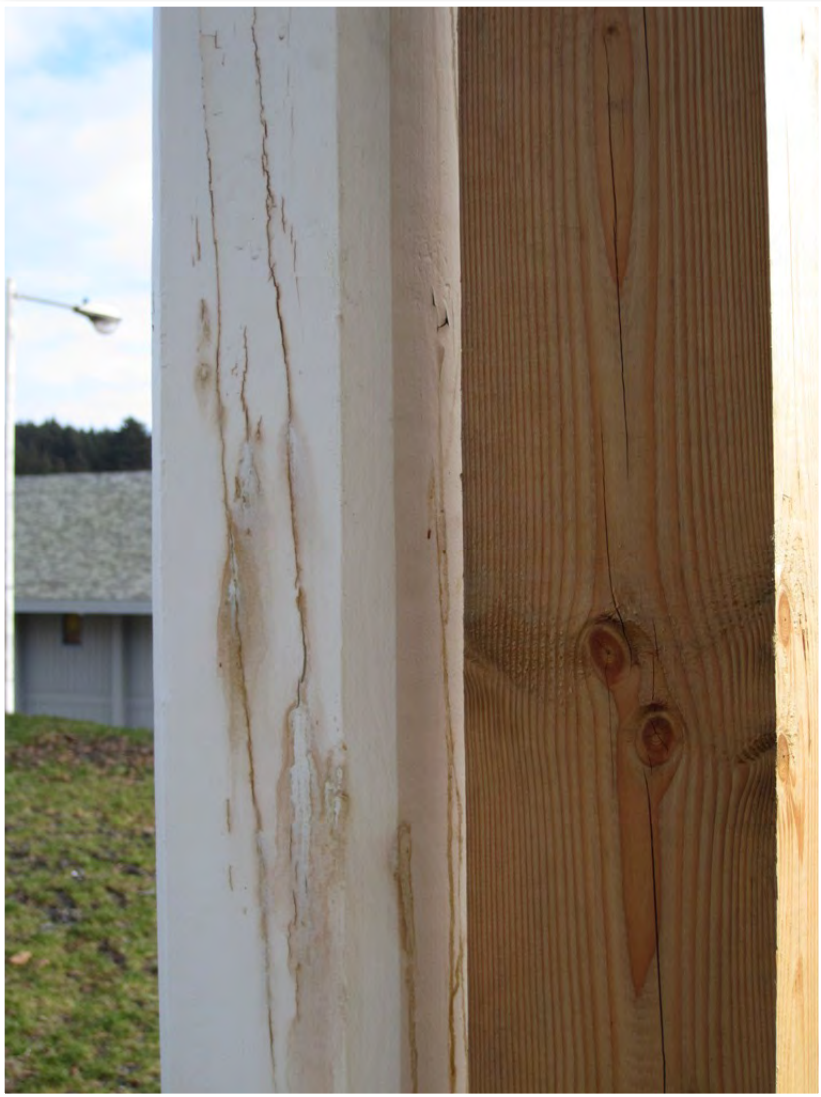
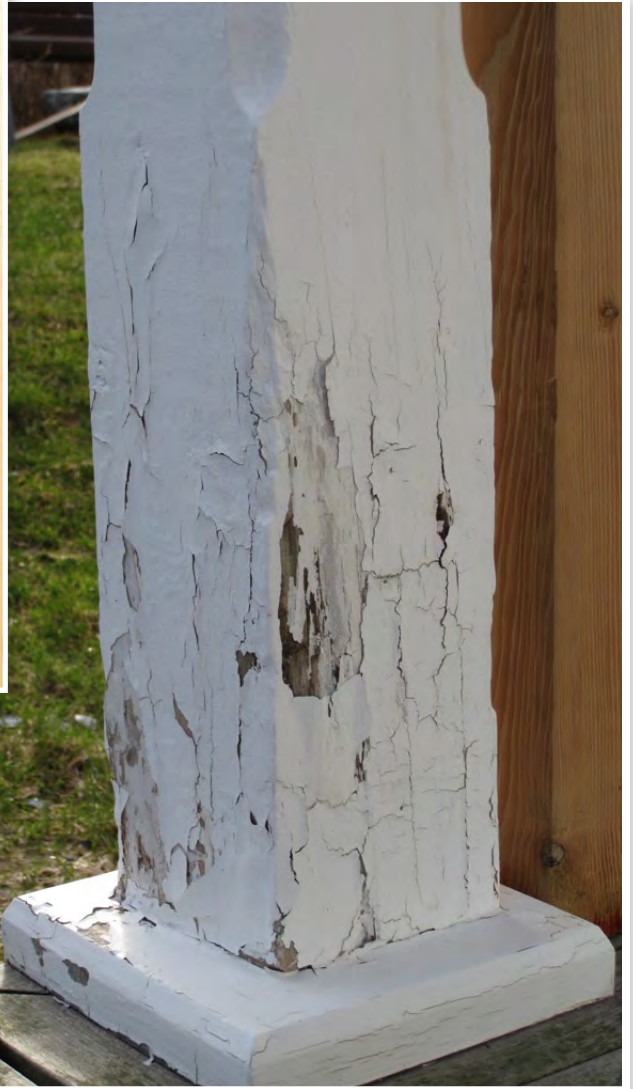
Replacement of structural posts and beams: The four structural posts and two beams on the front porch of the Baranov Museum have decayed beyond salvage. During restoration work to the building's exterior redwood siding in the late summer of 2009, contractors removed the existing paint, applied an epoxy-resin hardening agent, and repainted the posts. In the five months since this treatment, the paint has cracked and flaked off, and the posts have leached moisture, indicating that the internal moisture problems are beyond repair. In December of 2009, the City of Kodiak Public Works Department installed a single untreated post to provide additional support to the porch roof. Immediate work is necessary to prevent collapse.

Photos 2 & 3. This post illustrates the severity of the decay problem among all structural supports on the front porch of the Baranov Museum. All posts were treated with wood hardener in October of 2009, a temporary solution that did not successfully extend their use. The unpainted beam visible in the photos was installed as an emergency measure to support the roof.

materials will be reused to the greatest extent possible and replacement materials will accurately represent the historic appearance of the existing windows. All window openings will be fitted with weather-proof flashing materials prior to reinstallation to prevent further moisture infiltration to the wall systems. This phase of the project will also see the fabrication of historically correct wooden storm windows. Their proper installation will add to the process of protecting against moisture infiltration. Mr. Corwin will also remove and replace the front porch posts and beams with identical materials milled to duplicate the existing historic material.

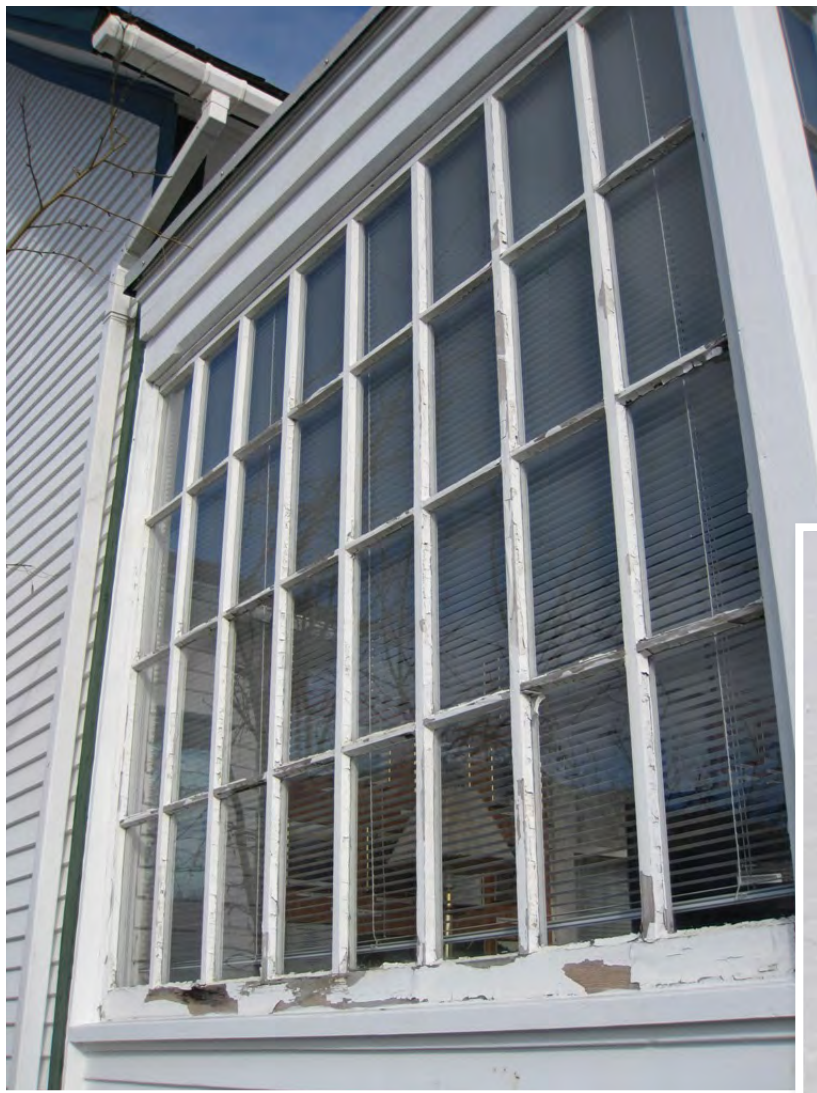
Window Restoration: Moisture is a significant threat to the preservation of any historic building, but particularly a building constructed with logs. The most serious issues related to moisture penetration at the Baranov Museum are failing windows. In the summer season of 2008 and 2009 we were able to fully restore thirteen window units on the Baranov Museum building and fabricate custom wooden storm windows for each unit. Phase III will address the remaining units on the southern elevation of the building as well as the front porch sunroom area. The windows in the sunroom area are in very poor condition and are failing due to years of exposure and the effects of wind driven rains in our wet maritime climate. Water is penetrating the building through the windows, endangering the museum collections and further degrading the frames, sills, and sashes. Exterior paint failure has led to biological growth and warped sills. The original wood construction material is exposed in multiple locations.

Photos 4 & 5: These close up images of the sun room windows illustrates the extent of the paint failure problem. Dirt and moss build up on the exposed wood, accelerating the deterioration. As the frames deteriorate, the wood components settle and spread apart allowing rain to penetrate the buidling.

For this project we will work with Don Corwin, a restoration carpenter with West Wind Woodworking of Skagway, Alaska. Mr. Corwin was identified by the National Park Service, Alaska Support Office, as one of two carpenters in the state qualified to undertake the window restoration work on the building. He will remove and restore each failed window unit and the window casing and trim. The existing historical

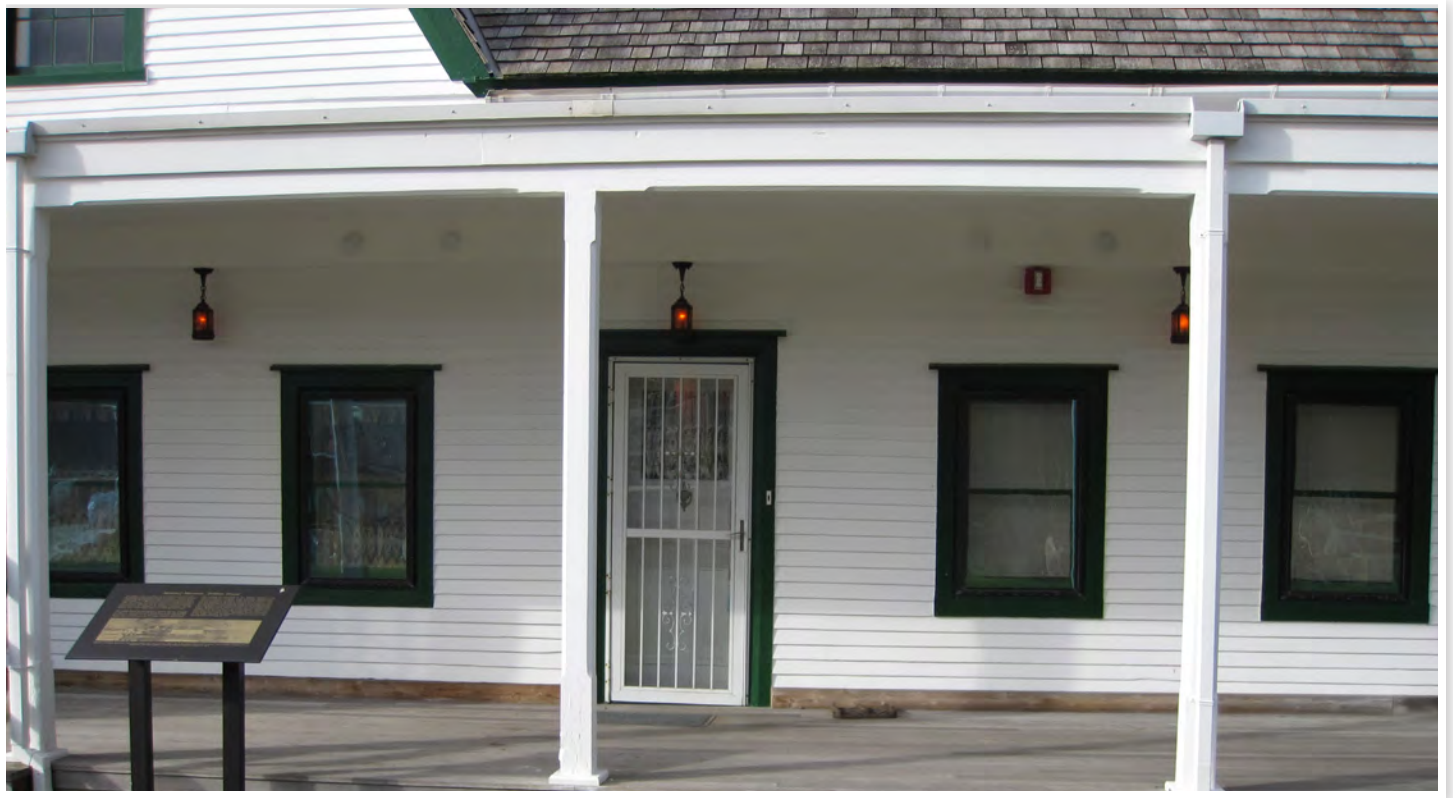
Photo 6 This project will also include the restoration of four 19th century windows on the front porch and the fabrication of custom wooden storm windows for these units.
