Agency: Commerce, Community and Economic Development**Grants to Named Recipients (AS 37.05.316)****Grant Recipient: Chugach School District****Federal Tax ID: 92-0057727****Project Title:****Project Type: New Construction and Land Acquisition**

Chugach School District - Construction Teacher Housing in Chenega Bay

Chenega Teacher Duplex Housing

**Chugach School District
New Teacher Housing Project Timeline & Expenditure Schedule**

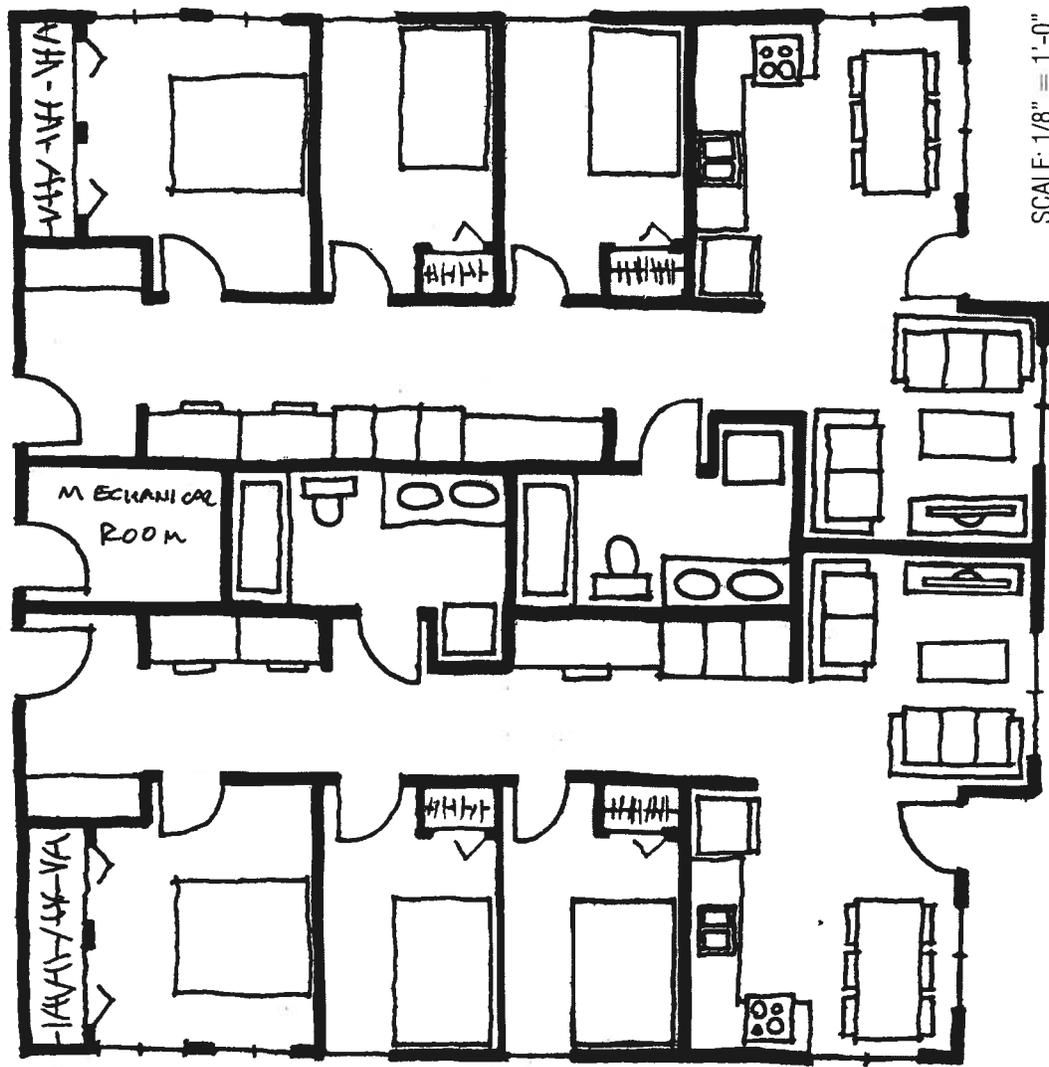
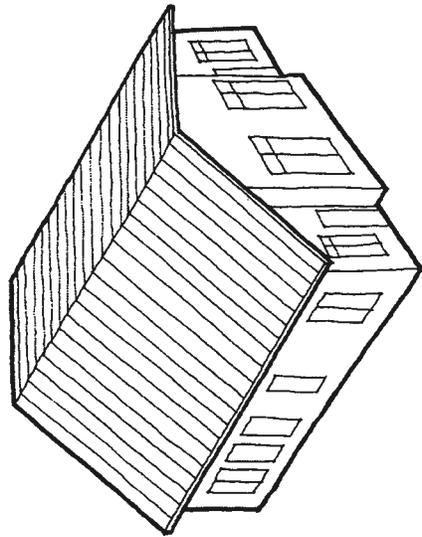
Conceptual Studies

SCALE: 1/8" = 1'-0"

The design concept for this project is to demolish the two current stand alone homes and construct one duplex facility. This design will not only contain construction costs. The new energy efficient residences will be constructed in the same location as the current homes.

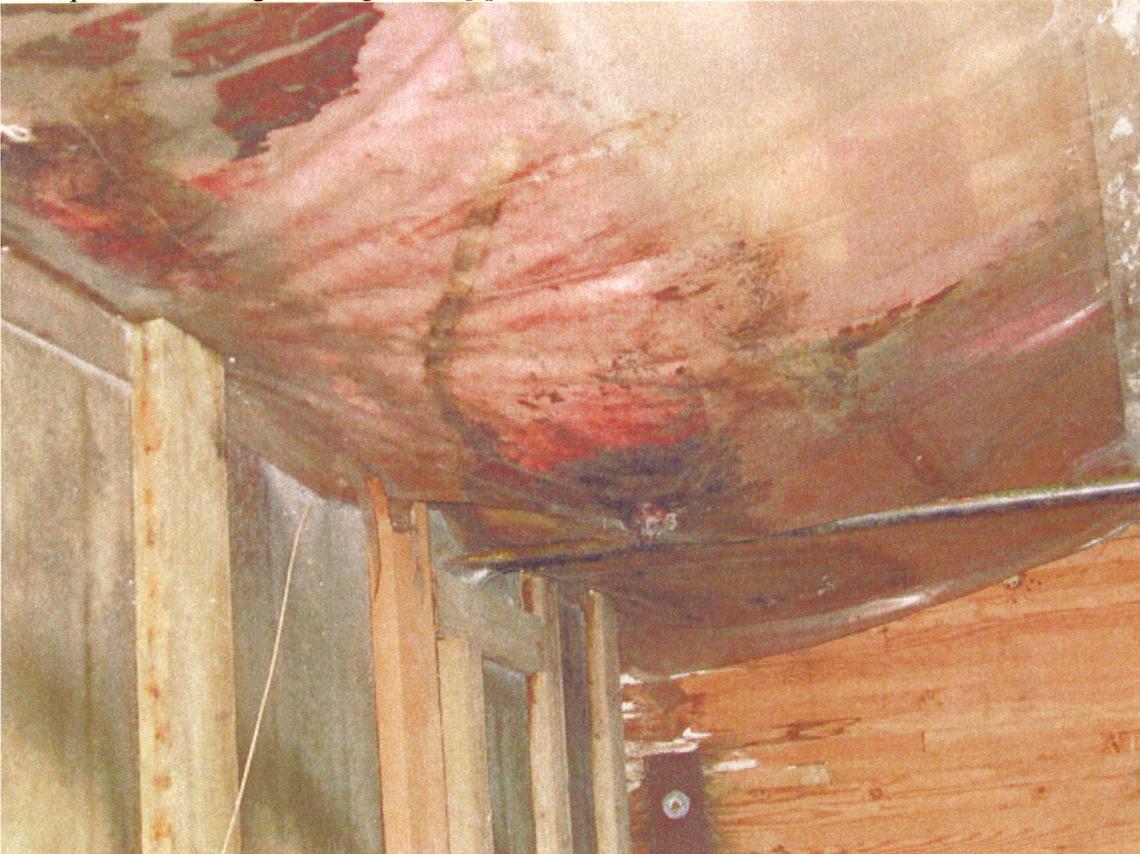
Water damage from leaky walls and roof. Mold and mildew.

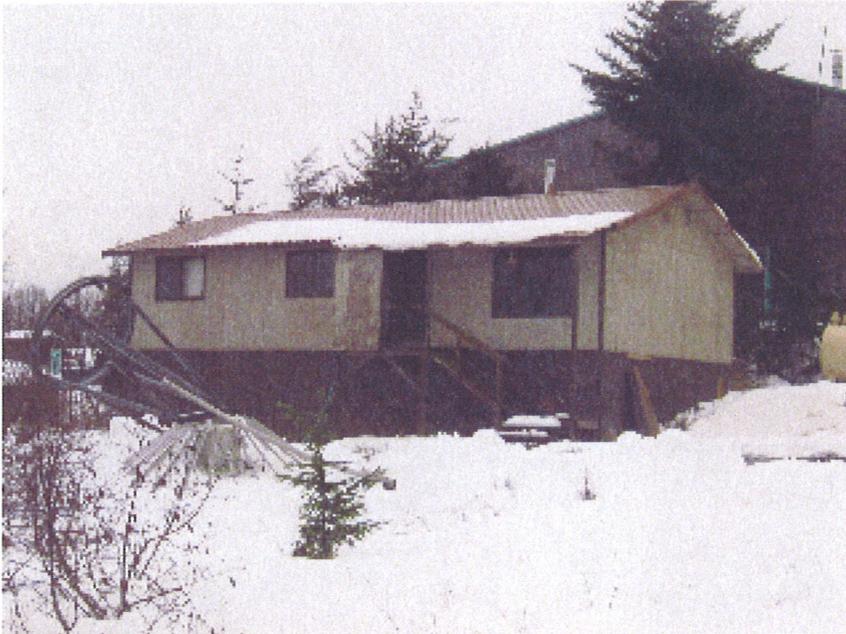
Teacher housing # 2. Has rot and water damage through out building.

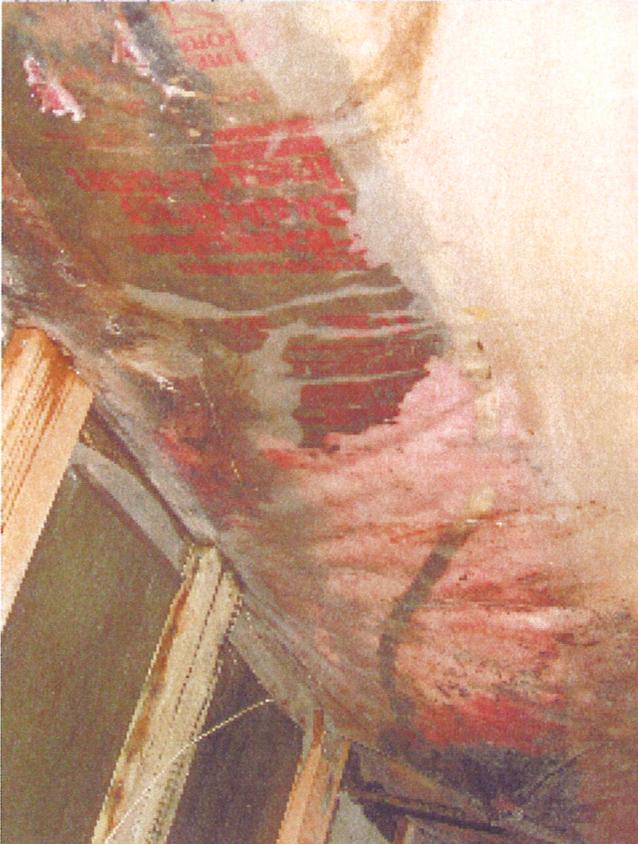
Water damage in the attic and insulation.

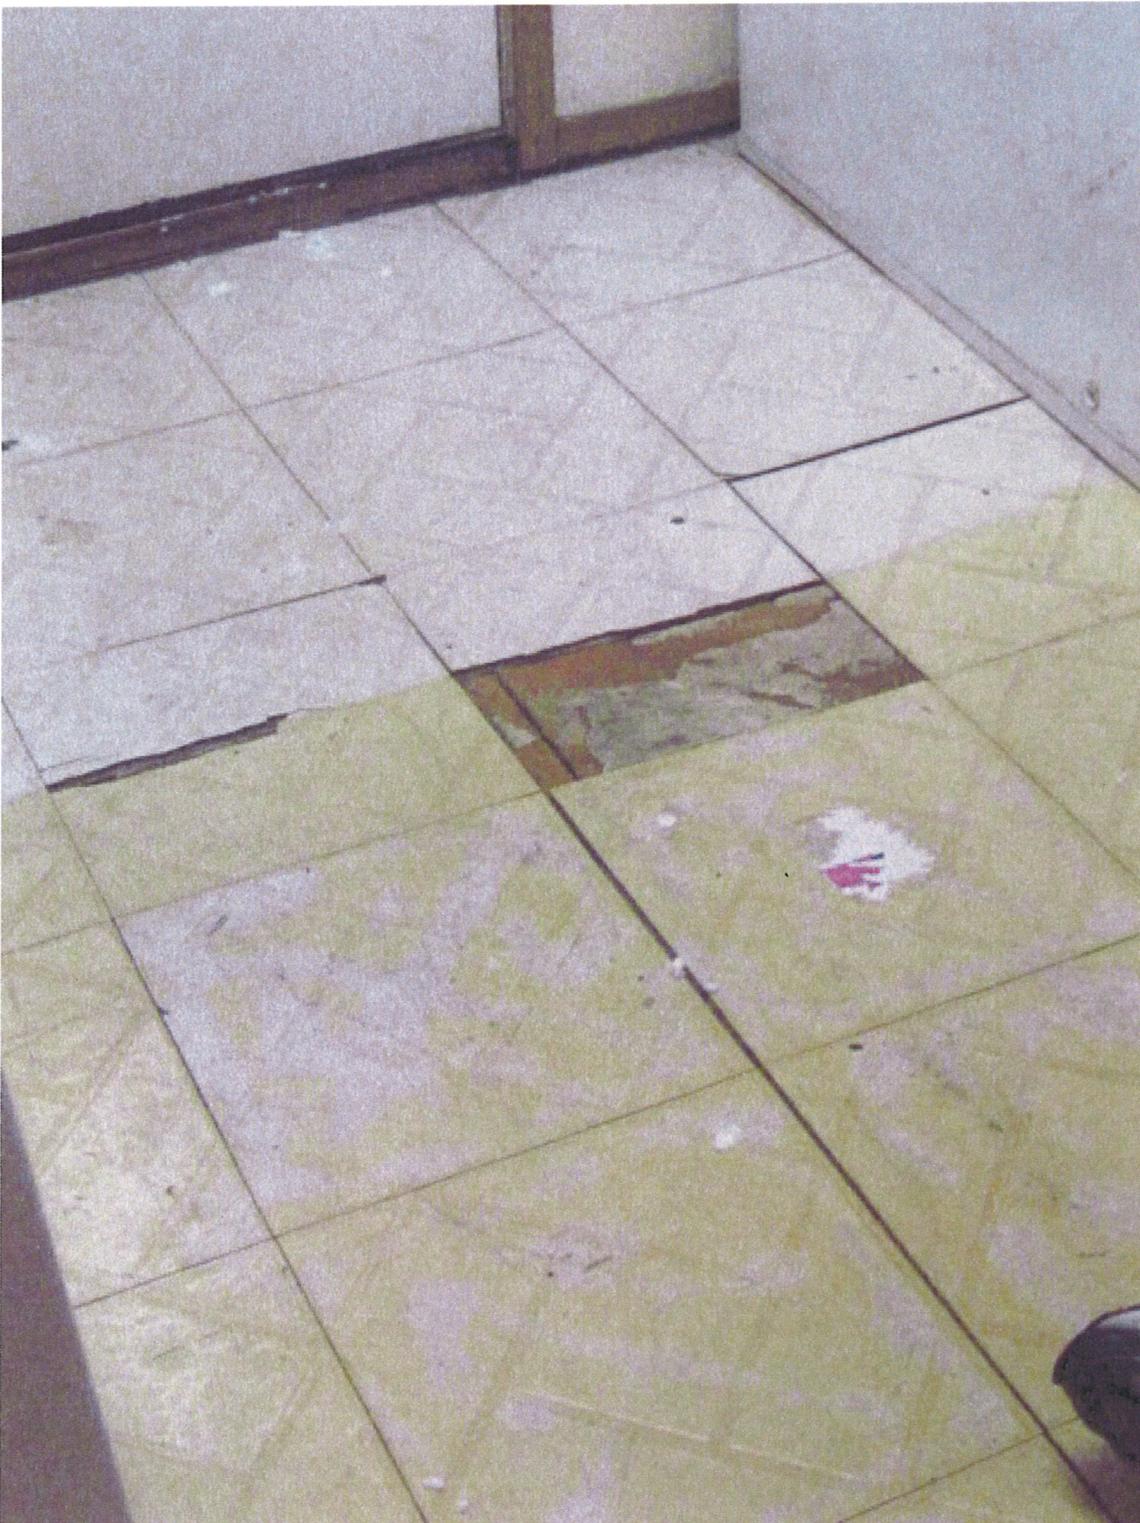
Tiles won't stay fastened due to moisture coming in from the crawl space.

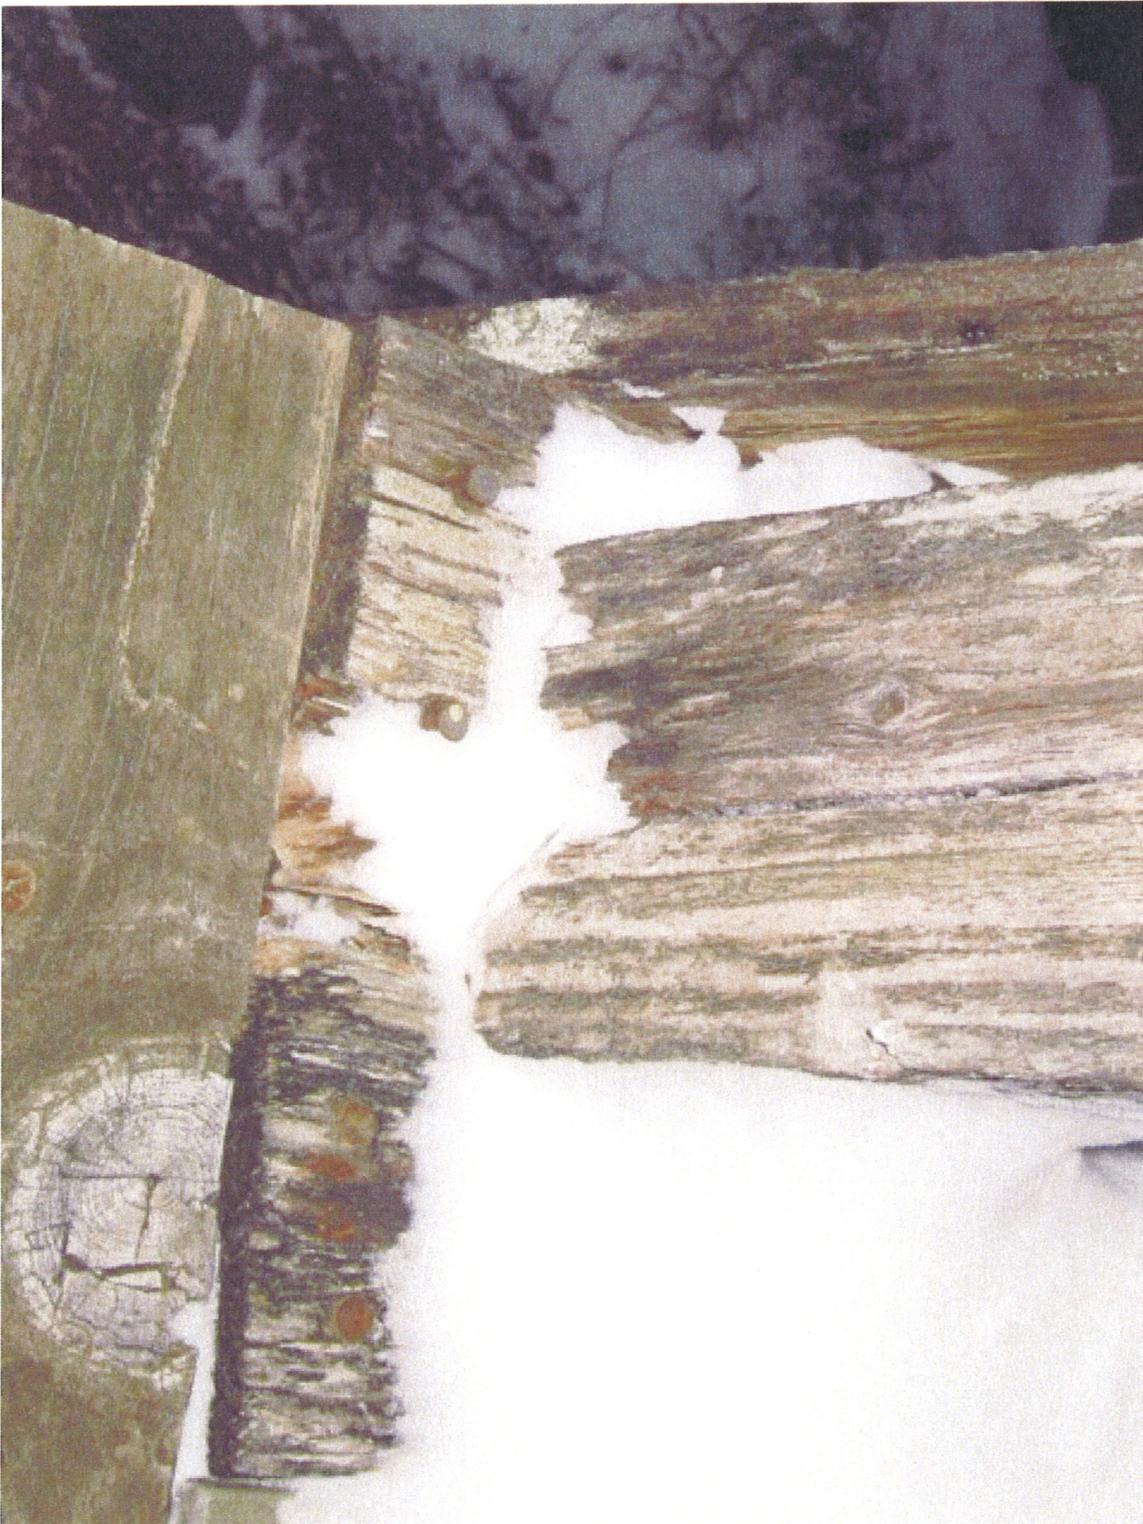
Rot on the out side of the foundation

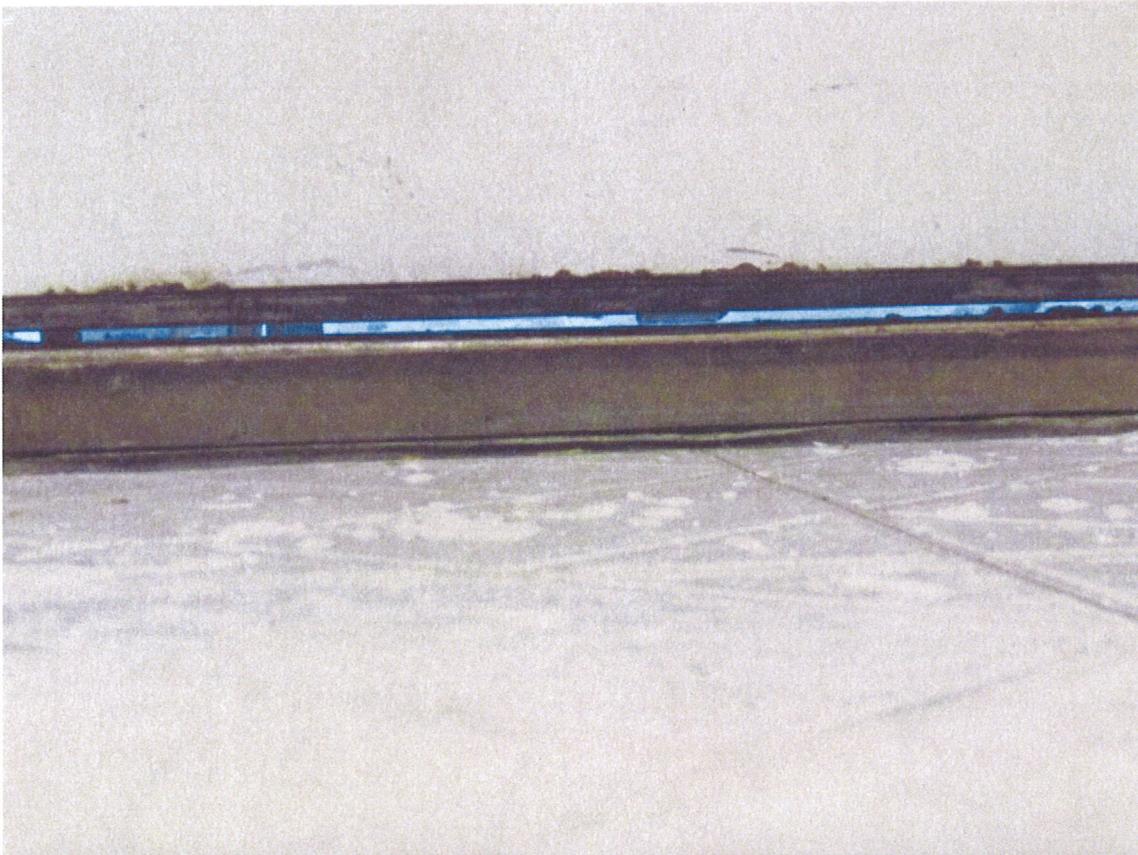
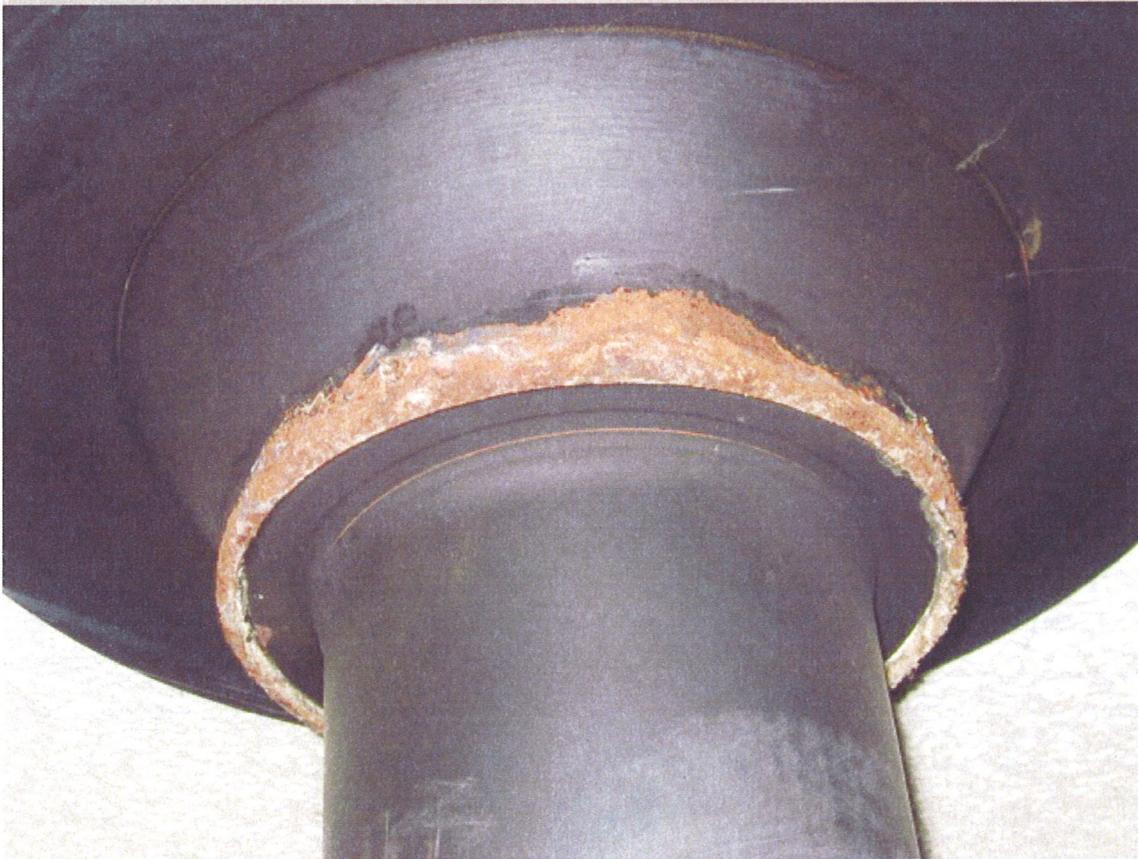
Water leaking in from the rusted out metal roofing.

- Roof leaks around chimney and is rusted badly in places
- Unable to lock many windows allowing cold air in. (We tape blankets and garbage bags on some to keep heat in.)
