# Dillingham - Wastewater Treatment Plant Upgrades

Upgrade the Dillingham wastewater treatment plant to bring it back into compliance with state standards for its effluent discharge.

**FIGURE 1  
 DILLINGHAM, ALASKA  
 WASTE WATER TREATMENT PLANT STUDY  
 LOCATION AND VICINITY MAP**

# SEWAGE TREATMENT FACILITY IMPROVEMENTS

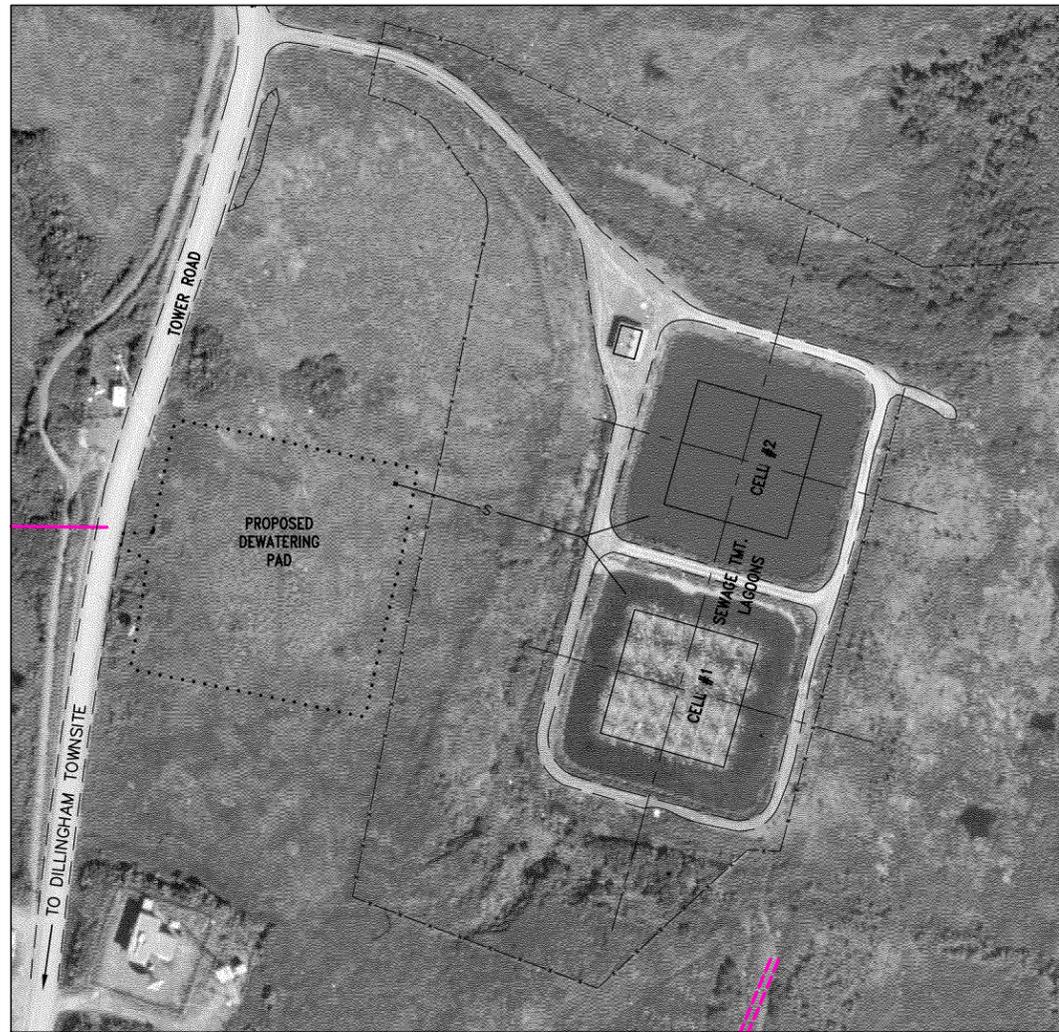
**1 SLUDGE DEWATERING PAD LOCATION**  
 SCALE: NTS

SUMMARY OF QUANTITIES			
ITEM NO.	ITEM	UNIT	TOTAL
-	GEOTEXTILE SEPARATION	SQUARE YARD	7,400
-	EMBANKMENT	CUBIC YARD	9,850
-	IMPERMEABLE LINER	SQUARE YARD	7,400
-	GEO-TUBES	EACH	24
-	6" SECURITY FENCE	LINEAR FEET	1,020
-	COLLECTION SUMP	EACH	1
-	6-INCH SEWER PIPE	LINEAR FEET	330

As a first and immediate step, the sludge should be removed from the cells, dewatered using geotubes, and then transported to the landfill for permanent disposal after at least one freeze-thaw cycle. The next step after sludge removal is to eliminate the direct discharge of septic pumping trucks into the lagoon. Bristol recommends that a septage monofill be constructed at the City landfill for septic pumping trucks.

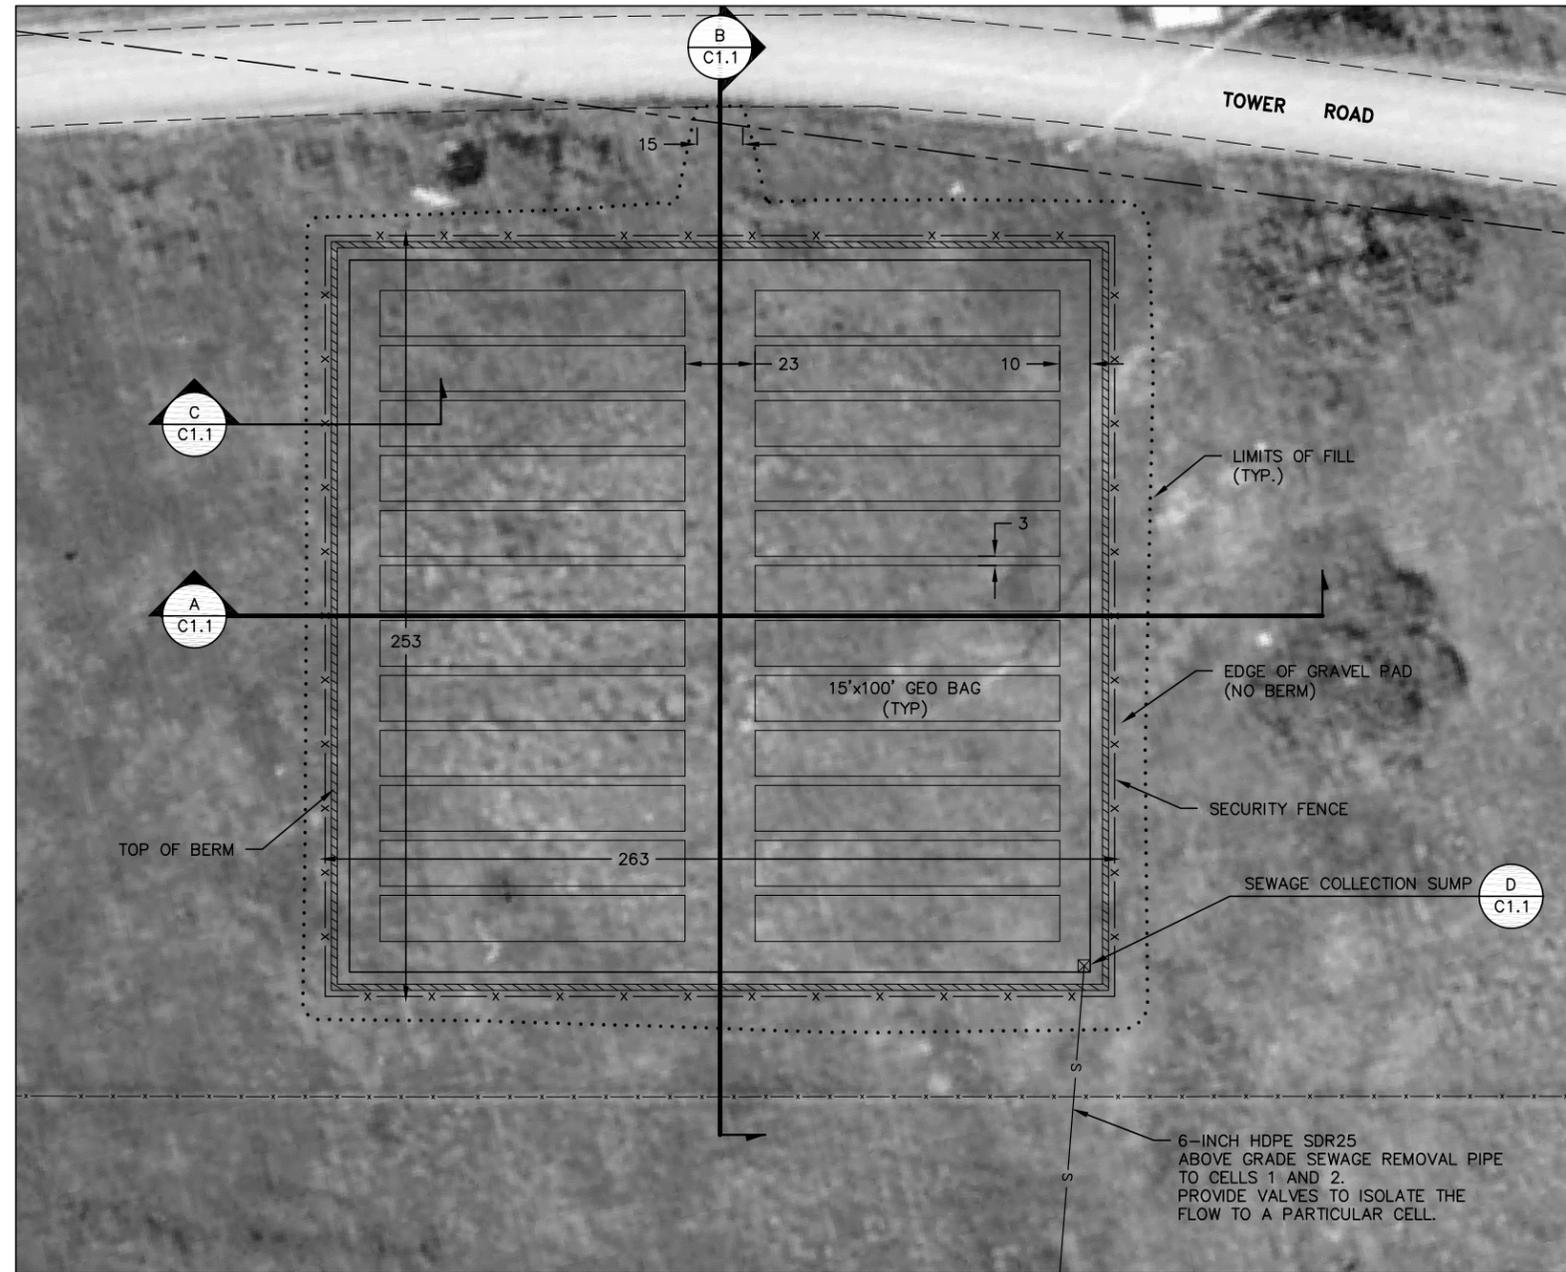
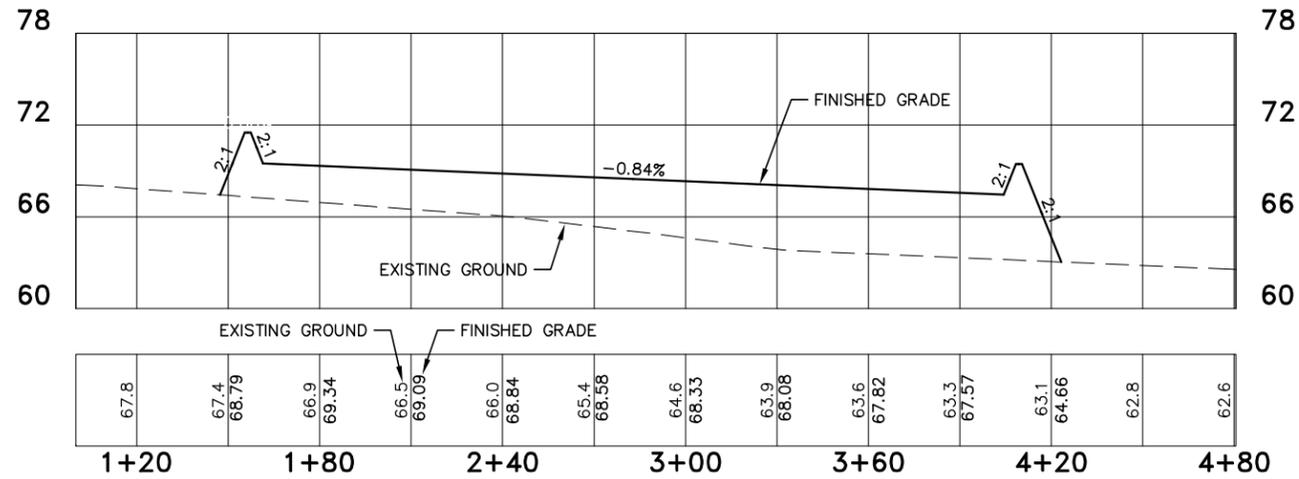
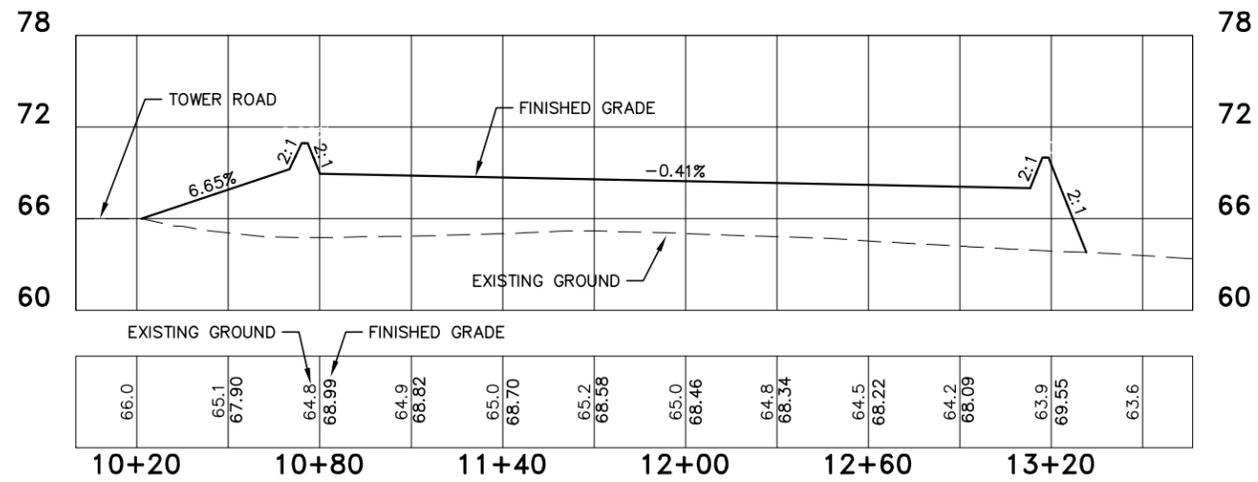
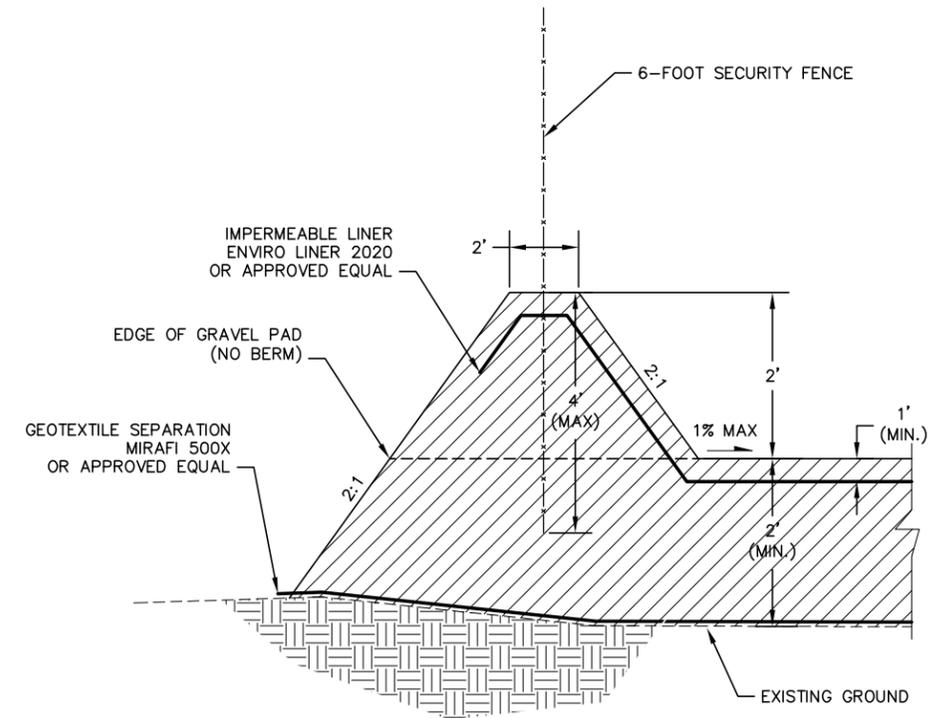
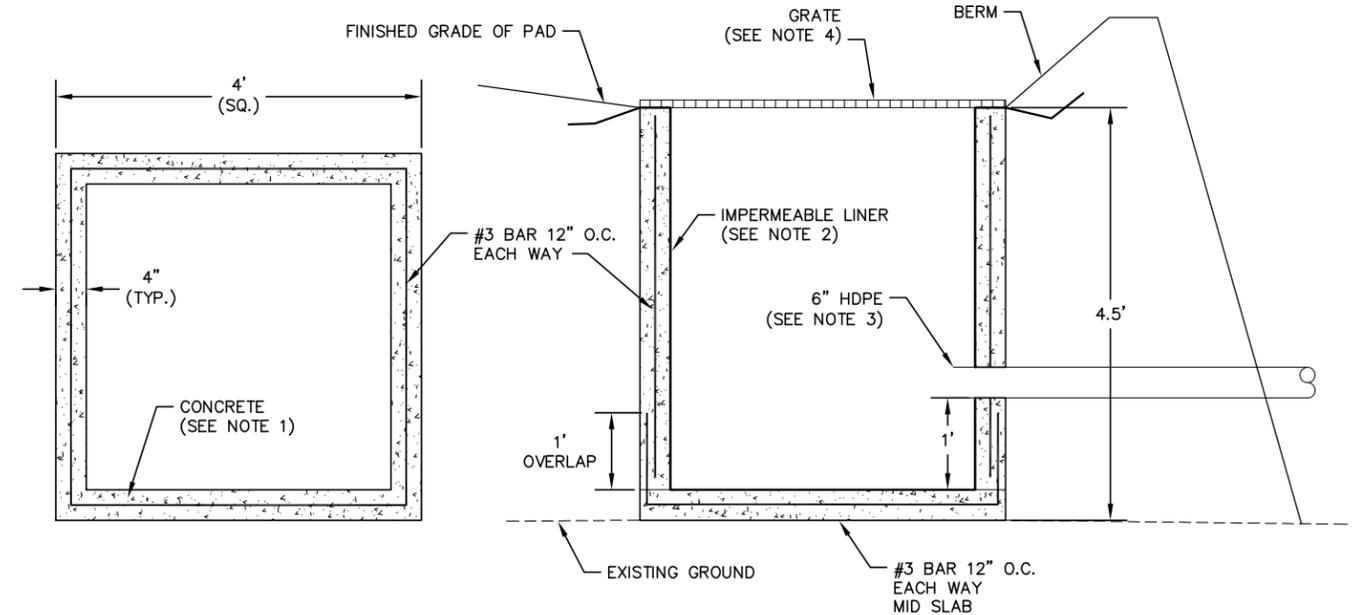
**FIGURE 8**  
DILLINGHAM, ALASKA  
WASTE WATER TREATMENT PLANT STUDY  
SLUDGE DEWATERING PAD DETAILS

**2 SLUDGE DEWATERING PAD**  
 SCALE: SHOWN

**B EAST-WEST CROSS SECTION**  
SCALE: SHOWN

**C TYPICAL PAD SECTION**  
SCALE: NTS

**D SUMP DETAIL**  
SCALE: NTS

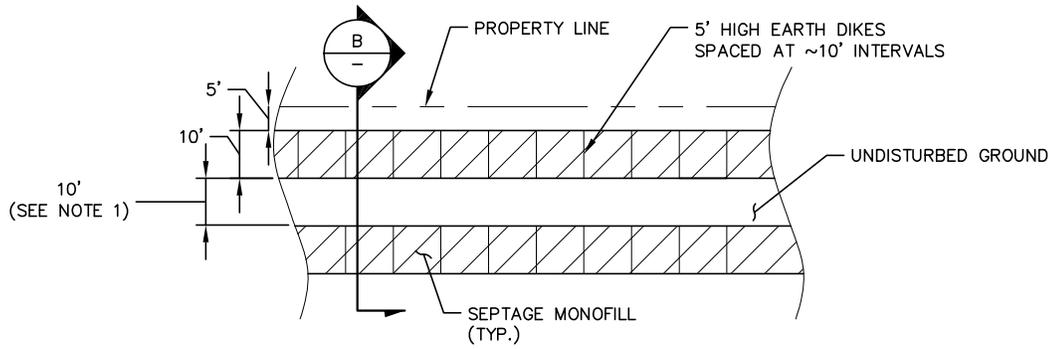
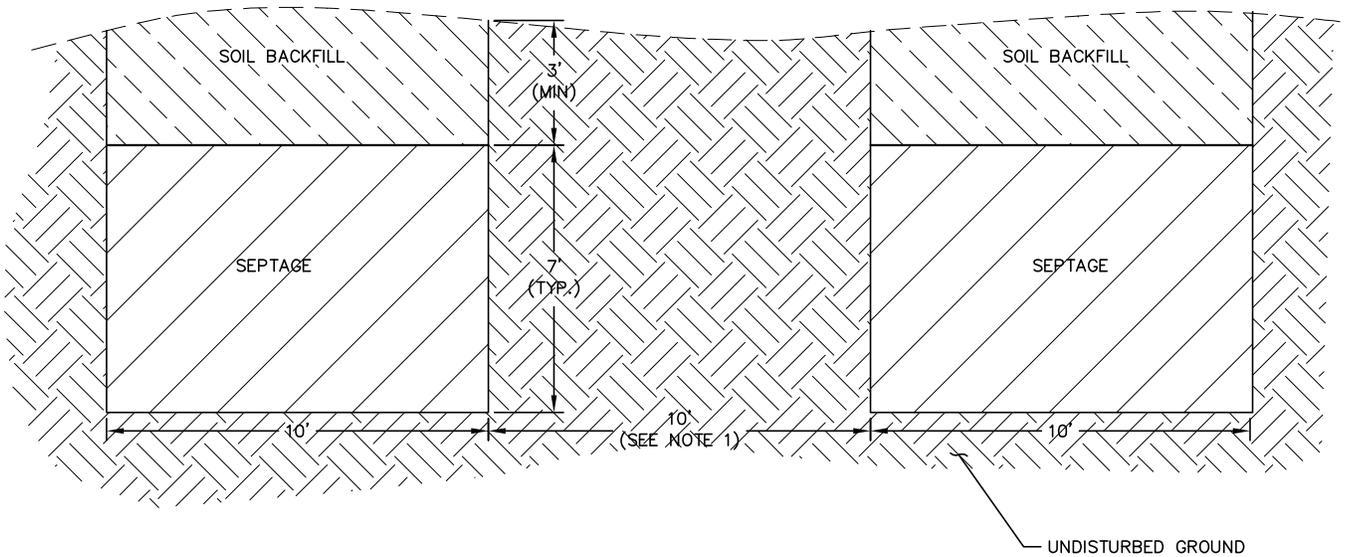
**A**  
—  
**SEPTAGE MONOFILL PLAN VIEW**  
SCALE: NTS

1. THE SPACE BETWEEN THE MONOFILL CELLS MAY BE DECREASED AS LONG AS THE SEPTAGE DOES NOT FLOW FROM ONE CELL TO ANOTHER.

**B**  
—  
**SEPTAGE MONOFILL PROFILE VIEW**  
SCALE: NTS

The next step after sludge removal is to eliminate the direct discharge of septic pumping trucks into the lagoon. Bristol recommends that a septage monofill be constructed at the City landfill for year-round access by septic pumping trucks.

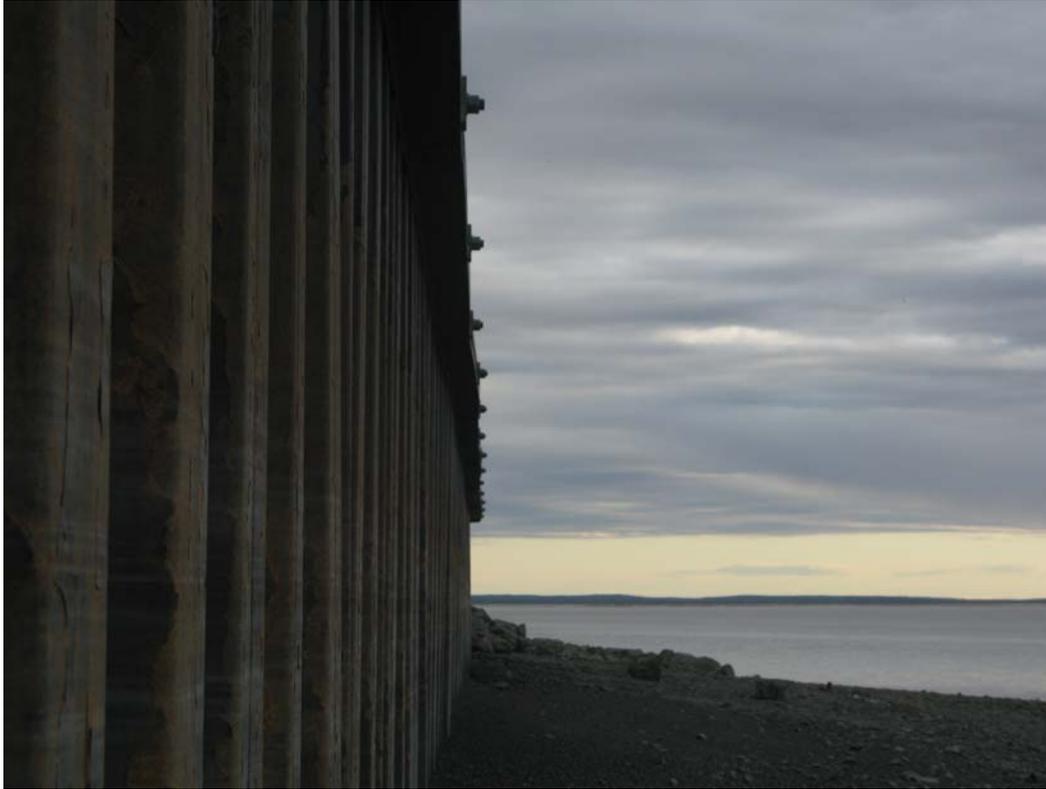
- h. Access ladders were noted at the following stations: 13+26, 15+79, 16+81, 19+68 and 23+00. Ladders are extensively damaged (possibly from ice) and are non-functional.

Photo 2 Damaged access ladder near angle Pt. #5 @ STA 19+68

4. Recommendations:
- a. Continue annual monitoring of scour at the base of the bulkhead.
  - b. Ladders need to be repaired, extended to near the mud-line, and maintained.

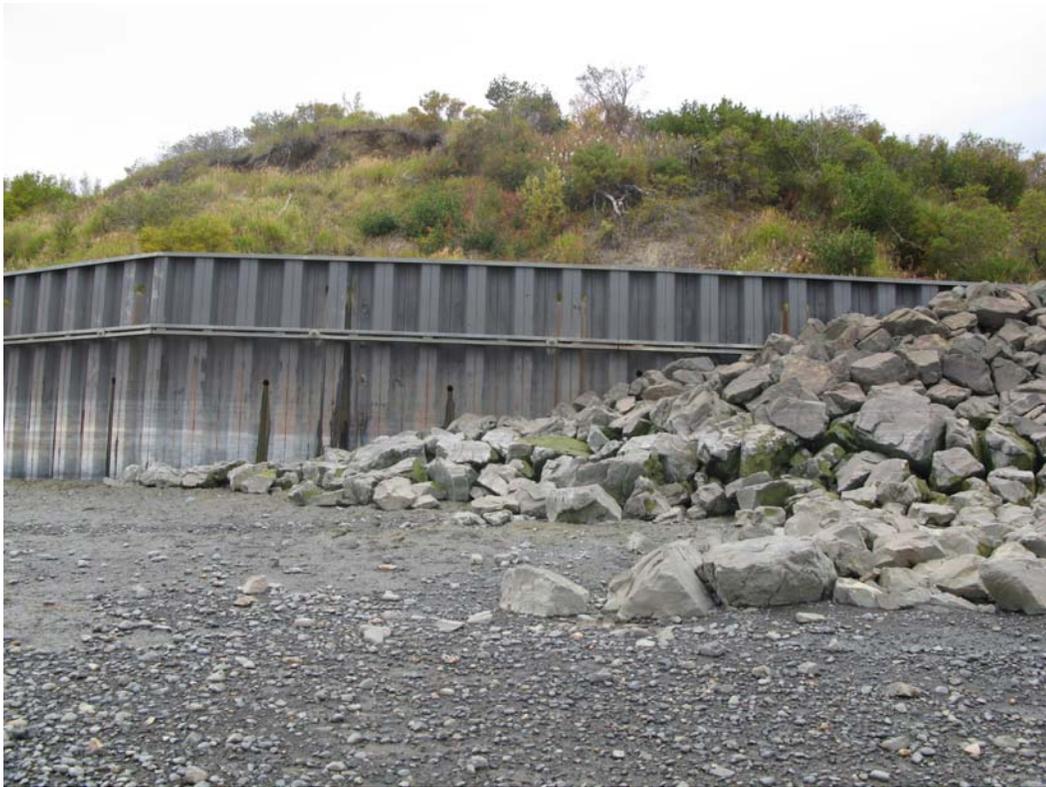
Photo 3 Sheet pile bulkhead – Small bulge in wale @ tie rod @ STA 23+93

- d. Monitor the exposure of the sewage outfall, especially after storms.
  - e. Annually monitor the small bulge noted in the waler near STA 23+93.
5. For additional information please contact Mary Azelton (phone 907-753-5706, email [Mary.T.Azelton@usace.army.mil](mailto:Mary.T.Azelton@usace.army.mil)) or Robert Tedrick (phone 907-753-5745, email [Robert.C.Tedrick@usace.army.mil](mailto:Robert.C.Tedrick@usace.army.mil)).

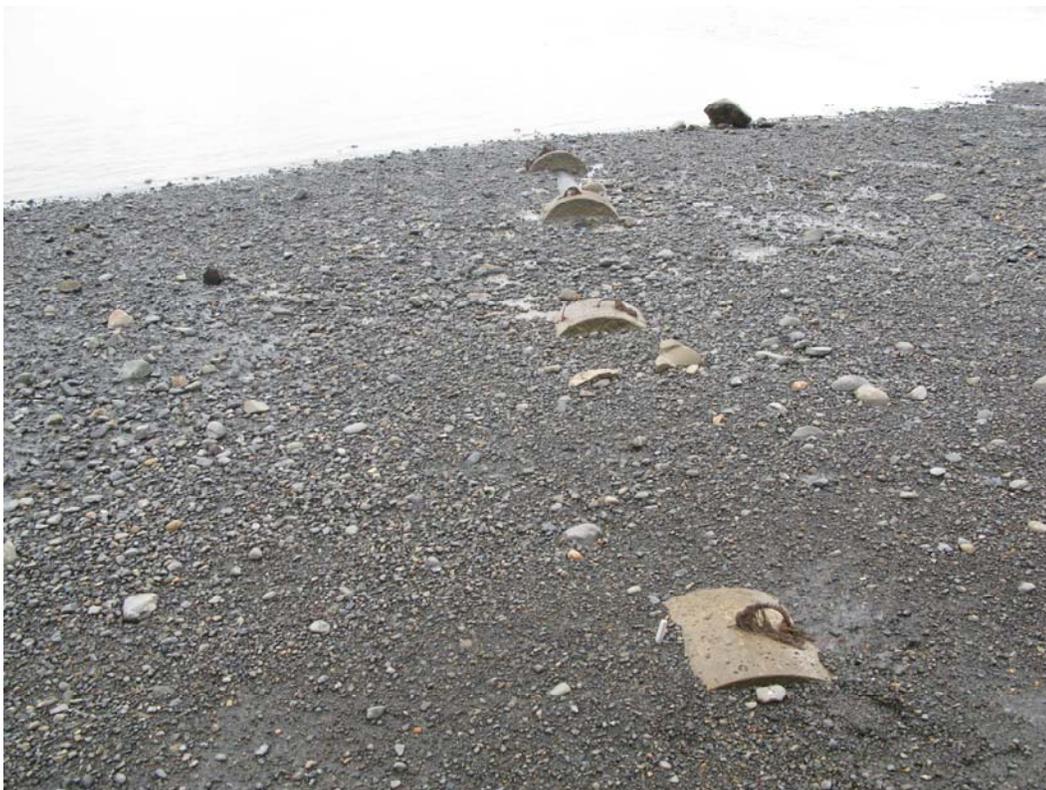
Photo 5 Exposed section of HDPE sewage outfall pipe

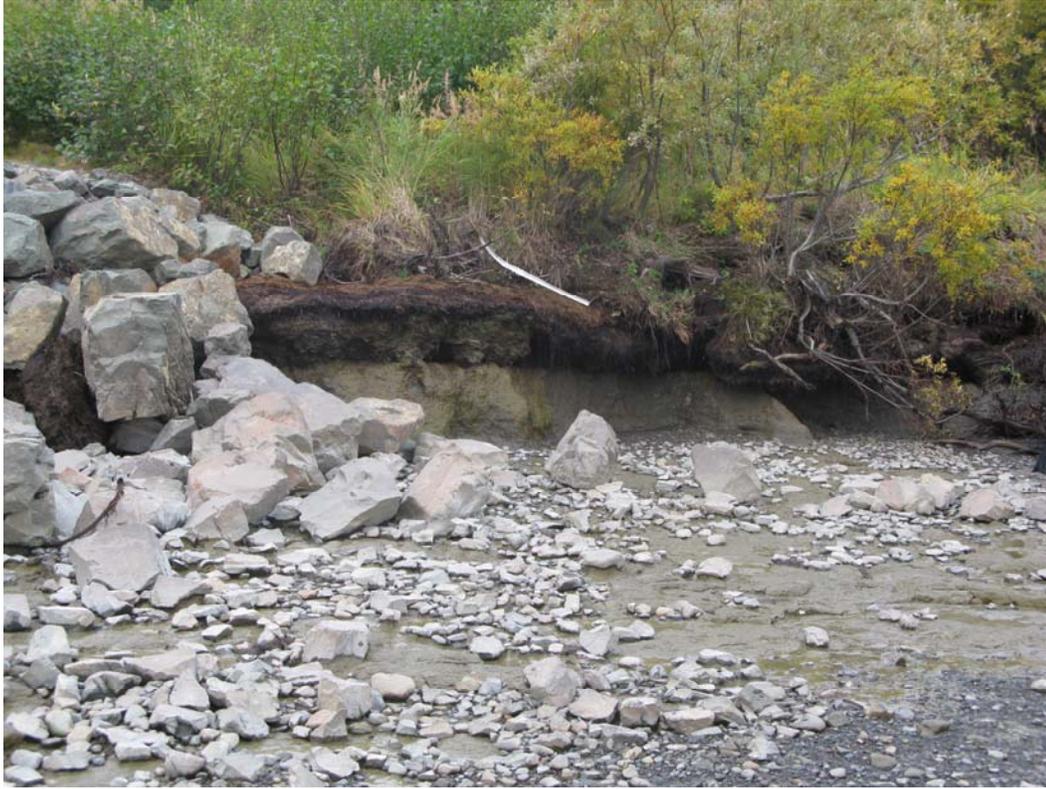
Photo 6 Exposed section of sewage outfall – Approx. 37' between outermost blocks

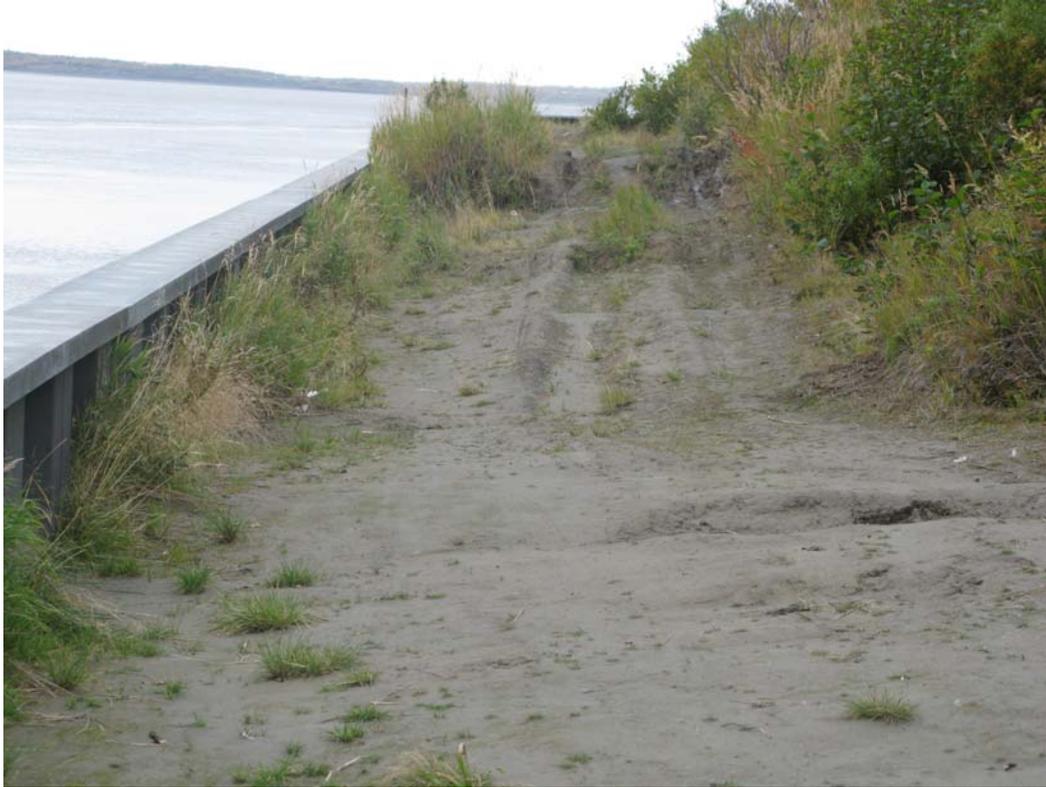
Photo 7 Erosion adjacent to project @ upstream/up-station end

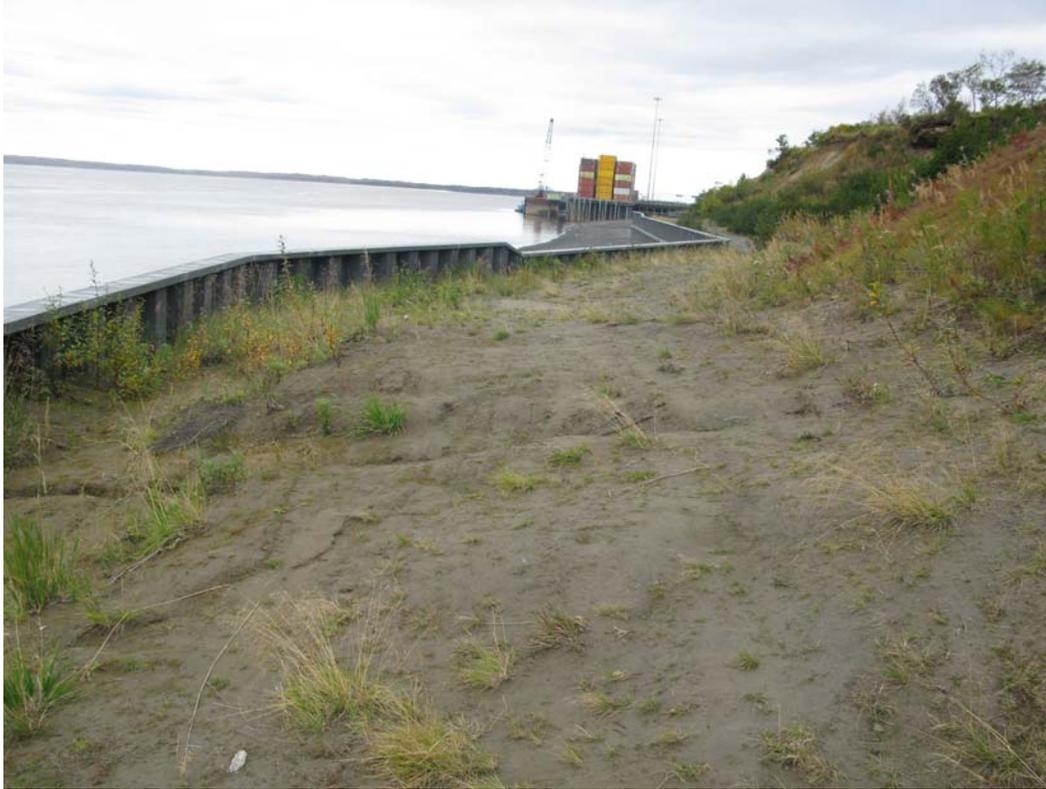
Photo 10 Exposed force main parallel to bulkhead – Approx. 63' near STA 22+50

- c. Provide protective cover for the 10" ductile iron force main to prevent this line from damage that could cause an uncontrolled discharge of sewage. The cover for this line should be monitored, especially after storms.

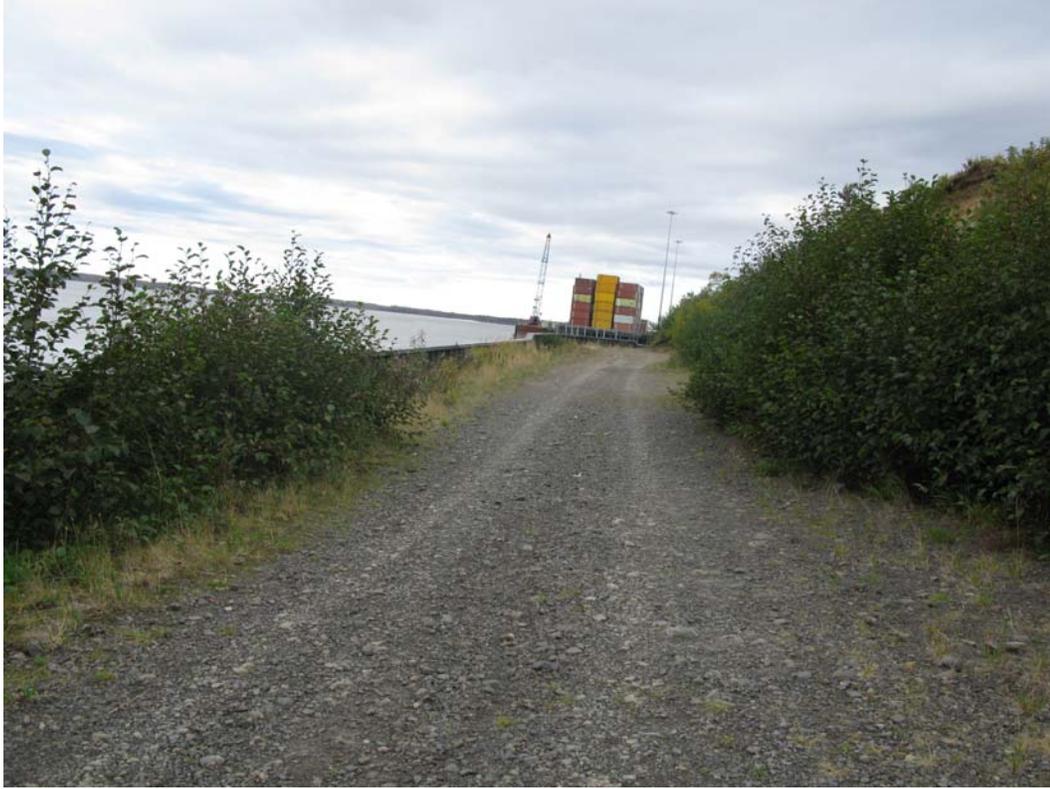
Photo 12 Drainage near weep hole at top of bulkhead
