Bethel Police Station

Photos Showing Need for New
Law Enforcement Center

City of Bethel
Bethel, Alaska

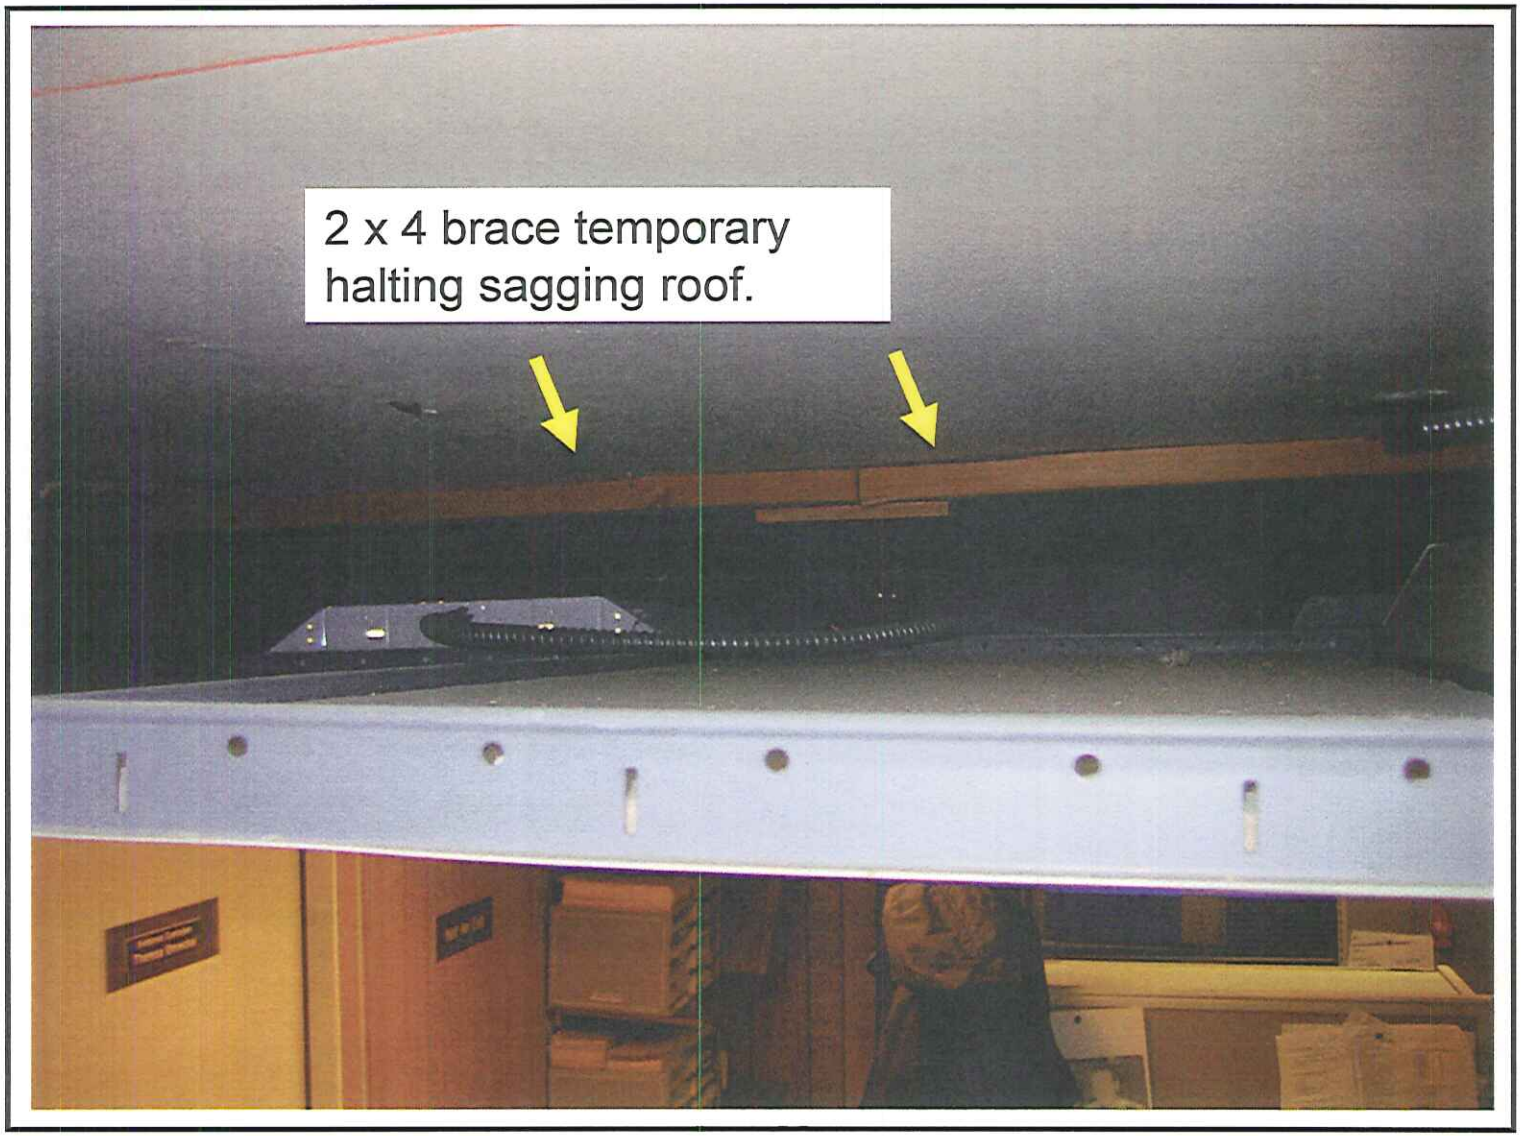
A couple of makeshift 2 x 4s serve as a brace to support the failing roof truss. The brace was recently replaced after it fell down. View is from above the ceiling tiles. Below is the police officer cubicle area.

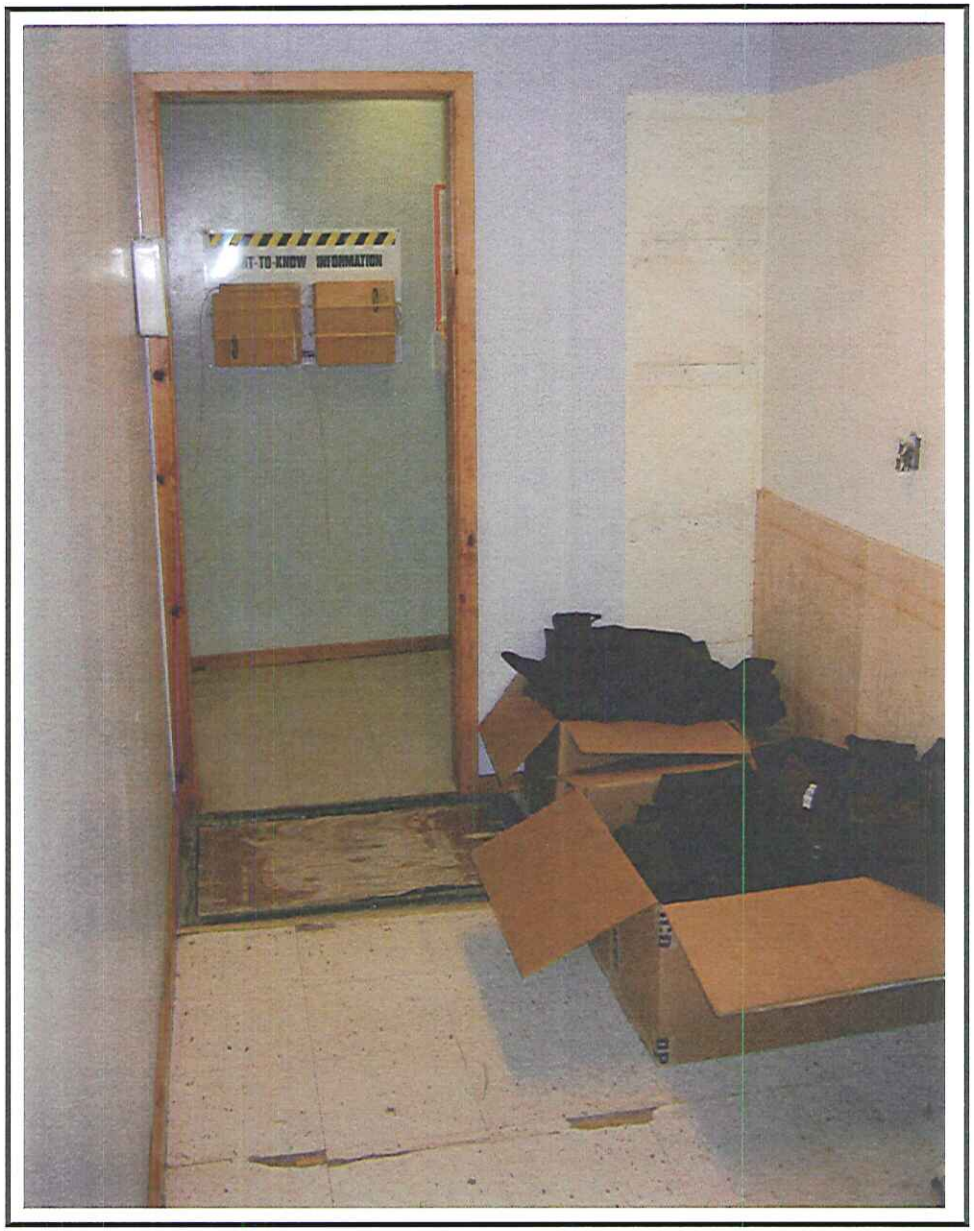
View of hallway turned “kitchen” and “break room.” Trap door hole in the floor by the door it the sewer system access. Sewer tank emits awful odor into the kitchen on a daily basis. Tank freezes require Property Maintenance personnel to continually unfreeze pipes to insure working toilets.

View of sewer trap door that is located just inside the kitchen area. Property maintenance crew uses this door to access sewer tank situated under the building. Sewer smell is so strong that employees are unable to stay in kitchen for long. Plastic bag was placed over the trap door in an effort to reduce the amount of foul odor coming into the room.

Employees report that when the sewer tank freezes during subzero temperatures, the smell is "unbearable."

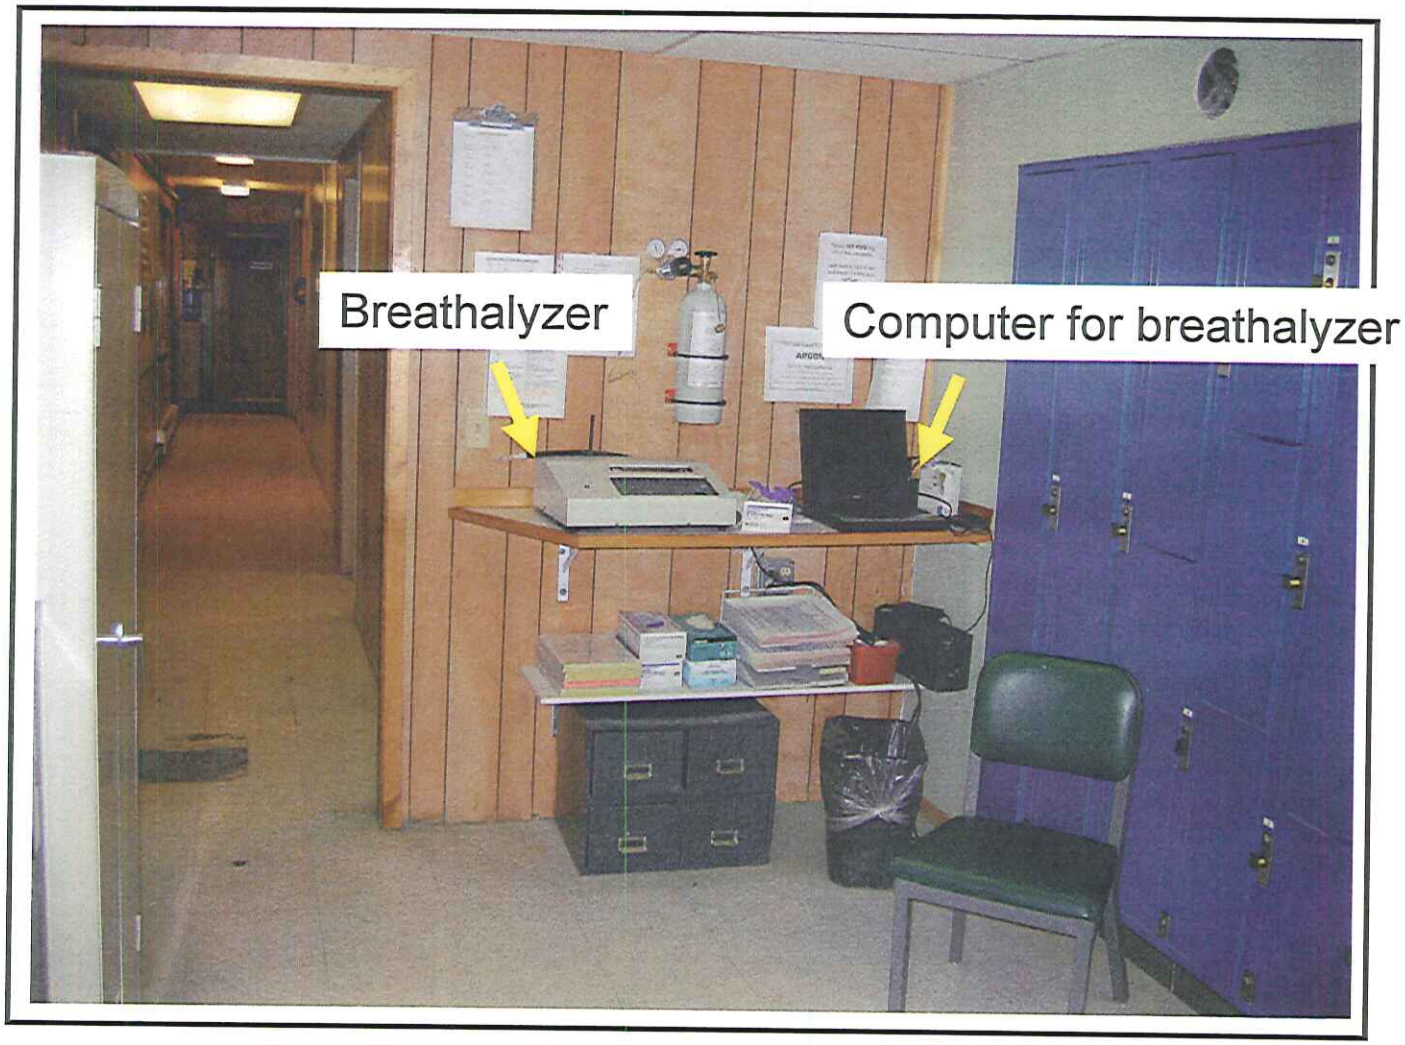
Police officer storage lockers in blue provide the backdrop for the green chair in which the person sits who is having his or her breath analyzed for alcohol content. The cabinet on the left is used to store evidence tape, paper, evidence collection kits, and other supplies. Recordings of the breathalyzer process often contain interference, distracting noises, and other voices.

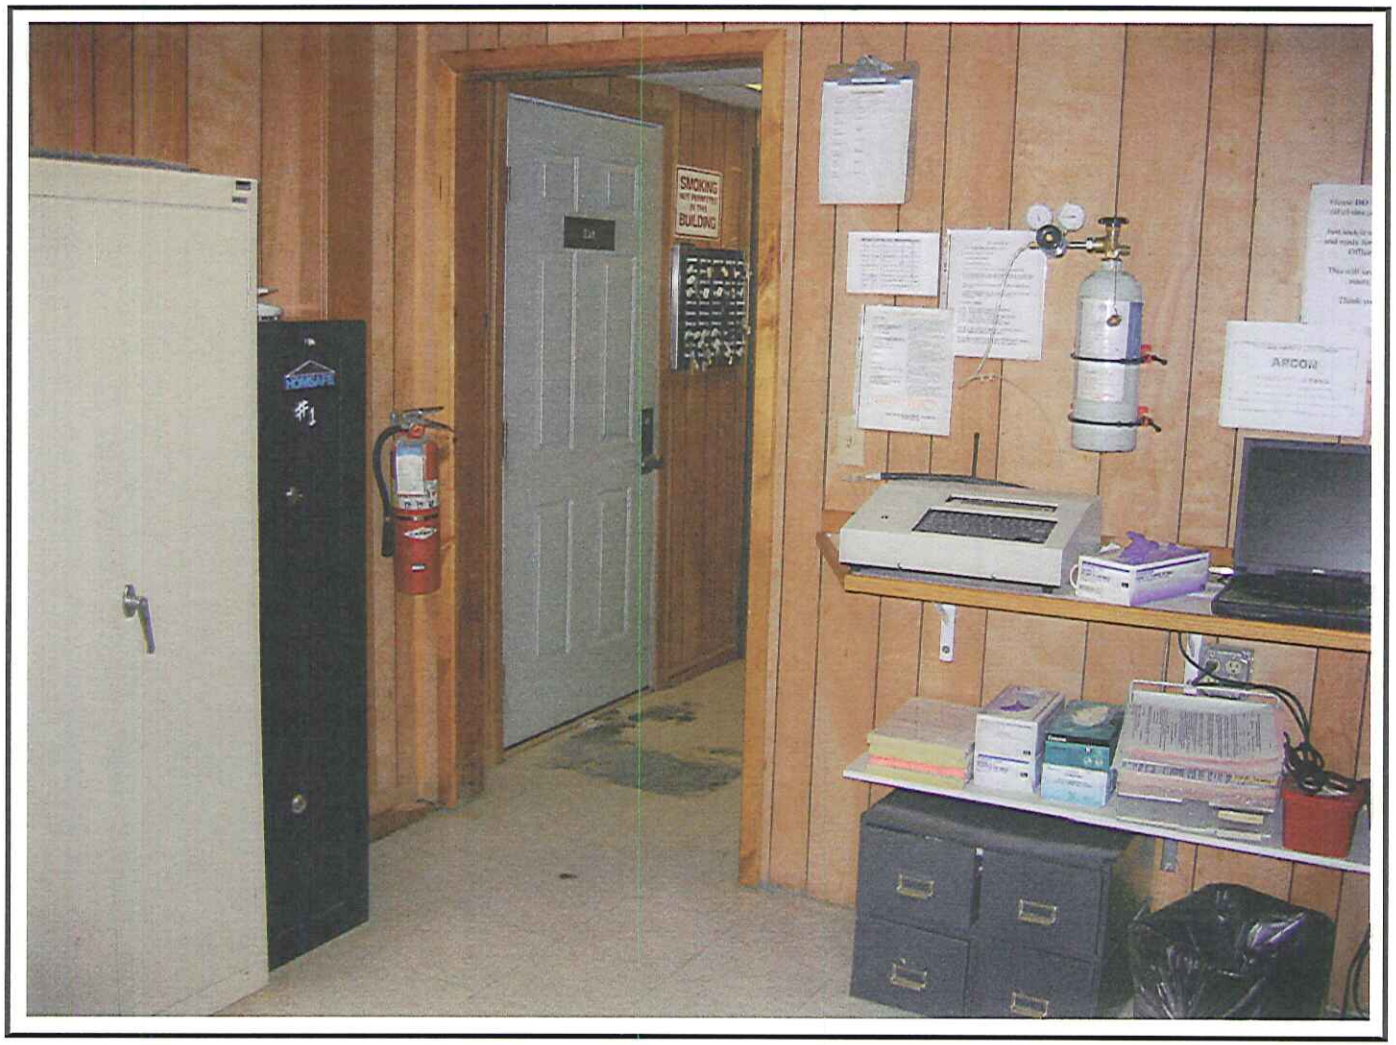
Breathalizer tests are often conducted in this hallway due to lack of space. Taperecorders used to record the tests often pick up extraneous sounds, like voices from nearby cubicles and hallway traffic. Administration staff walking through distrurbs the process.

The only indoor evidence storage room at the existing police station. While the boxes and items stored here are organized and neatly arranged, there are many more boxes of evidence stored outside in the department's one 20' storage container that should be stored inside to preserve it as evidence. This room has filled to capacity over the years.

Photo of one corner of the inside evidence storage room. Confiscated weapons, drugs, money, and other evidence is stored here. The refrigerator and freezer must be used to store sexual assault kits, evidence containing blood, and other perishable items. Currently, the freezer is jammed full of a rug containing blood from a murder scene. Evidence from homicides must be kept forever, putting a severe strain on storage space.

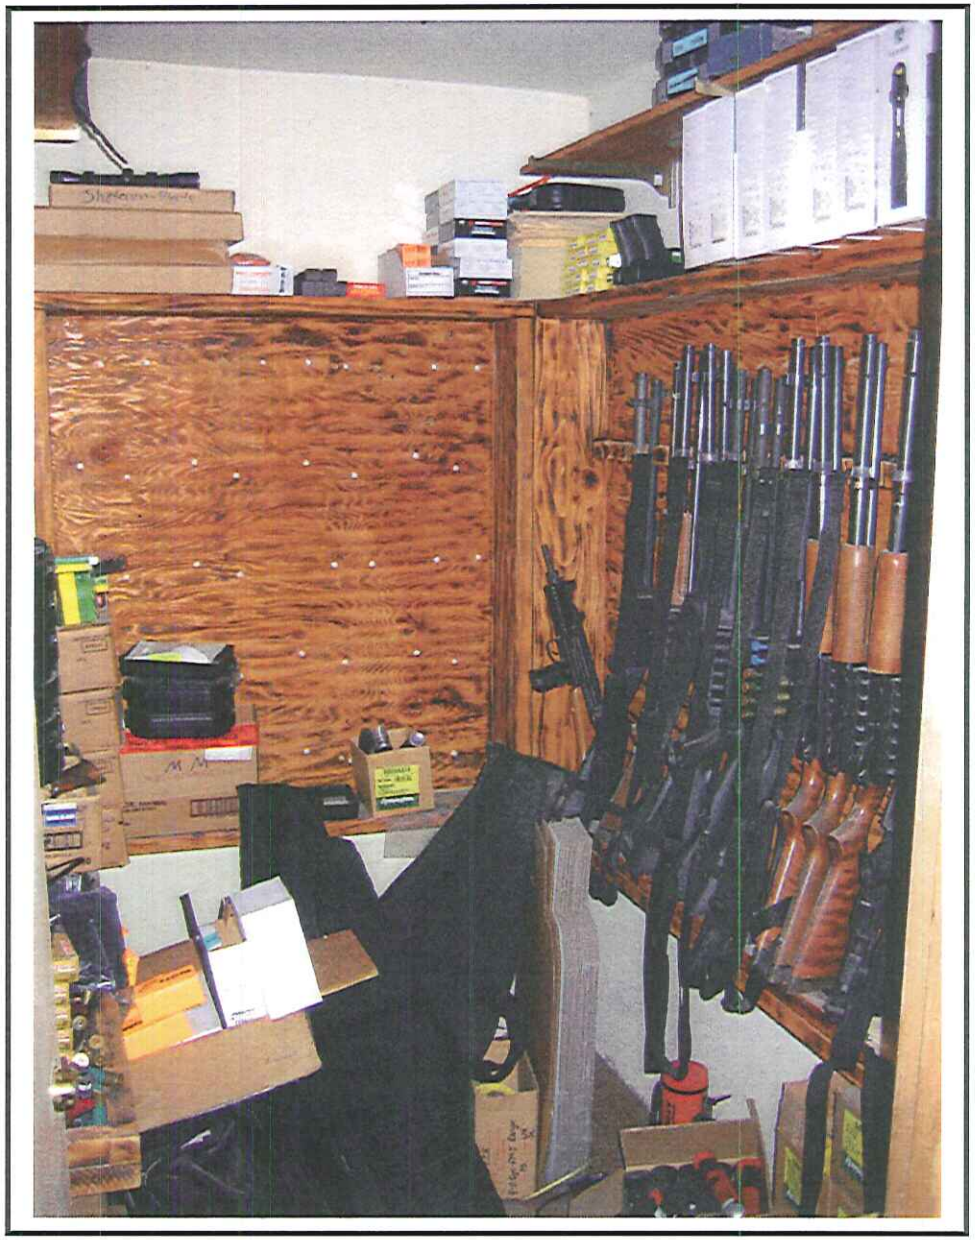
The artillery storage room (gun room) containing rifles, shotguns, tazers, ammunition, and pepper spray has spilled over to the Quartermaster's storage area.

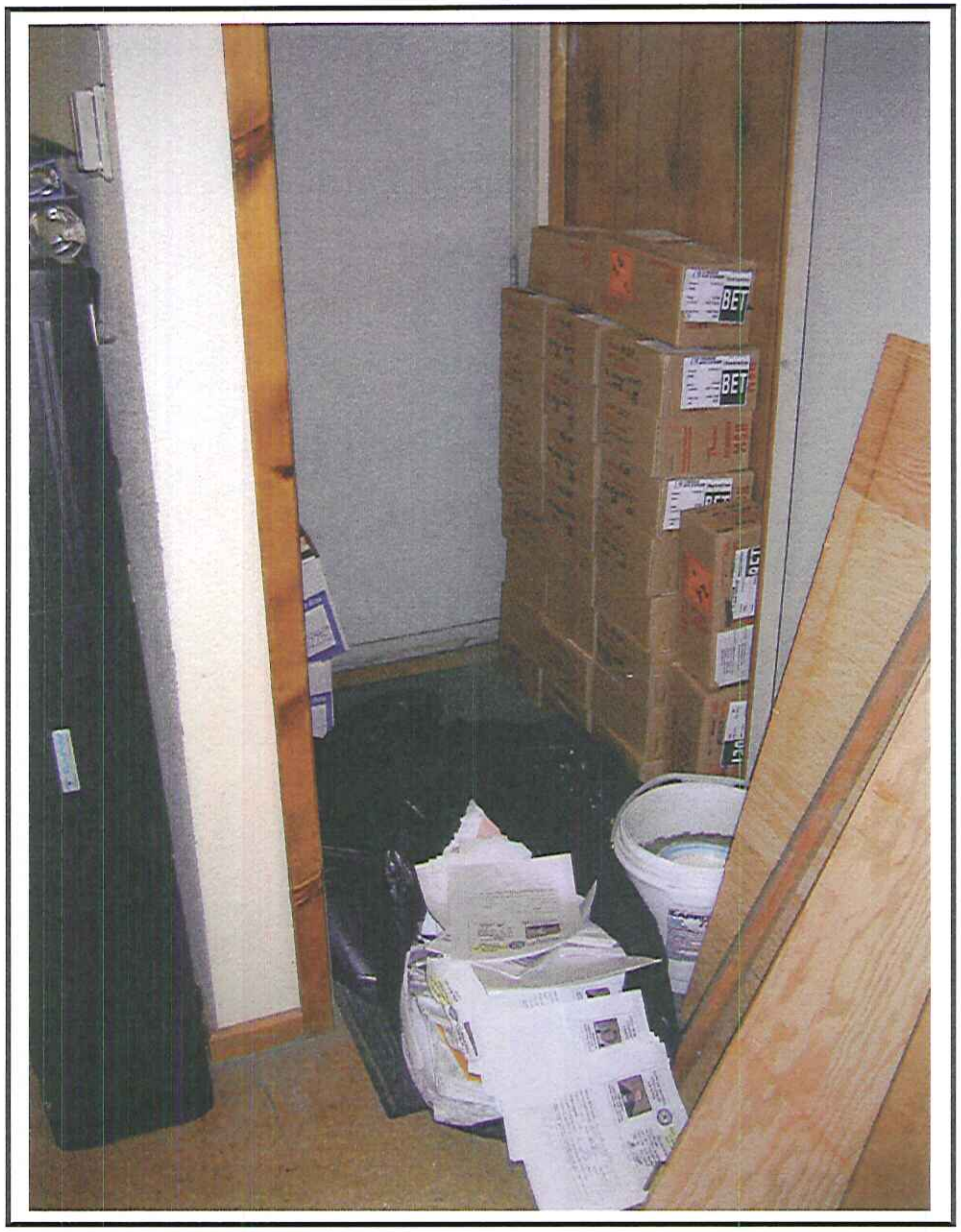
A lack of space in the gun room means that these boxes of ammunition are stored in the corner of this supply room, rather than in the gun room where the rifles, shotguns, and tazers are located.

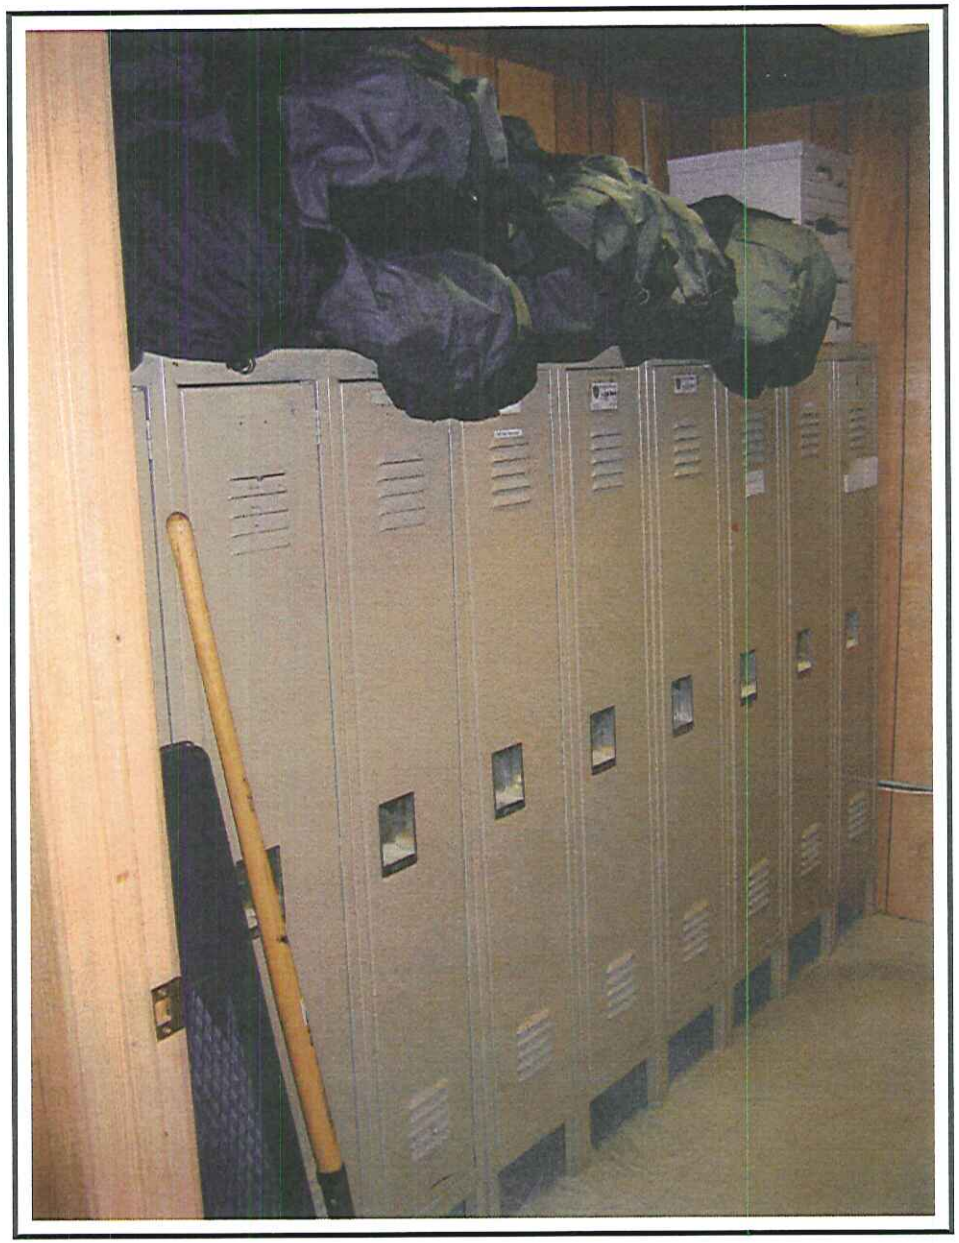
Crowded locker room also contains winter clothing gear stored in black bags.

Quartermaster closet full to capacity.

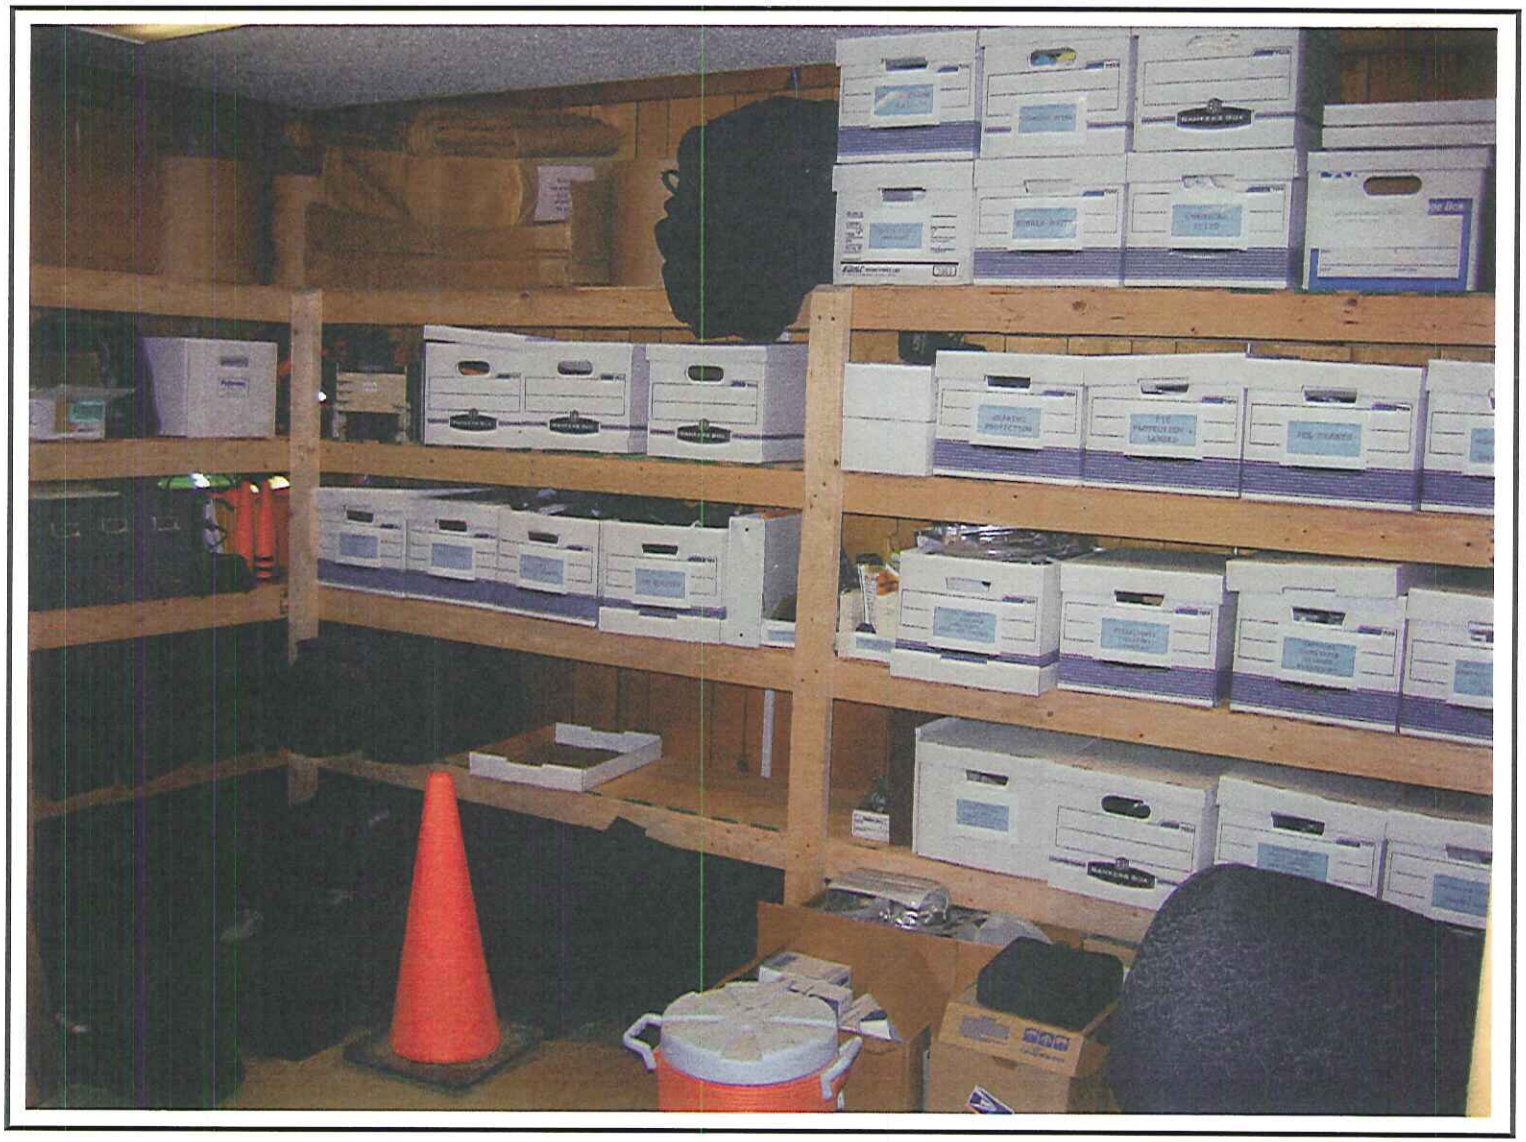
The Qurtermaster equipment room shown here contains duty bags, evidence collection kits, and boxes full of cameras, digital recorders, batons, body bags, body liners, etc. Notice all of the materials on the floor due to insufficient shelf space.

Another supply room appears to be overflowing with stuff. Administrative Assistant Laurie Strickler is seen holding one of the stuffed teddy bears used to hand out to sexual assault victims before an officer begins an interview. Sexual assault interviews are conducted in the Sergeant's office and dispatcher's office because the station does not have a warm, inviting, private room ideally suited for these types of interviews.

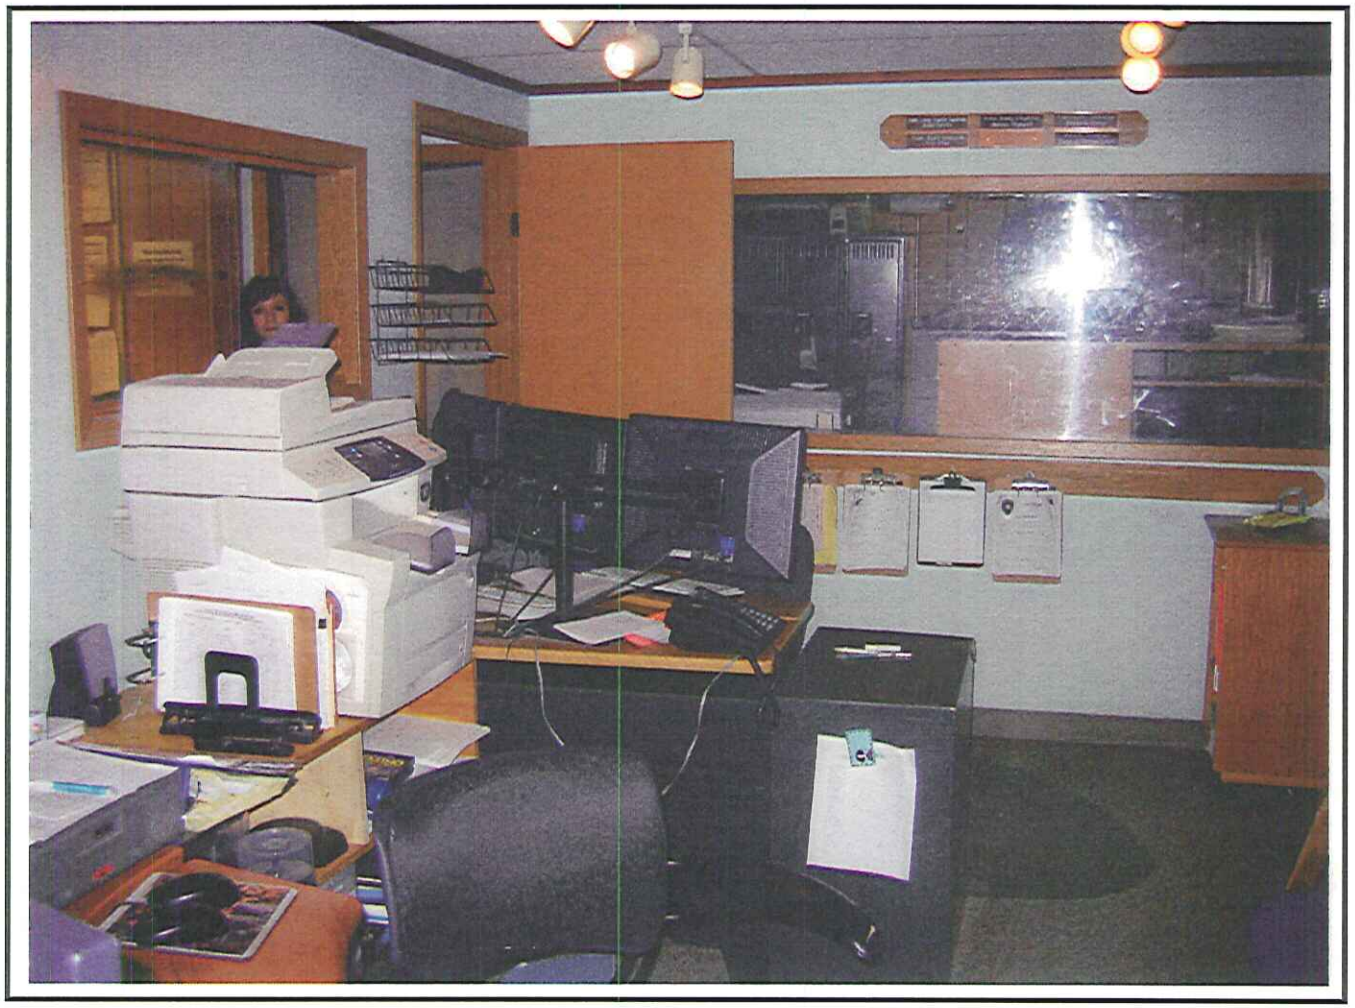
The Disptach Communications room is barely adequate to hold the computers, screens, desks, radios, and other equipment for the two dispatchers who work there. Each dispatcher can easily be distracted by conversations of the other dispatcher, keyboard noises, and people in the lobby using the intercom. The dispatchers have a challenging job dealing with many life-threatening situations at the same time. The dispatchers received 3,035 emergency 911 calls last year from Bethel and the surrounding 58 villages.

A shade is seen here covering the bullet-resistant window between the Dispatch Communications Area and the police station lobby. The sheetrock walls offer no additional protection to the dispatchers who can be the only ones in the station at night.

The Dispatch Supervisor's office area shown here is also shared by the Records Custodian because there is not enough office space. The floor slopes backward and the floor tiles are coming apart. Computers, fax machines, and other technological devices accumulate massive dust inside the station—more than any other City building.

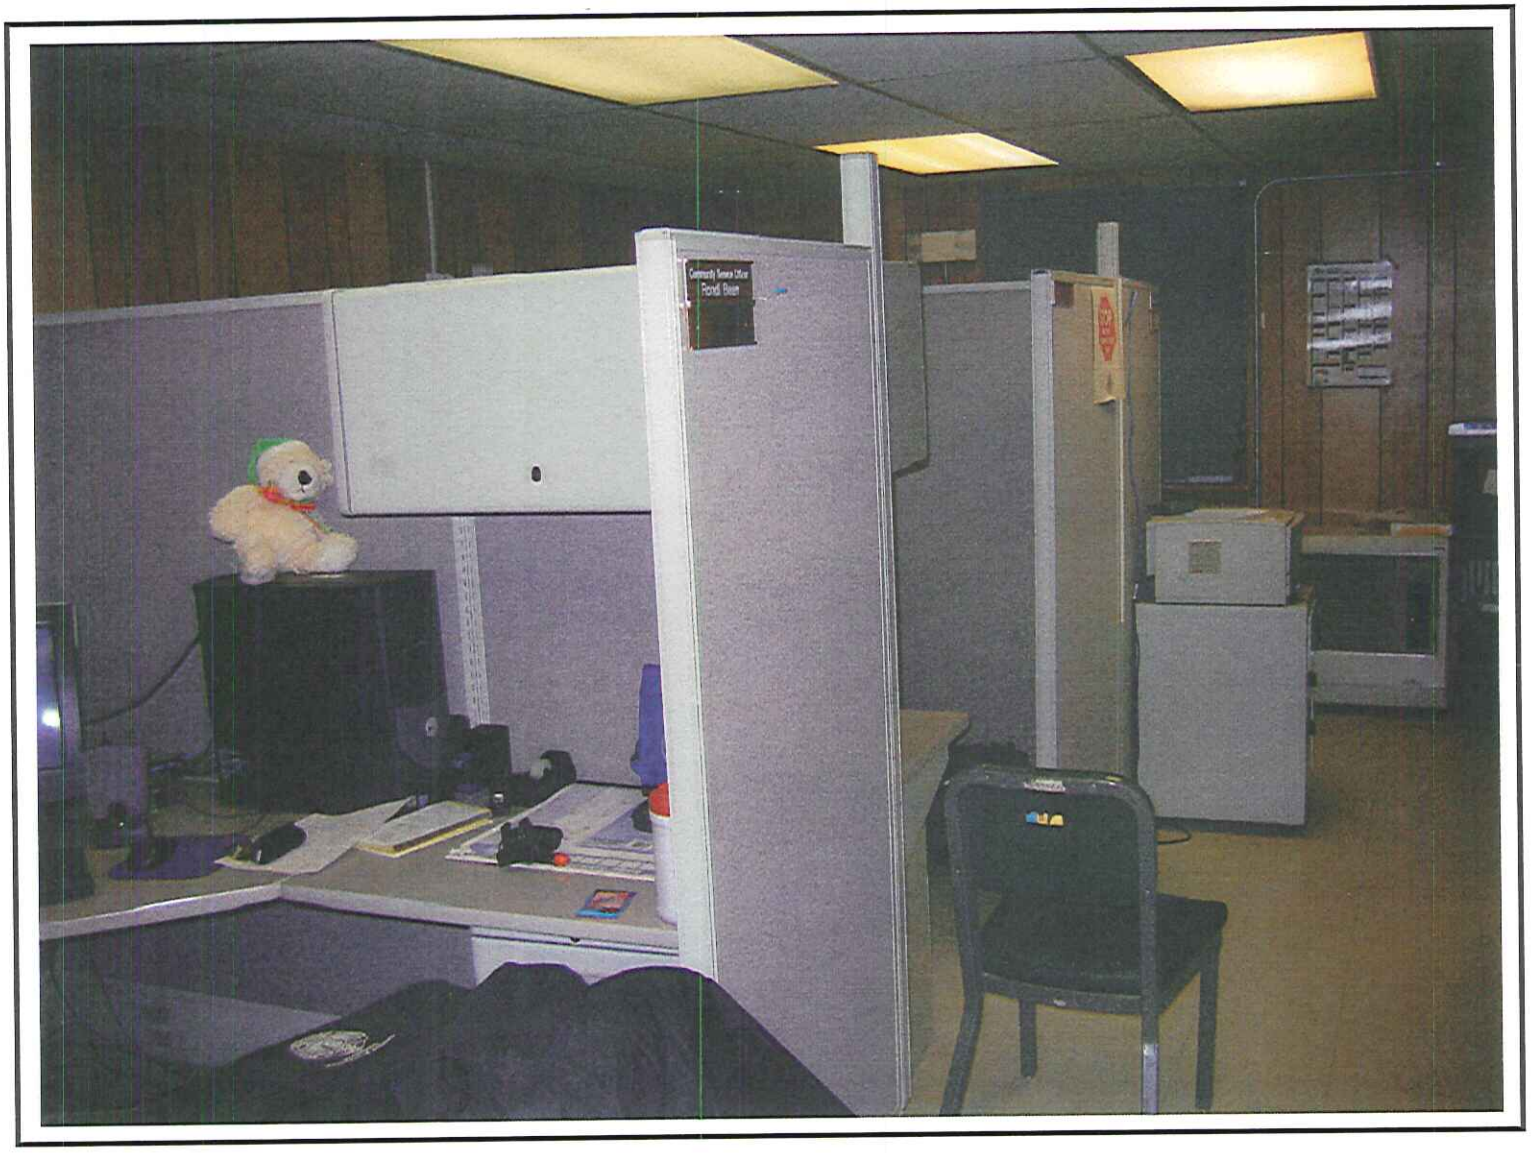
Four cubicles for use by 8 officers when department is fully staffed. Copy machine placed on file cabinet due to lack of space. Officers also use this area to perform breathalizer tests, which ideally should be conducted in a private closed-door office.

Numerous boxes contain forms that must be used on a daily basis. These forms are located in the corner of the area containing the four cubicles for eight officers. What the stacked slots offer department personnel in organization, they take away in efficiency. Department personnel in other sections of the building must retrieve their forms from this location.

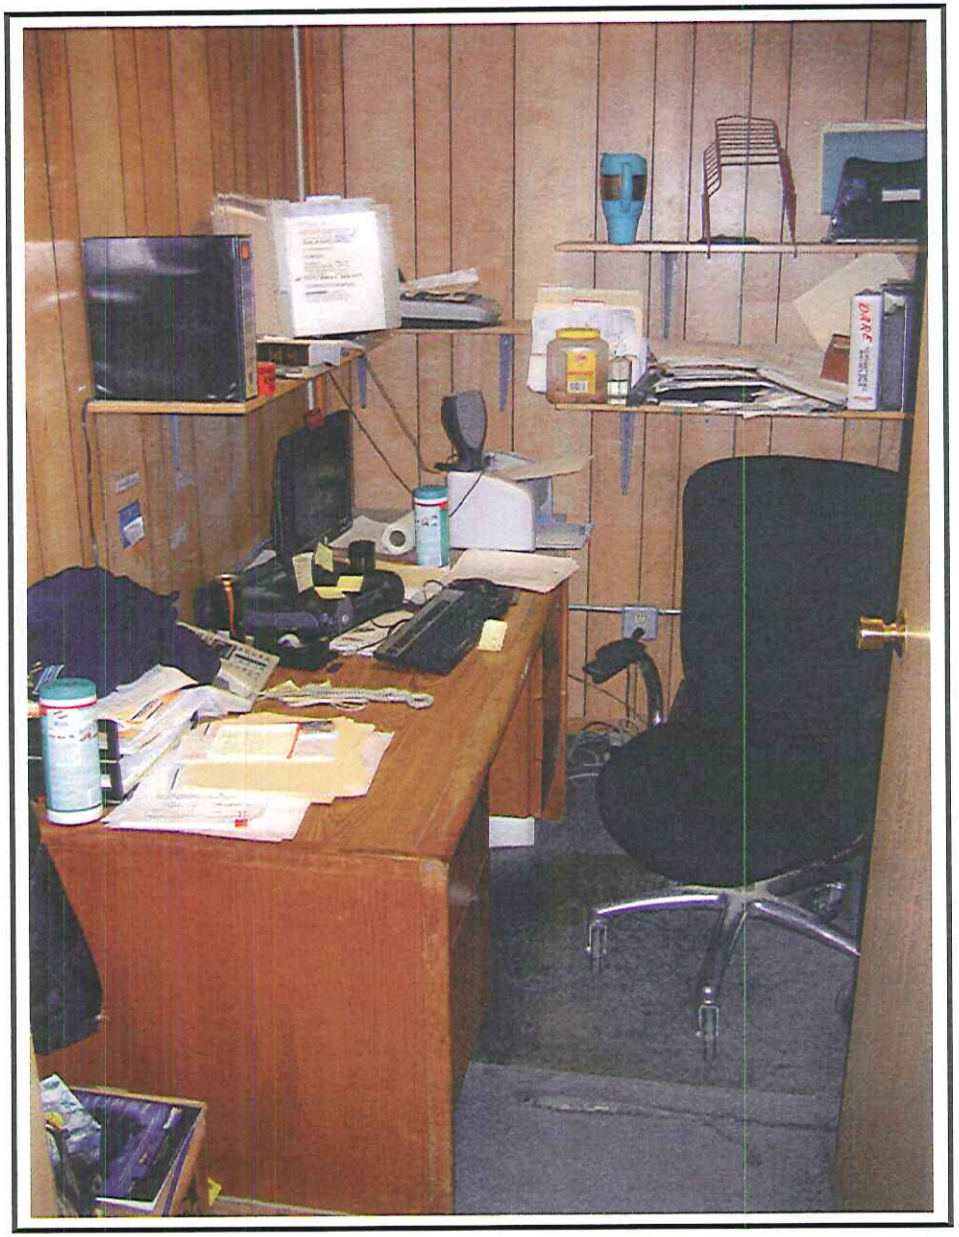
Police Corporal's office requires two individuals to share it when the department is fully staffed. This closet-like office has very little room.

Hard tile floor cracks appear to the front of the chair.

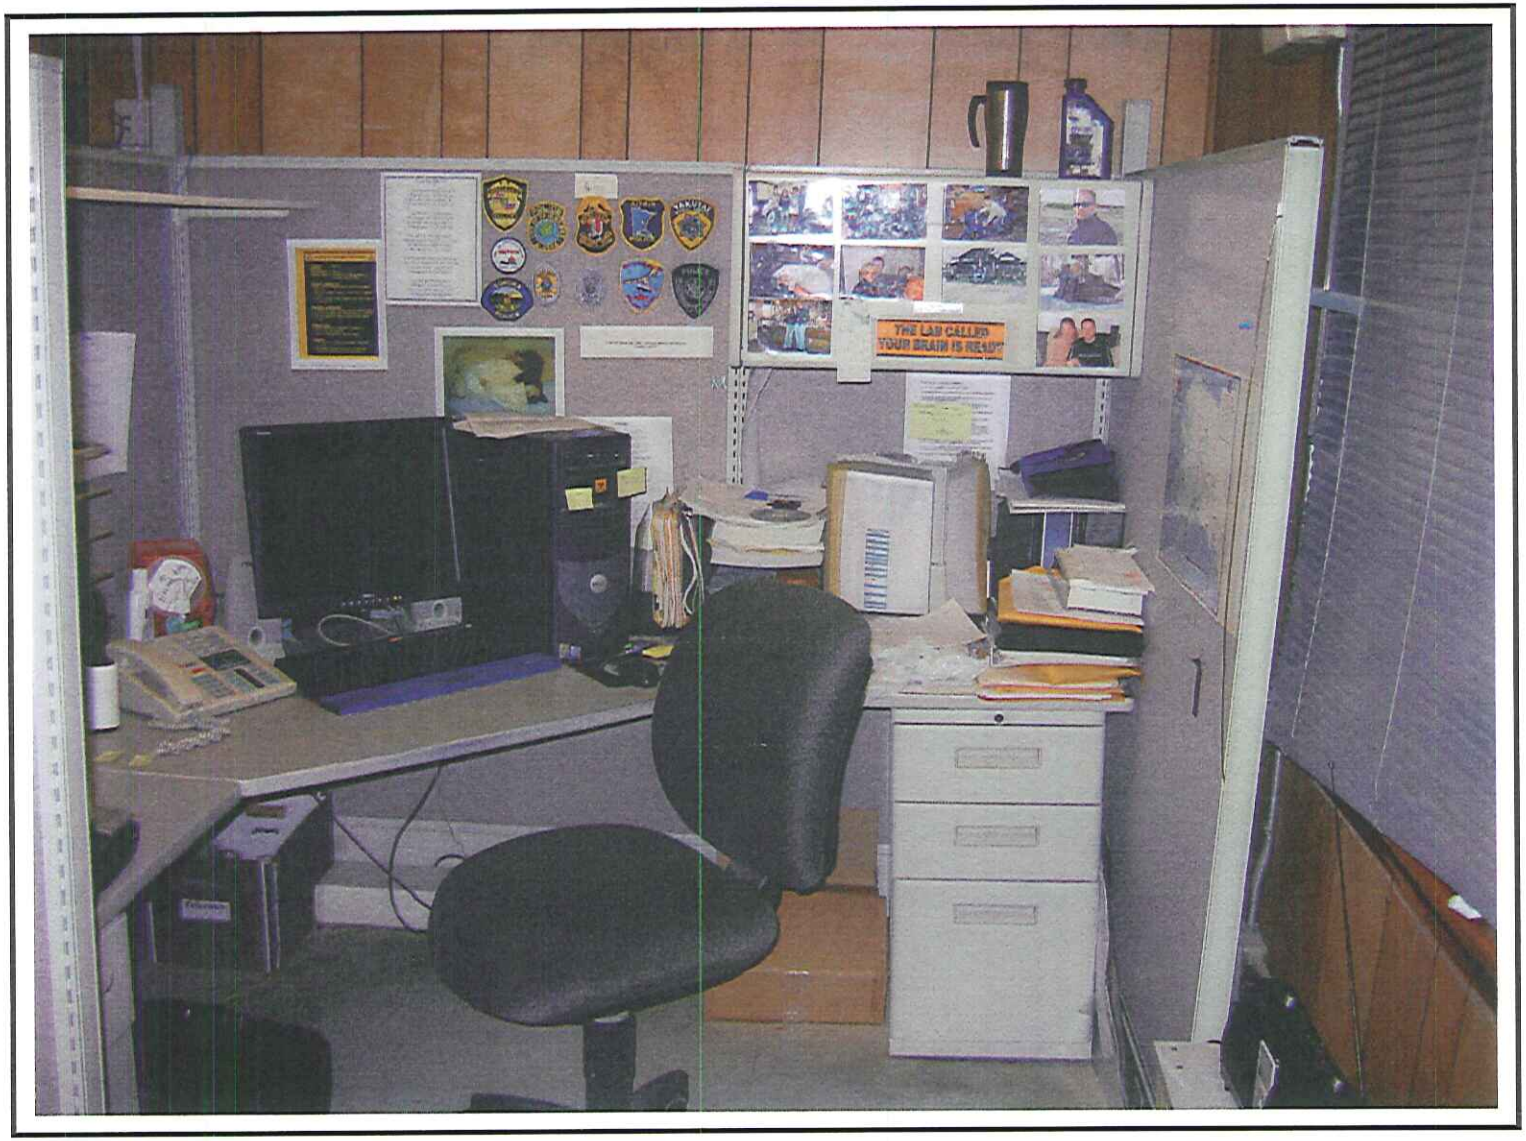
Second Corporal space (cubicle) in police department. The Toyo stove to the right either cranks out too much heat, making it uncomfortably hot, or doesn't put out much heat at all, making it uncomfortably cold. Corporal faces constant breeze from the window. Notice document storage box placed under desk due to lack of space.

View of one of two bathrooms. The shower is hardly used by the officers because the hot water only gets lukewarm. The ambient air temperature also keeps bathroom too cool.

Ceiling has water leakage stains. The sink vanity wood has visible signs of rot.

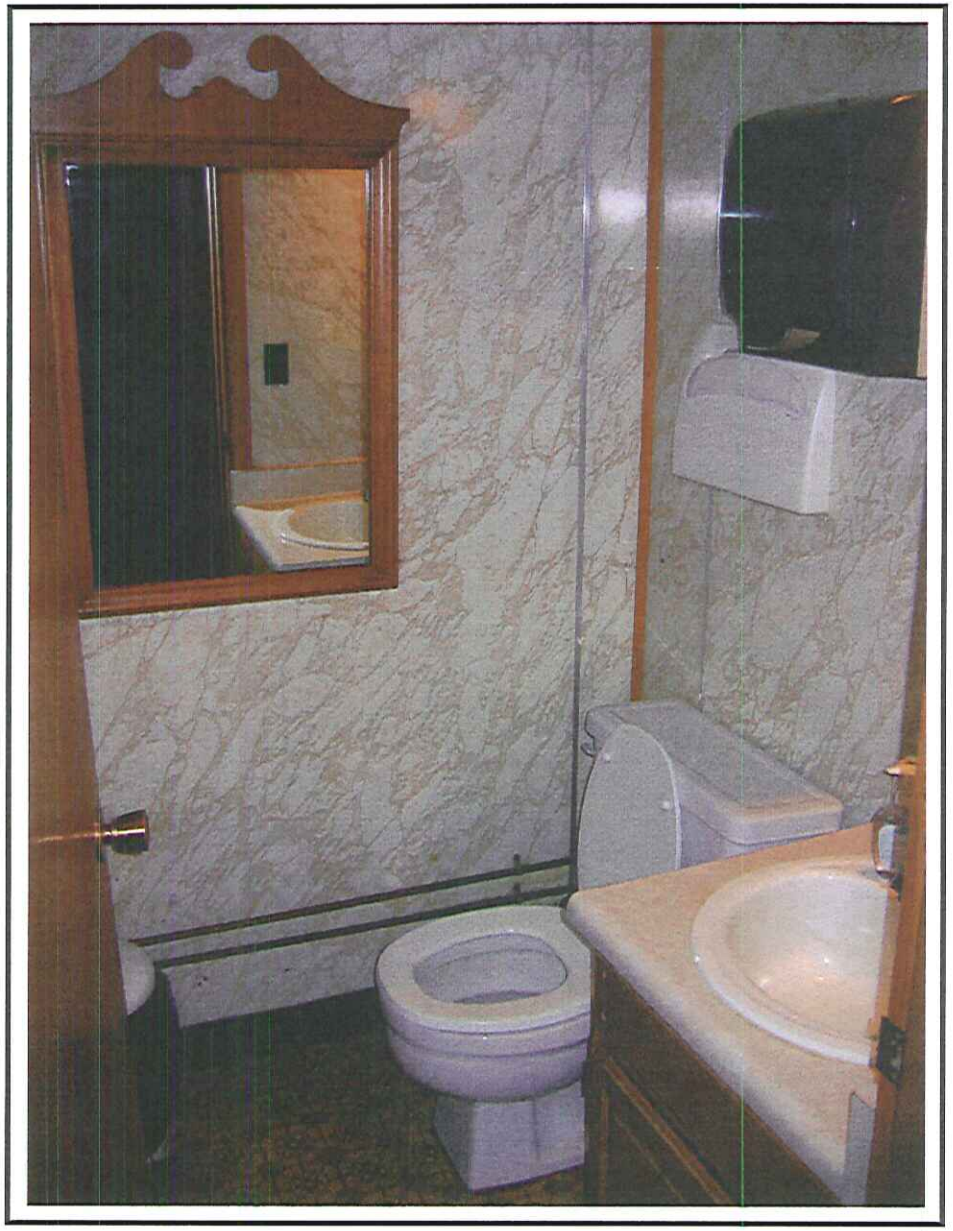
One of two bathrooms. This floor in this bathroom is caving and there is evidence of ceiling leakage. The toilet emits a constant urine odor due to an old, malfunctioning sewer system. The wooden vanity is deteriorating. There is also a strong mold smell.

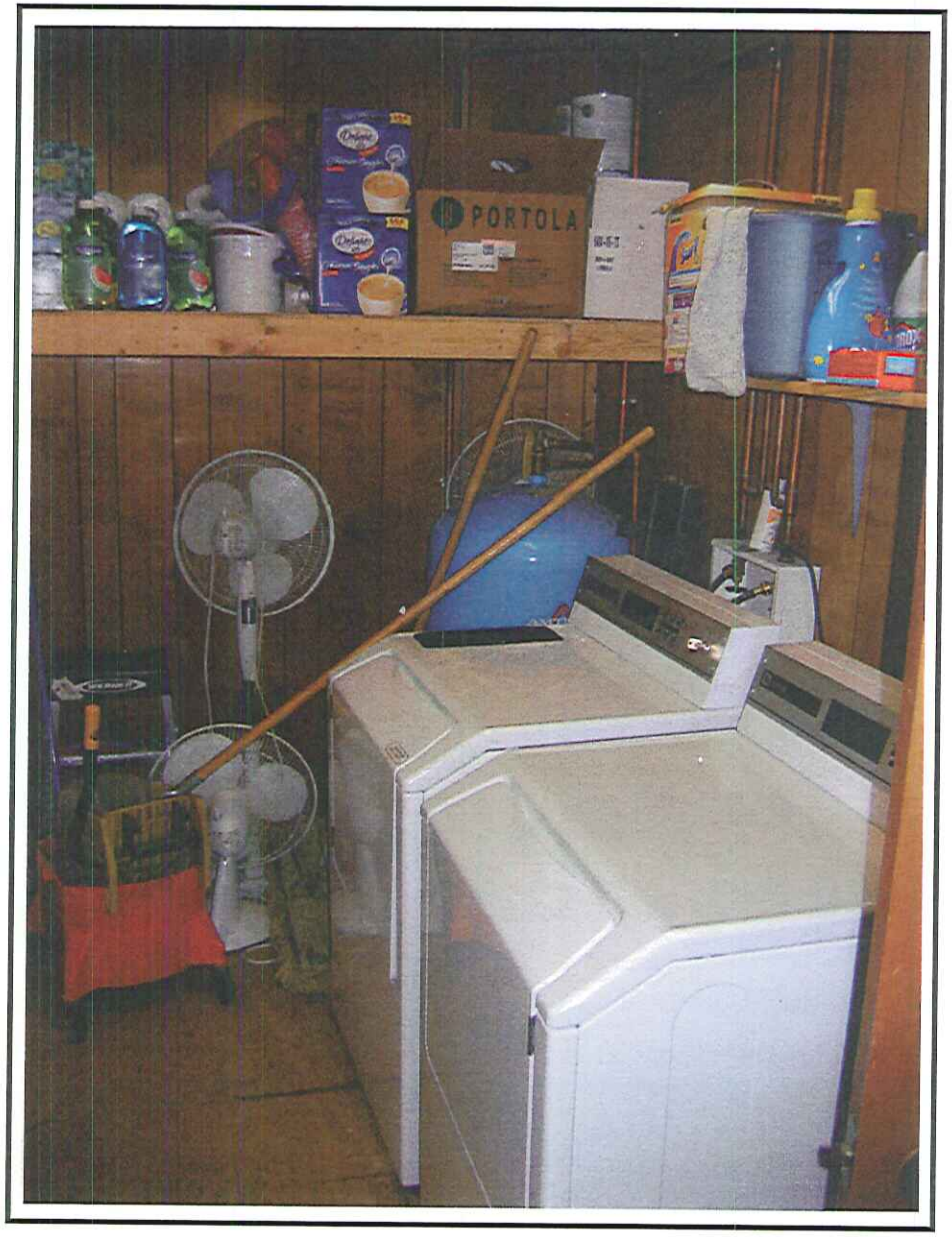
View of laundry and storage area. This room suffers like other rooms at the station from a lack of storage space, cracking tile floor, exposed pipes, and slanted floor. Only one person can do laundry at a time.
