Catholic Community Service - Building Design and Renovation for Children's Behavioral Health and Family Services

CCS APARTMENT BUILDING CONDITION SURVEY

JANUARY 2013

The following report describes the condition of the existing apartment building at 1805 Glacier Highway, Juneau Alaska, and the feasibility of converting the building to serve as program space for the Child Care and Family Resources (CCFR) Division of Catholic Community Services (CCS).

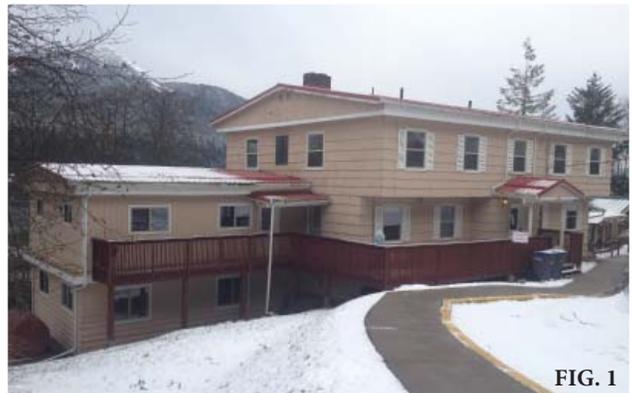
Given that the apartment building has actually proved to be a liability to the organization, it was decided to cease operation as a rental facility. However, the building is still an asset with potential (fig. 1). In particular, it is large enough to support most of the CCFR programs presently provided at the downtown administration building and the Mendenhall Valley senior center. This report documents the existing conditions and costs to fully renovate the existing building to support CCFR programs. Experience with the building has demonstrated that nothing short of a full renovation will render then building suitable for use by a professional social services program. Anything less will repeat the liability and financial drain of the existing building. It also compares the costs of renovation versus new construction, as well as the likely cost of renting space in a building more suitably located. The following documents our observations that form the basis of the cost estimates. The Apartment building consists of an original three level main building and a two story annex. Because these two are essentially different buildings, they will be considered separately.

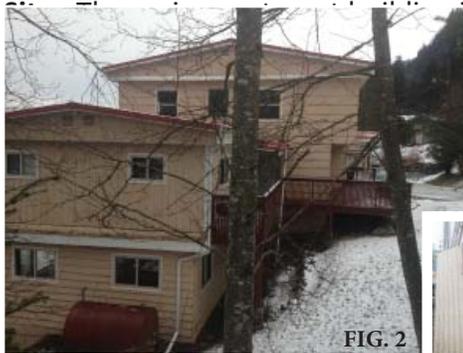
The building is located on a sloping site parallel to Glacier Highway, with the long axis running east-west and perpendicular to the slope (fig. 2). The sloping site necessitates the first floor being a daylight basement. The site appears to consist of unconsolidated overburden on a rocky substrate- a rock outcropping is visible under the Annex building (fig. 3).

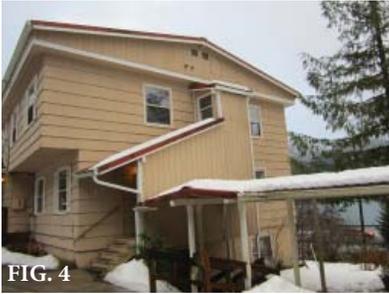
The building includes an elevated deck on the north side aligned with the sidewalk linking parking with the other site elements. The daylight basement has a doorway to grade on the south side. On the west side there is a doorway with steps leading up to the covered sidewalk connecting directly to the Adult Day Center. The adjacent grade is retained around the doorway area with rockery retaining walls (fig. 4).

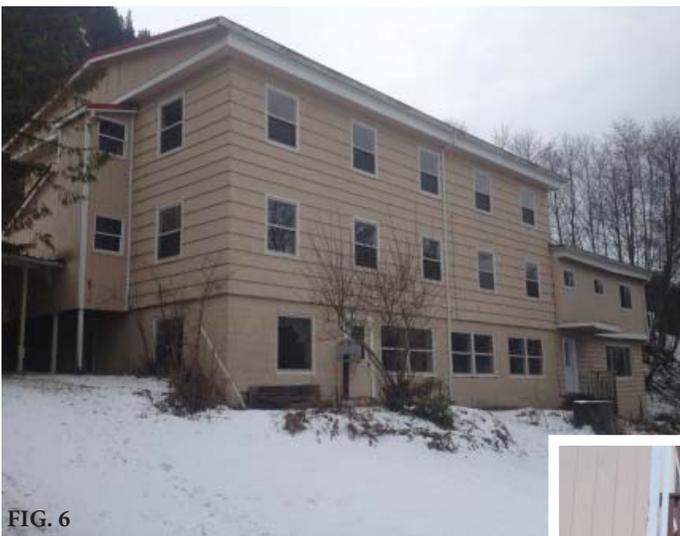
Building: The existing building consists of a daylight basement under a two story wood framed building. For clarity, they are referred to in this report as basement, main floor and second floor (fig. 6).

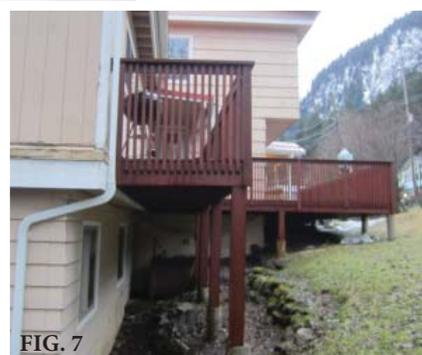
The building is reported to have been renovated numerous times. No drawings or formal confirmation of the age of the building is available to us. The siding and window treatment is similar to materials and detailing we have seen in Juneau on buildings dating from the mid 1950's. The original concrete entry porch is visible in places. North side of the building features a pressure treated lumber deck and railings on treated wood posts (fig. 7).

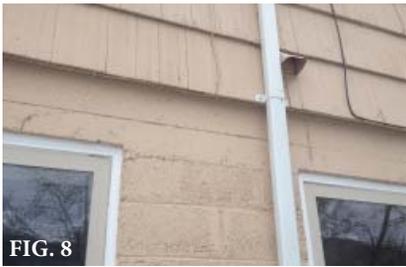
The basement consists of a slab on grade with 8" concrete masonry units (CMU) on the retaining walls (north, west and east walls) and 6" CMU in non retaining wall conditions (South and portions of west and east walls. The 6" CMU walls are topped with a 6"x16" cast in place concrete bond beam (fig. 8). It is unknown if the CMU is reinforced or not. The slab is covered with a wood floor consisting of wood furring under plywood. We did not detect water leaking in the CMU walls.

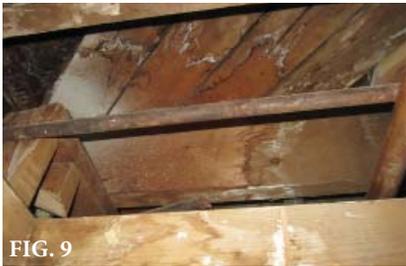
The floor framing above for the main floor consists of 2x12 at 16" (fig. 9). There are multiple layers of ceiling soffits apparently installed over the years attached below the floor framing reducing the floor to ceiling height to less than 7 feet. The second floor framing is similar to the main floor. Roof framing appears to be spaced 2x rafters installed at a 3:12 pitch installed over an original flat roof structure. It is topped with exposed fastener metal roofing (fig. 10).

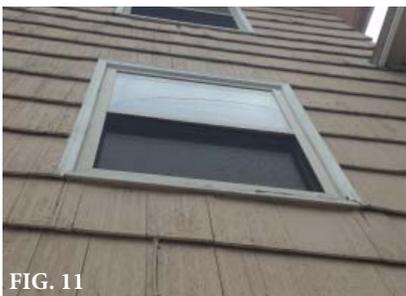
Windows are double hung vinyl replacement windows installed in the original openings. Exterior doors are insulated metal doors (fig. 11).

1. Remove and replace main entry canopy.
2. Remove and replace covered stair at the east elevation
3. Replace all exterior doors and windows.
4. Replace shingle panels siding with metal siding in a rain screen configuration.

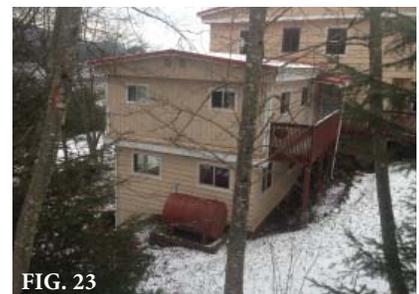
**FIG. 23**

The Annex building is a two story wood building on a wood foundation. It appears to have originally been a single story building with a flat roof. Second floor was added, it too with a flat roof. Later the sloped metal roof was added (fig. 23).

The original construction of the annex was very poor. The advanced state of deterioration and lack of foundation suggest that it would be simpler and more cost effective to tear down this portion of the building and replace it. The existing 500 gallon oil tank at the west elevation can be relocated to support the new renovation.
