Ouzinkie - Mahoona Lake Dam Repair and Replacement

FIELD INSPECTION REPORT MAHOONA DAM (AK00207)

Field Inspection Report
Mahoona Dam AK00207
6/10/2011

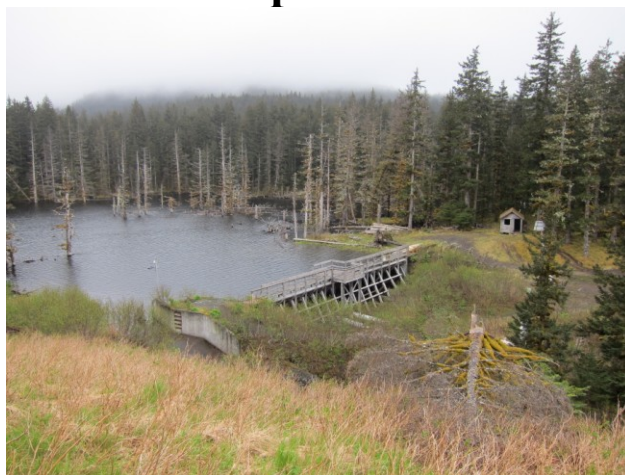
Field Inspection Overview: The ADNR Dam Safety and Construction Unit (Dam Safety) visited the Mahoona Dam at Ouzinkie, AK on June 10, 2011. The Mayor of Ouzinkie, the Honorable Dan Clarion, accompanied Dam Safety during the field visit.
