# Kodiak Regional Aquaculture Association - Kitoi Bay Hatchery Deferred Maintenance and Upgrades

Alaska Department of Fish and Game

March 2012

# KITOI BAY HATCHERY

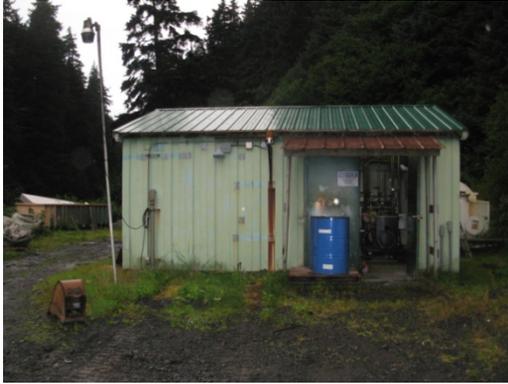
**Power Plant**

The generator sets are in fair condition and will need replacement or a major rebuild in approximately five years.

The controls are comprised of programmable logic controllers (PLC's) for the engine-generator operations, status conditions, and alarms. Additionally, they monitor the electrical conditions via solid state protective relays and secure the system appropriately for fault conditions. They also facilitate paralleling operations allowing switching of the generators and two generators to operate together to power the hatchery. The PLC and accessories is outdated and in poor condition. Some of its functions are no longer used due to newer generators and motors not being compatible with the old PLC system. Although this control system was well devised when it was fabricated, it is complex and difficult to maintain in a remote location.

Along with replacing the generators within five years, the switchboard should be replaced with one using modern components. However, attention must be made to select a simpler control system with fewer components. Such systems are available today.

Considering the need to maintain operation of the power plant all of the time, replacement of the switchgear requires a special strategy to ensure continued operation of the system. This might involve construction of a new power plant, and demolition of the old one upon commissioning of the new. The design of a new power plant should include a careful evaluation of the loads to allow the generators to be sized for optimal operation and economical fuel consumption. The effort to configure a new power plant might also include an evaluation of incorporating a hydro-turbine generator.

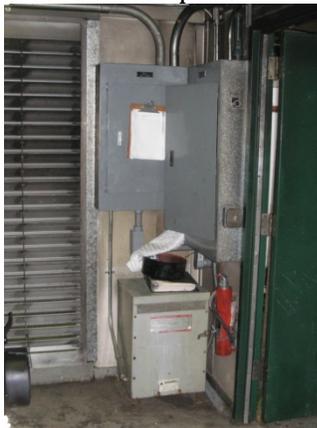
**Power Plant Panels**

The branch circuit panel in the power plant primarily supports circuits to the power plant ancillary equipment, but it also supports feeders to the egg take building and storage shed. This panel is fed from the main distribution panel via a 15 KVA step down transformer with an operating voltage of 208Y/120, three phase. The transformer is in moderately good condition and the panel is in fair condition. The circuit breakers should be replaced in the panel in the next five years.

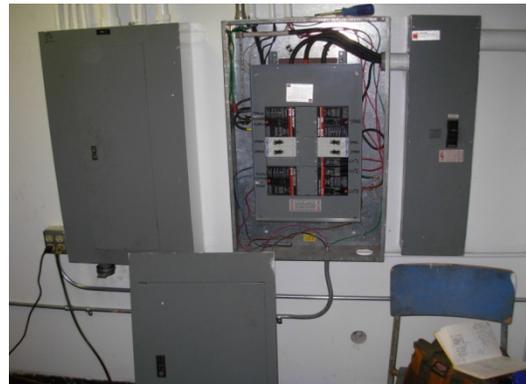
**Hatchery 480 Volt MDP and Panel B**

The second feeder from the switchgear is directed to the hatchery as single conductors in buried conduit. This feeder supports a main distribution panel in the electrical room. The main distribution panel feeds three ultraviolet (UV) units, a plasma cutter receptacle, and a branch circuit panel via a 45 KVA step down transformer. This panel is in fair condition with some newer circuit breakers, along with some old ones. The older circuit breakers should be replaced within the next five years.

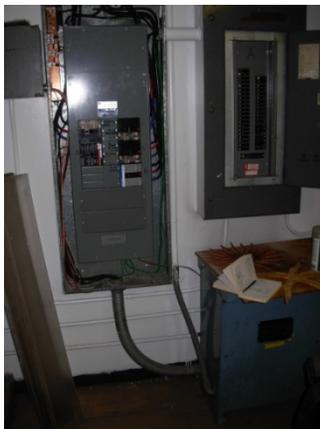
**280 Volt MDP and Panel A**

The step down transformer is circuited to a 208Y/120 volt main distribution panel, also inside the electrical room in the hatchery. This panel supports feeders to branch circuit panels in the original and new hatchery, as well as a small main distribution panel in the Hanger Dock building. This panel was originally configured for a 120-240 delta, three phase configuration. An unconventional neutral bus has been added to convert it to support a wye configured system. Although the panel is in good condition, it does not comply with the National Electrical Code (NEC). This panel should be replaced within two years. Note: the feeder to the new hatchery branch circuit panel is undersized for the provided circuit protection and should be corrected.

Branch circuit panels A and B are located in the electrical room and support circuits inside the original hatchery building. Panel A also sub feeds Panel C in the shop. Panel A is old and in poor condition with a poorly fastened cover. It should be replaced in the next two years. Panel B is in good condition. Panel C is in fair condition and should be replaced in five years, or less. The circuit breakers in Panels A & B should be replaced within five years. The feeders to these panels are all in good condition.

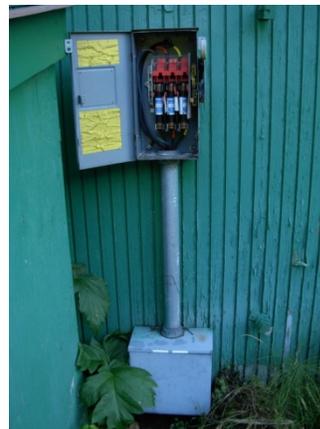
**Bunkhouse Main Disconnect (480 volt)**

The feeder to the bunkhouse enters a disconnect on the exterior of the building, and then a step down transformer in the crawl space. The disconnect is in poor condition and should be replaced with the bunkhouse remodel. The transformer is in good condition, although it is close to the floor joists and should be repositioned to allow better clearance. The transformer feeds a single branch circuit panel inside the bunkhouse. This branch circuit panel is in poor condition and will be replaced with the bunkhouse renovation.

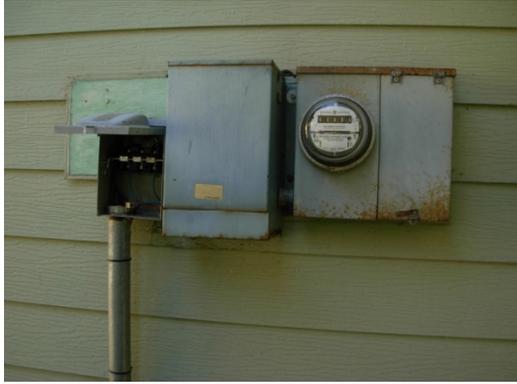
**Residence Main Disconnect, Transformer and Meter/Disconnect**

The feeder to the housing units is tapped in underground vaults with sub feeders routed to each dwelling. At the dwellings, the circuit is routed through a disconnect and step down transformers to yield 120-240 volt power. Meters with secondary main circuit breakers monitor and protect the feeder into the panel inside the dwelling. The disconnects, transformers, and meter/mains on the original three dwellings are in fair condition and will require replacement in the next five to ten years. The equipment at the duplex is new.

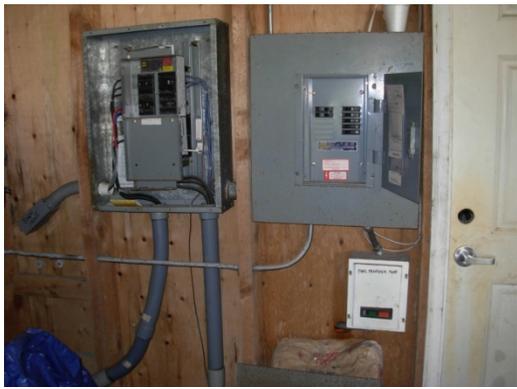
**Hanger 208 Volt MDP and Panel**

The main distribution panel in the Hanger Dock building supports feeders to branch circuit panels in the Hanger, in the Net Shed, and in the Barn. This panel and feeders are in good condition. The branch circuit panel (load center) in the Barn is new and in good condition. The panel in the net shed is a used panel in fair condition.

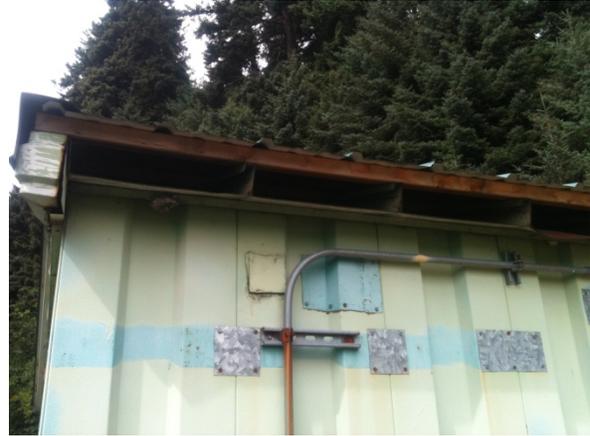
**Roof detail**

The generator building exterior envelope is in poor condition. The original metal roofing failed and exposed fastener metal roof was installed over it as a stopgap measure. It was not designated for wind uplift, lacks flashing, insulation or ventilation measures. Windows and doors are all badly deteriorated. Combustion air intake and exhaust are in poor shape, heavily corroded and lacking weather integrity. The wall siding is a dual skin metal siding with approximately 1.5" of fiberglass insulation between the painted metal panels. It is corroded through in places, lacks weather integrity and has a very poor prognosis. The panels do still appear to have sufficient structural integrity to serve as a backing for replacement panels.

Roofing and siding could be replaced along with doors, windows, louvers, and other exterior envelope elements if it is decided to retain the primary equipment inside the building (generators, switchgears, etc.) However, if it is determined to replace the primary generation equipment the existing building could be replaced with a new generation building installed on the site while the existing plant remains in operation. Demolition of the existing building could take place after the new building is brought on line. It is likely some site clearing, including excavation of adjacent uplands slope would be required to accomplish a level site on which to build a new generation building.

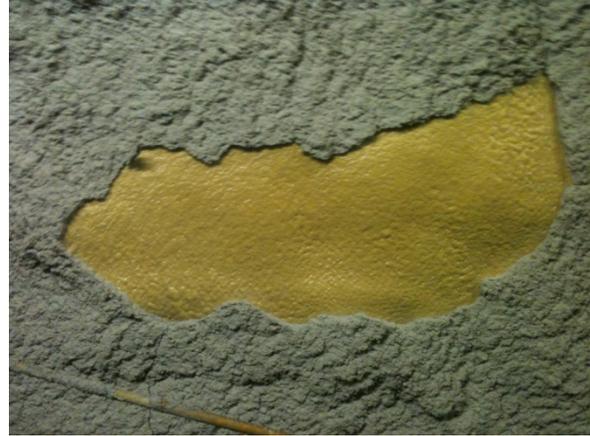
**Exposed insulation**

**Roof:** Metal roofing was painted approximately 2 years ago in effort to stretch the useful life of the assembly. Staff states that the roof was heavily corroded prior to the paint being applied. Corrosion is evident under the paint, especially at panel edges. The paint was a stopgap measure- the roof is past its useful life and should be replaced. The existing roofing can remain in place and a new metal roof installed on top of it. Insulation can be placed in the void space between existing and new roof panels as an inexpensive way to raise the thermal performance of the roof. Spray fireproofing has become dislodged from the urethane foam adhesive in a number of places. Trowel on fireproofing patch material should be applied at all areas where the urethane is exposed.

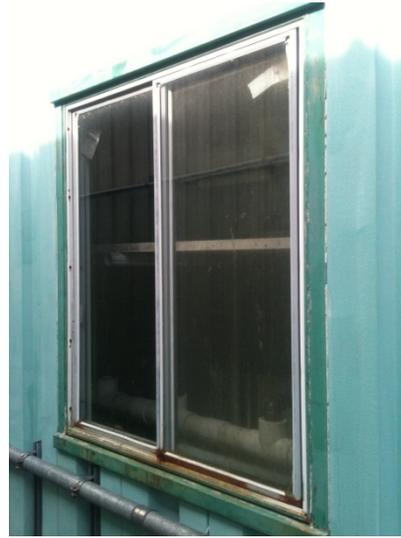
**Typical Window**

**Windows:** Of the 17 original windows on the building, two have been replaced with insulated vinyl units. The remainder are single pane steel frame windows. All exhibit corrosion, leak in heavy weather and are passed their useful life. They should be replaced along with the metal window flashing.

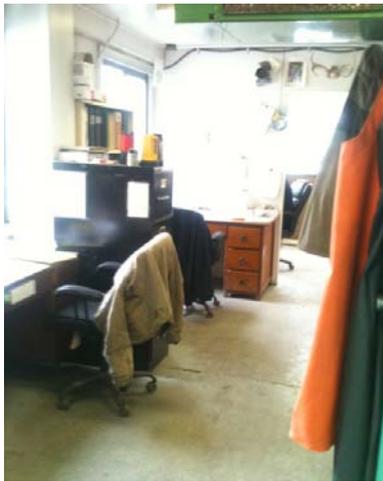
**Office**

**Office areas:** Casework furniture and other FFE items in this area are past their useful life and should be replaced. Most of the circuits in this area of the hatchery are composed of single conductors in EMT. There is some NM cable for more recently installed equipment. The control circuits utilize open cables that are in poor condition and should be replaced. Although convenience receptacles are scattered through most of the rooms, many key locations are without such as evidenced by the number of extension cords routed around rooms and plug strips. The system of receptacles and corresponding circuits is in poor condition. The lighting includes linear fixtures with T12 lamps and wrap around acrylic lenses mounted to the ceiling surface (some of the lenses are missing or broken). Some small areas are illuminated with open incandescent lamps. All lighting is controlled with manually operated wall switches. The lighting is in poor condition.

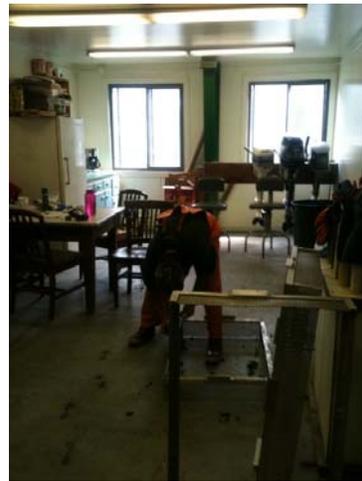
**Breakroom**

**Break Room:** Breakroom is presently used for a variety of purposes- as a workroom, small engine storage and electronic repair. The conflicting uses create conditions difficult to manage. It is suggested that the spaces be re-programmed to subdivide the spaces and create a more defined break room, possibly with its own entrance and divesting area. One way to accomplish this would be to convert the adjacent, sockeye incubation room into a work room. Break room furnishings are past their useful life are unsanitary and should be replaced. It is suggested that plumbing be provided in the break room for a handwash sink.

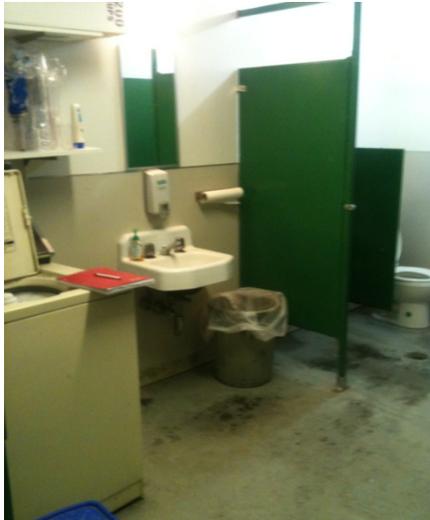
**Toilet Room**

**Toilet:** Only one toilet is provided in the hatchery building and appears to be the only toilet provided at the facility outside of the residences. The toilet is collocated with the laundry area and janitor space and separated only by a metal toilet partition. Toilet area, since it is used by both genders, should be afforded more privacy. It should also be located in closer proximity to an outside door to make it more accessible to workers without forcing individuals to walk through the main hatchery area in order to use the toilet. All surfaces are past their useful life and should be replaced in this area, with separate areas provided for laundry and janitorial functions.

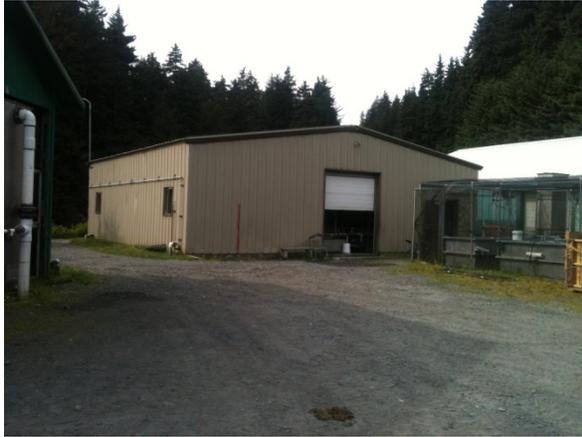
Incubation Building

**Incubation Building:** Single-story 40' x 42' steel structure with steel roofing and siding built in 1989. The foundation is a reinforced concrete slab with thickened perimeter footing and foundation pads under columns. Interior spaces are finished with FRP wall panels. Building is in very poor condition and should be replaced.

**Structural:** The structure is a pre-engineered steel building. The steel columns, roof beams, and roof purlins all are corroded. The corrosion is significant enough that the structure should be demolished and replaced.

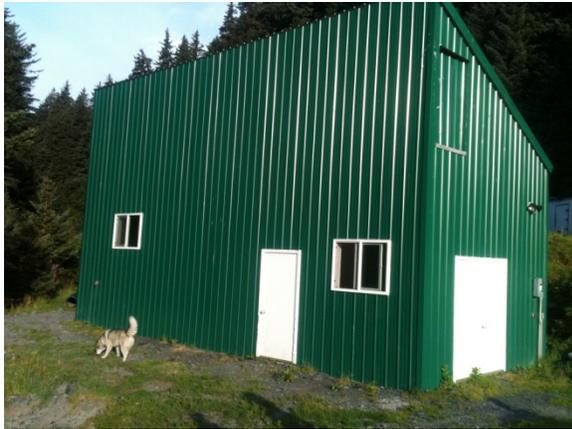
**Egg take building**

The building is in good condition. To help support long term maintenance, it is suggested that additional sealant be applied at window sills and transition between sill and metal siding to prevent water from entering wall assembly. It is also suggested that additional grade adjustment take place at high side of building to prevent water from entering at floor slab level.

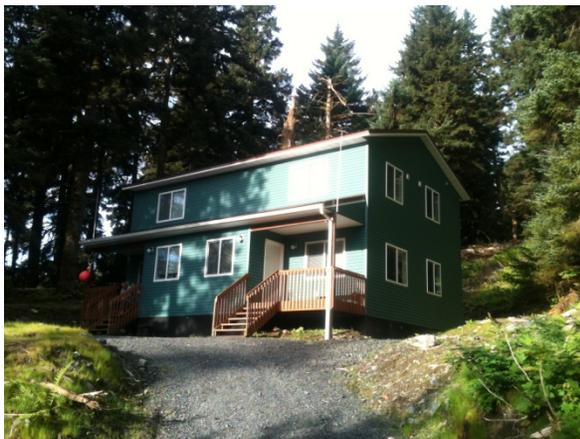
**Duplex Residence**

Water leaks into the existing crawl space due to groundwater oozing into the lowered space from the uphill slope.

Suggest following procedure to reduce moisture intrusion:

Re-grade surfaces surrounding the building to ensure that surface water is redirected away from the building;

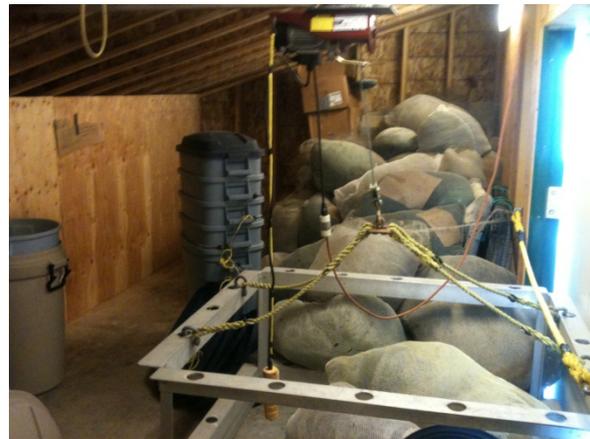
**Mezzanine Storage**

Mezzanine storage area reached by ladder. If the mezzanine is considered an occupied space, it must have a stair. Opening through floor for ladder is not guarded by an operable guardrail. Suggest installing an operable guardrail at the stair opening.

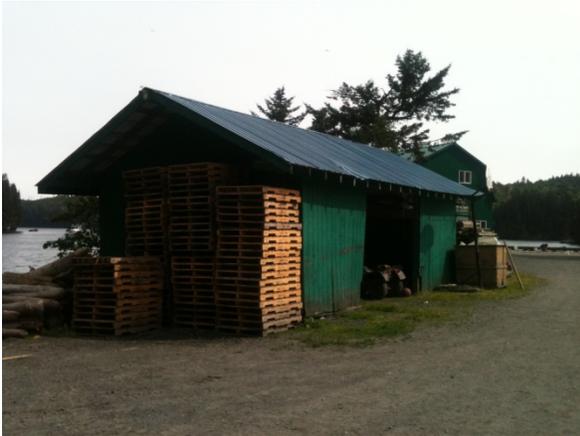
**Storage Building**

The high bay storage building used for storage of floats and other in water related equipment as well as uplands equipment, located on the east end of the site. It has no foundations, insulation, structural connections, lateral or seismic tie downs. There is dryrot and deterioration present in siding and structure. The existing structure is unsafe- lacks any sort of structural integrity, no seismic stability. It should be demolished and replaced as a life safety risk. It should be replaced with a new storage structure, perhaps in conjunction with other planned building projects on the site which could lead to greater efficiency while providing the necessary dry storage.

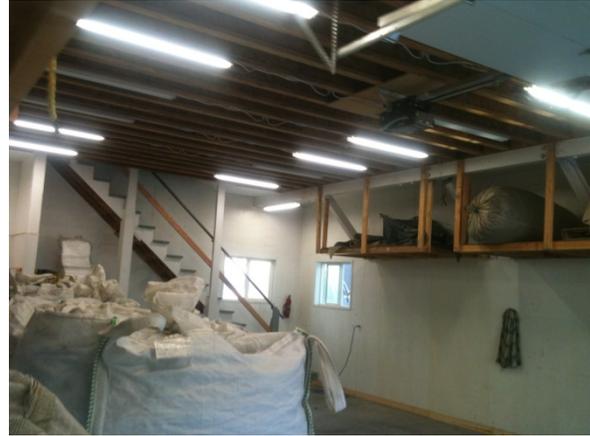
**Stairs**

Stairs are 11" treads, 9" risers, railings consist of two rails. Floor to floor is 13'-6", stairs are a single run greater than 11' high. Because the space upstairs is used as a recreation occupancy and overflow bunkhouse, it needs two exits and a code compliant stair. It may remain as-is if used only as non-occupied storage space.

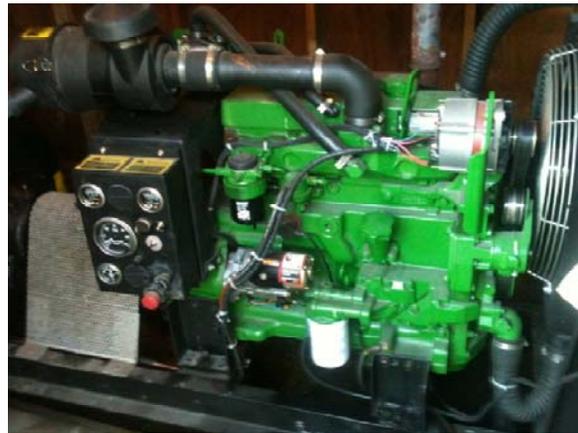
**Saltwater Pump**

The recessed concrete slab floor is below level of adjacent grade, which could allow seasonal leaks to damage sensitive electronics for the pump and engine controls. No insulation is provided in the structure, and while it is not necessary to heat the building, it would be preferred to insulate the building to reduce potential temperature swings that can cause condensation. The structure is indeterminate, no seismic provisions or hold downs provided. The double doors providing entry to the building are worn out and do not close properly. The bears at the site could easily enter the building, and damage the contents.

Dryrot is occurring at framing and siding at the base of walls. Roofing is at the end of its useful life. Given the number of concerns with this building, it is suggested that the existing wood framed structure be replaced with a low maintenance, galvanized storage structure.

Whether or not the building is replaced, the fuel system should be improved as described in preceding sections, and the engine exhaust system should be upgraded. Specifically, the exhaust pipe wall penetration should be replaced with an insulated thimble and the exhaust pipe hangars

should be replaced with thermally-insulated material that prevents conduction of heat to combustible materials.

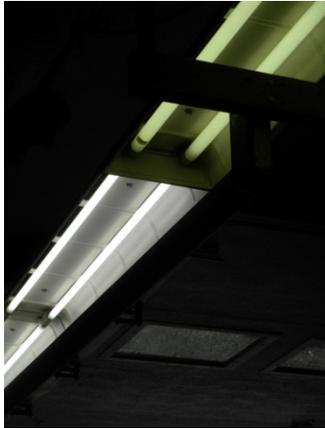
**Area Lighting:** "Barnyard" type fixtures with mercury vapor lamps are installed on steel pipes in several locations illuminating some of the pathways between buildings. These fixtures are in poor condition and should be replaced soon. The lighting should be evaluated and repositioned to better illuminate the pathways for safety. The illumination may be limited to low levels, but the uniformity needs to be greatly improved. Fixtures utilizing LED sources should be considered for the best energy economy. Controls increasing the illumination levels from low to bright when motion is sensed may be included. The replacement of the area lighting should also include replacement of all of the circuits utilizing new underground cables.
