Alaska Center for Children and Adults - ACCA Facility Upgrade and Expansion

FACILITY UPGRADE AND EXPANSION FAIRBANKS, ALASKA

Bettisworth North Architects and Planners has been requested by the Foraker Group to perform a facility assessment of the two buildings mentioned above. The assessment will focus on the existing conditions and identify deficiencies affecting the facility operations, durability, and code compliance. This assessment has been organized to present the existing conditions, report the observed problems, and document the proposed upgrades. Options for renovating and providing additional area have also been created in concept form and included in this report. This report, included in the following pages, shall assist both ACCA and the Foraker Group in planning facility improvement projects or plan for new additions to accommodate a growth in the ACCA program and related space needs.

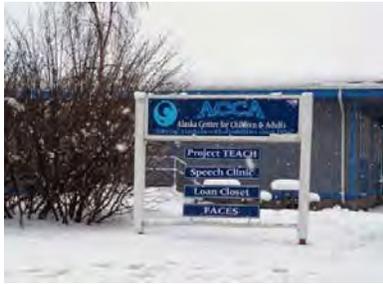
Building Signage

4. Building signage is located on the northeast side of building facing traffic on Barnette Street.

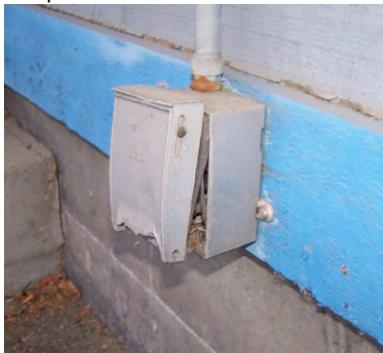
Engine Block Heater Outlets

6. Engine block heaters are provided and are residential grade weatherproof units. Many of the protective covers have been broken or are missing.

1. The addition of sidewalks serving the parking lot would greatly improve access to building.
2. We recommend removing monument planter to improve safety and access of vehicle and pedestrian routes to the building.
3. Landscaping between building and parking would soften the look at the entry and could help reduce heat gain in the summer months by shading the west windows.
4. Building signage at the front entry would improve wayfinding and visibility for the community.
5. Removal of the existing storage shed and providing indoor conditioned storage for holding overflow from equipment loan program would make access to this equipment more convenient, as well as extend the life of the equipment.
6. Replacement of engine block heaters with new GFI type weatherproof units.

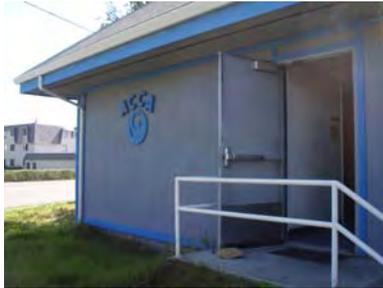
Natural Ventilation

1. Reports of high interior temperatures during the summer months inside the facility are an indication of possible venting problems and lack of insulation in the roof. While both the soffit and gable end vents are present, there is no ridge venting to allow excess heat to leave the attic space. This should be further investigated to determine how shear walls were provided in the attic space.

1. The complete removal and replacement of the existing asphalt roof with new asphalt or metal panel roofing material. Shingles with a similar reflectance or metal panel would be recommended. Additional ridge venting should be installed during this process if determined to be required, to reduce heat gain in the building.
2. While the windows are not in need of replacement, it is advised that they be a part of any major renovation or addition to improve their energy efficiency and match any new work.
3. Close off existing crawl space vents with concrete block to match. This needs to be done in conjunction with the addition of conditioned air in the crawl space.
4. Adjust existing exterior doors to ensure proper function and seal.

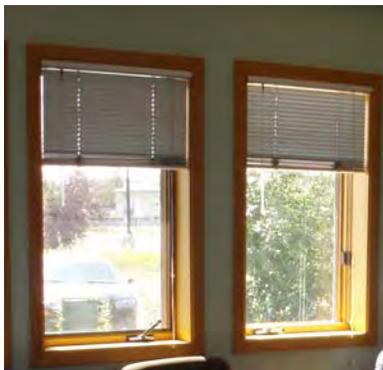
Original Windows

3. Windows in the facility are in reasonable condition, but are 20+ years old. New windows on the market are much more energy efficient and would require much less maintenance.

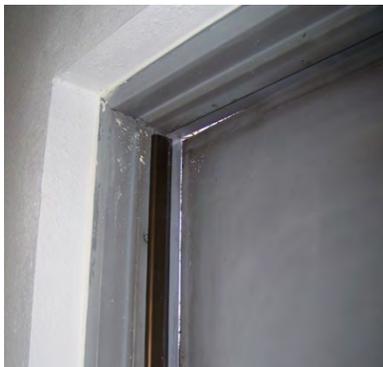
Racked Door

4. Secondary exterior doors need adjustment to close and seal properly. Some of these doors are racked or twisted and other are in need of adjustment at the hinges. At the time of the survey, several were leaking conditioned air to the exterior.

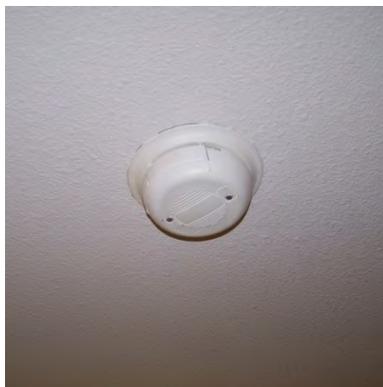
Smoke Detector

2. There is no automatic fire suppression system in the building, and many of the smoke detectors have been disabled. This creates a life safety issue for the staff and clients.

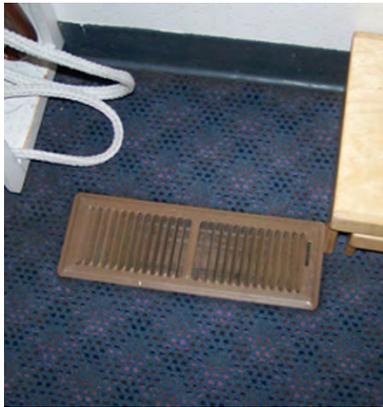
Air Ducts

3. There are reports of poor air quality (“stuffy”) in the building and poor ventilation. Fresh air ducts are using old forced air ducting system with registers at the floor level. This does not allow fresh air to properly circulate in the room.

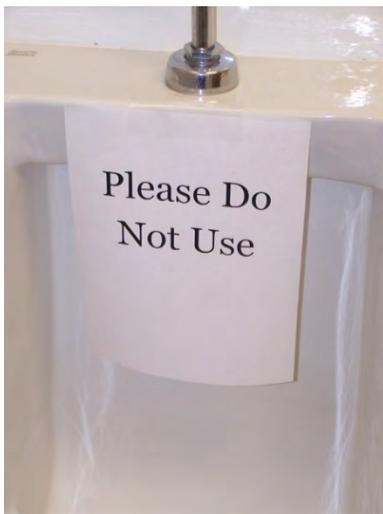
Men's Toilet Room

4. Men's Toilet Room: The urinal is out of order and facilities do not meet ADA/ANSI guidelines for clearances. UBC 1997 Plumbing code requires two (2) fixtures each for men and women's toilet rooms in B occupancies over 16 people.

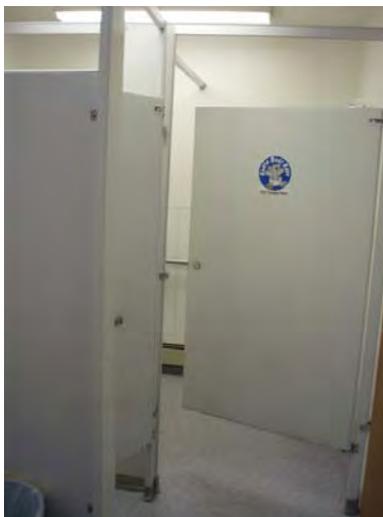
Women's Toilet Room

5. Women's Toilet Room: The door swing on ADA stall is not code compliant. The swing is in the wrong direction.

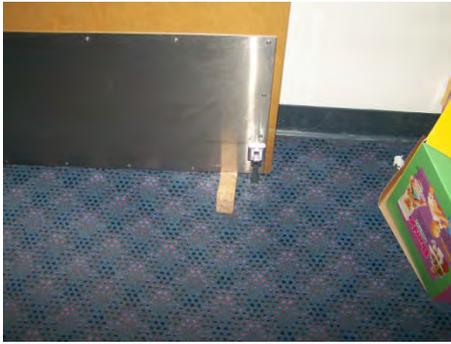
Door Stop

6. Interior doors and hardware need adjustment to operate properly. This includes door leaf seal, closure pressure and door stops.

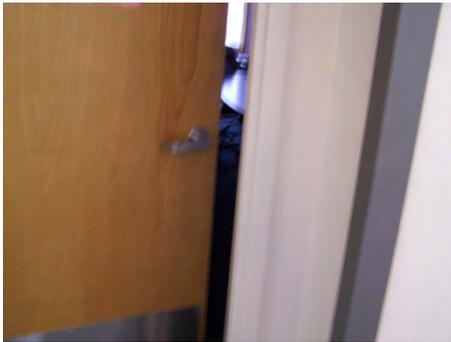
Door Swing/Clearance

7. Seven (7) doors in the facility do not meet the ADA/ANSI accessibility guidelines for clearances.

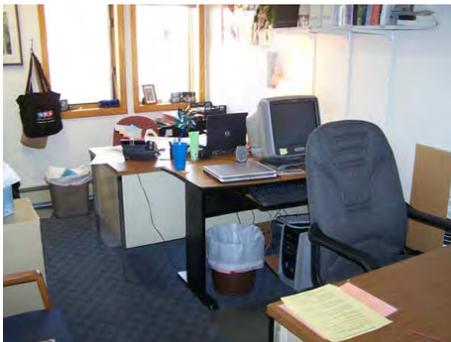
Typical Office Layout

8. Current office furniture is not appropriate for spaces, making it problematic for laying out office spaces for most efficient work space and storage. Most of the existing offices are 120 -140 sq. ft. and are being used by two staff members.

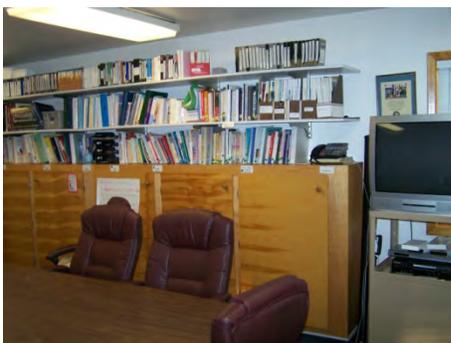
Conference Room Storage

9. The original storage room on the main floor of the facility has been converted into an office, eliminating any designated file storage or general office storage space in the facility.

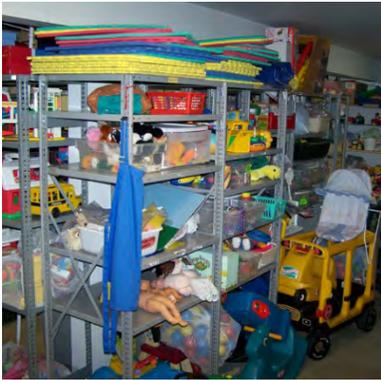
Equipment Loan Storage

10. Equipment loan program and toy storage has no designated space or appropriate storage system and is disconnected from appropriate sink for cleaning of toys after use. Storage is currently in basement and is difficult to access.

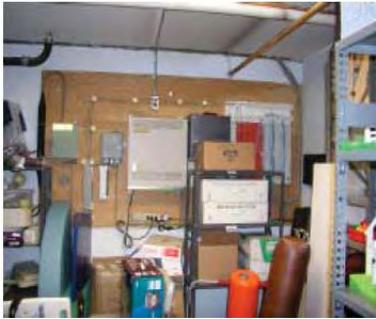
Telecommunications/Internet Equipment

5. No carbon monoxide detectors are present within the facility. The user indicated that during cold winter days they often smelled car exhaust brought in by their air intake system.
6. Telecommunications and Internet Access:
 - a. The area in front of the equipment is cluttered with storage items, which violates NEC working space requirements.
 - b. Discussion with the user indicates that the telephone system includes a paging function, and they are satisfied with the system that they have.
 - c. Discussion with the user indicates that they have subscribed to a wireless service, to include a wireless network within the facility, and are satisfied with the service and system that they have.

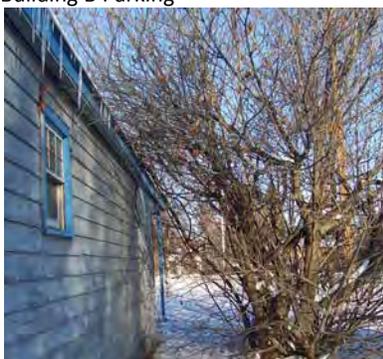
Building B Trees on East Side

1. Existing handicap ramp does not have a protective cover. IBC requires that ramps not be allowed to collect rain or snow.
2. Entry is not ADA accessible. ADAAG requires surfaces to be stable firm and slip resistant. The pea gravel at the entry does not meet this criteria.
3. There is no accessible route between the parking area and the building entry. The gravel parking lot has signs of puddling that should also be graded out.
4. Trees on east side of building have overgrown and are damaging siding.

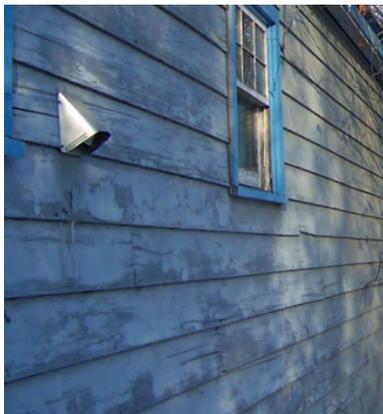
Building B Peeling Paint

2. Siding: Lap siding on original building has extensive peeling paint problems and dry rot. The siding on the west side of the facility was replaced over the summer of 2009. Siding on the ATCO units is becoming oxidized and discolored.

6. Siding: Remove and replace all existing siding with new rough sawn plywood to match the ACCA facility. The addition of 4" of rigid foam insulation to achieve R-25 in the walls.

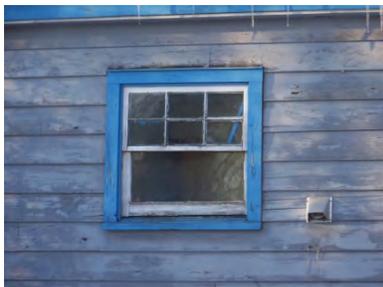
Building B Original Windows

3. Existing windows are original to facility and are in poor condition. Dry rot is evident on window trim and sills of original building. Also at areas around entry stairs on south side of building.

3. Replace all exterior doors new more energy efficient models, insulated metal frames and doors.
4. Windows: The existing wood and aluminum frame windows are inadequate. As part of any renovation project, these should be replaced with new fiberglass window units that have a U-rating of .25.

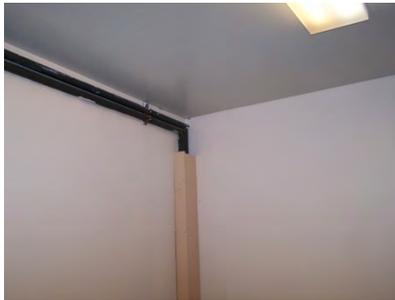
Building B Original Finishes

1. The interior is in poor condition, suffering from the result of poor craftsmanship in many areas throughout the facility. The addition of the ATCO unit section of the building and interior ramp creates an awkward transition between sections.

1. Prior to any work on removing finishes on the interior, there should be a hazmat assessment performed to determine locations of hazardous materials.
2. Renovate existing toilet rooms to accommodate ADA accessible toilet.
3. Remove existing original surfaces and replace with new finishes.

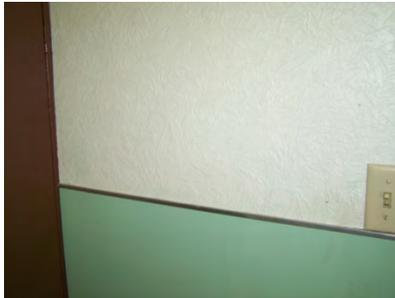
Building B Exposed Drywall

3. Walls: Paint is in reasonable condition in the original building and in the ATCO units. Underlying gypsum wall board is showing signs of wear. This would be in locations where finish looks original to building.

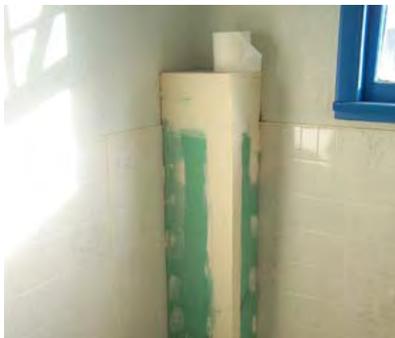
Building B Casework in Multipurpose Room

6. Casework and other finishes are a collection of items that are beginning to deteriorate.

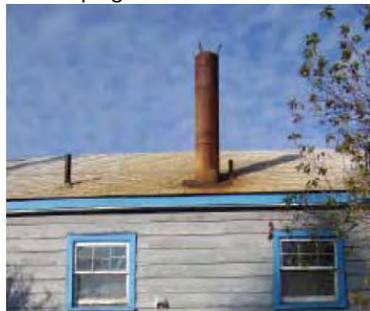
Boiler Stack

3. An old iron boiler stack was abandoned in place. Although it could not be confirmed, it appeared that the new boiler stack was routed within the abandoned stack. This situation should be inspected further to determine the exact construction and demolished if possible, as it provides a space for rain water to buildup and leak into the building.

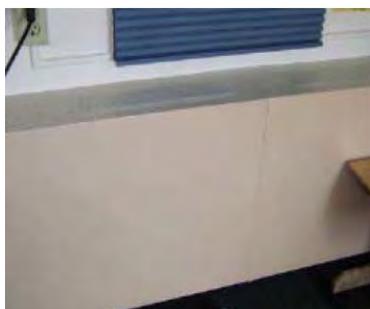
Wallpaper Covering Finned Tube Enclosure

4. Wallpaper has been installed over the finned tube enclosure, presumably to keep pencils and other materials from falling inside. Covering the vents interferes with proper operation of the radiators and dramatically reduces the heating capacity. The wall paper should be removed from the vents to ensure proper operation. Alternatively, the radiators could be replaced with sloped top enclosures to prevent persons from placing materials on top of the radiators.

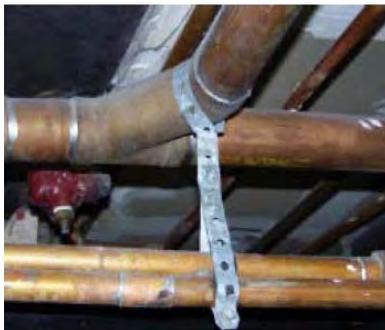
Improperly Supported Piping

1. Most of the hydronic piping is unsupported. The hydronic piping is not designed to support its weight and may result in failures, leaks or shortened life. Hydronic piping needs to be supported at regular intervals. For tubing that is 1-1/4" and smaller the maximum horizontal span should be 6 feet. Larger diameter tubing should have a maximum horizontal span of 10 feet. In both cases the maximum vertical span should be 10 feet. (IMC)

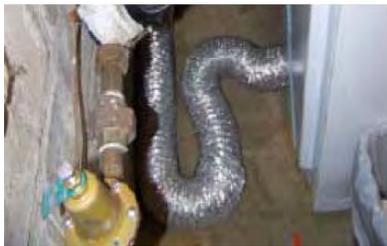
Flexible Dryer Duct

1. The dryer exhaust vent is noticeably crushed after the flexible run. The crushed section of the dryer vent should be replaced immediately. This situation increases the pressure in the duct and poses a potential fire hazard for the building.
2. The flexible duct on the dryer exhaust is excessively long and has several unnecessary bends. The flexible portion of the dryer exhaust duct should be shortened by cutting it so it does not have extra bends in the run.

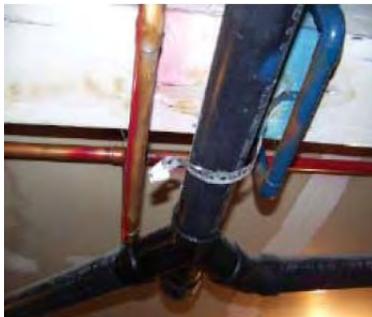
Failed Hanger Strap

1. A failed hanger strap has resulted in a low spot in the waste piping. Waste piping is required to maintain a constant slope for proper drainage. Replace the hanger strap to restore the sloping of the waste piping. The maximum span between supports for waste piping is 4 feet. Add additional straps as required. (UPC)
2. The domestic water service does not have a backflow preventer installed. Backflow preventers are required to prevent water from the building from entering the public water distribution mains. Install a backflow preventer on the domestic water service line entering the building. (IMC)

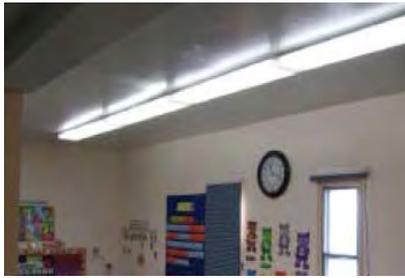
Fluorescent Fixtures

1. Lighting:
 - a. The fluorescent and incandescent fixtures are in fair to poor condition.
 - b. All of the lighting is manually switched and the switches are worn out. Concealed branch circuit wiring is likely to be Type NM cable, and along with visible device boxes may be in poor condition.
 - c. All of the exit signs are the self-illuminating type based on a radioactive isotope. The stenciled exit sign over the northeast doorway is a code violation.

1. Lighting:
 - a. The entire lighting system should be replaced with modern fluorescent fixtures for the main floor and the basement. While we did not discuss switching with the users, occupancy sensors can serve the facility.
