**Agency: Commerce, Community and Economic Development****Grants to Named Recipients (AS 37.05.316)****Grant Recipient: Pioneers of Alaska 19 Cordova Igloo****Federal Tax ID: 920100496****Project Title:****Project Type: Maintenance and Repairs**

# Pioneers of Alaska Igloo #19 - Igloo Building Preservation and Rehabilitation

This Condition Assessment Report with Recommendations for Treatment is intended to expand the Pioneer’s report and provide guidance following The Secretary of the Interior’s Standards for the Treatment of Historic Properties. The November 2011 inspection of the building included the site, crawl space, primary and secondary rooms, attic areas and the exterior elevations.

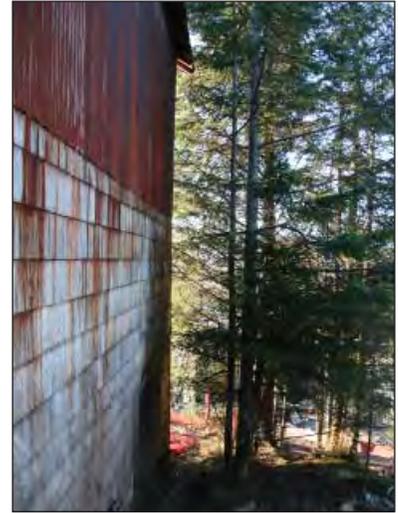
◀ The fire exit egress at the south elevation of the 1937 Frame Addition.

1. Trim or remove trees and vegetation with 3'-0" of building and foundation.
2. Remove debris and abandoned materials around the perimeter of the building.
3. Consider consulting with an historical architect to assist with the accessible route. It may be appropriate to have the historical architect coordinate as soon as possible with the design team at MRV Architects to incorporate the accessible ramp to the front of the Pioneer building. The elevated entry at the north elevation poses many challenges to successfully meet the American's with Disabilities Act of 1990 (ADA) without jeopardizing the historic appearance of the igloo building.
4. Consulting with the historical architect will aid in the effort to meet required handrail and landing areas required for an egress route. Neither meet code in the current configurations.

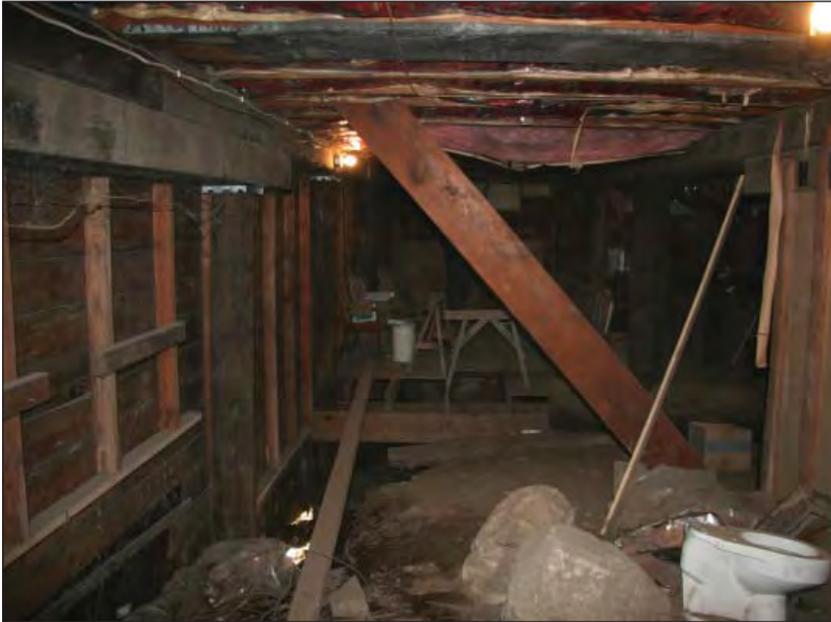
▲ A spliced column under the 1937 frame addition. The lower portions of many columns were replaced due to rot.

Most of the piles have received new bases presumably after it was discovered the portions in the ground had deteriorated. The original piles were cut level several feet above grade and a concrete footing was poured beneath. A new pile, often larger in diameter, was cut to fit and fastened with light gauge Simpson anchors. Some of the pilings may be pinned to the concrete pad.

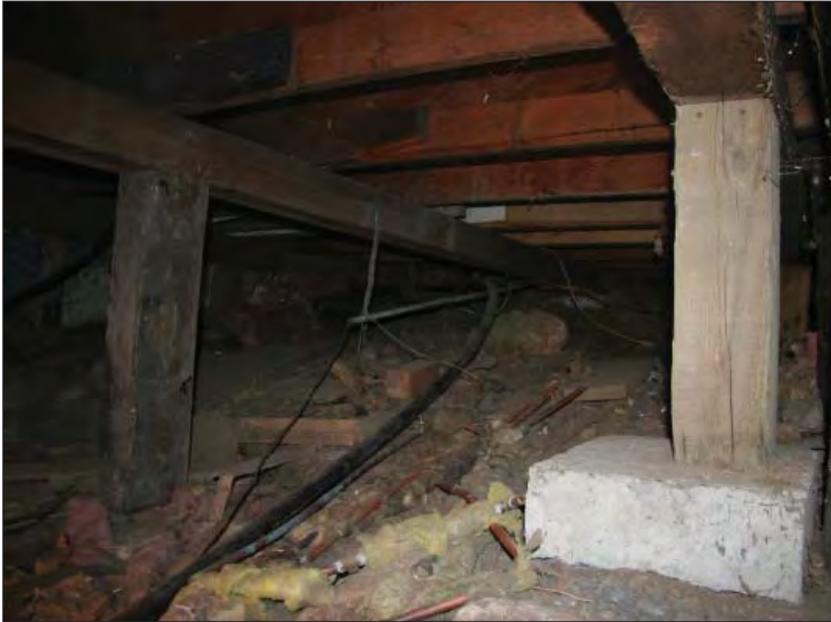
◀ The crawl space under the service addition is of post and beam construction to support the floor joists.

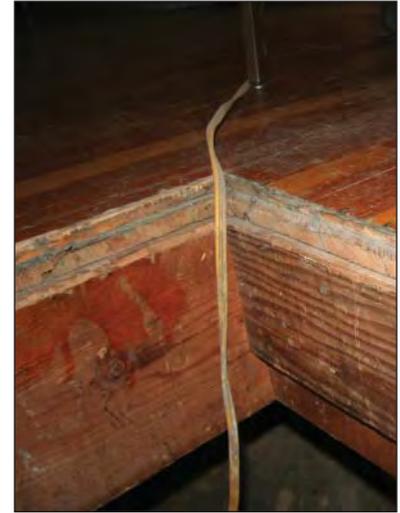
◀ The 1937 frame addition Douglas fir floor is original to the building and is well worn in some areas.

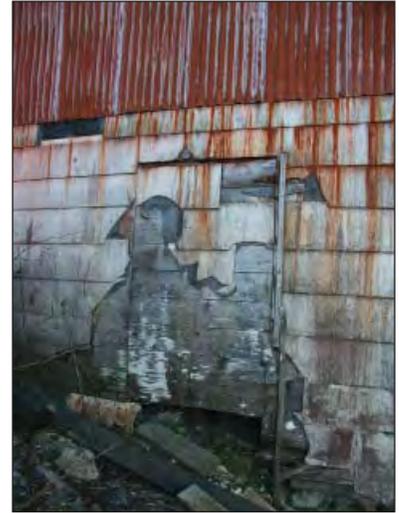
◀ The exterior of the service addition is clad in horizontal shiplap with multiple layers of paint. The vinyl window replaced an original wood frame window.

The exterior siding consists of plywood (oil tank shed) and painted ¾” x 7¼” horizontal shiplap siding. The foundation is skirted with untreated plywood.

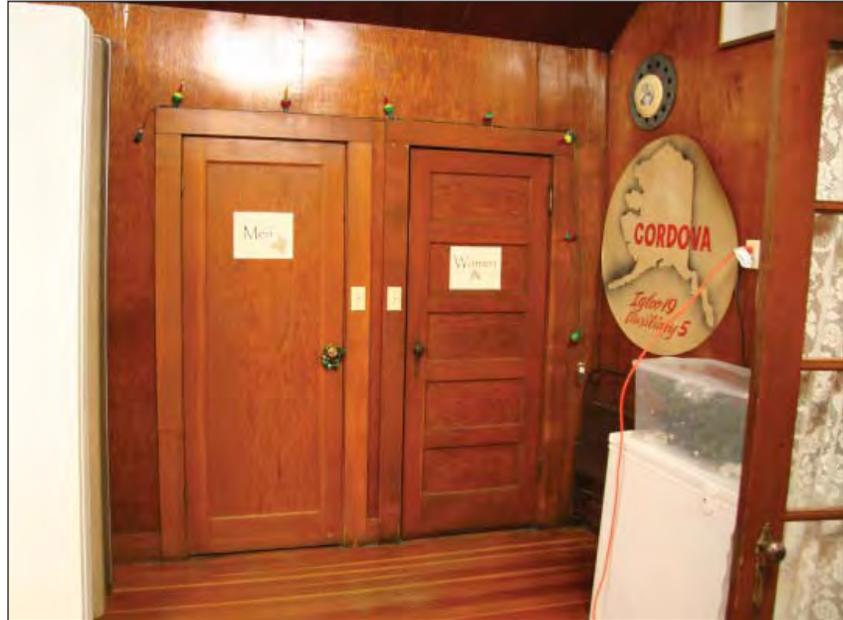
►  
The 5-panel wood sash door to the right is original to the building and retains its original hardware. The single panel door to the left is a replacement - its original may be in the crawl space of the 1937 frame addition.

The doors in general are in fair to good condition. The primary entrance door and opening have been altered. The infill at the exterior is comprised of dimensional lumber and at the interior, efforts were made to match the log appearance, but the vertical joint remains exposed. The metal rated door was likely changed following the deterioration of the original door or a code inspection. The interior doors are in good condition but some may not be original to the building.

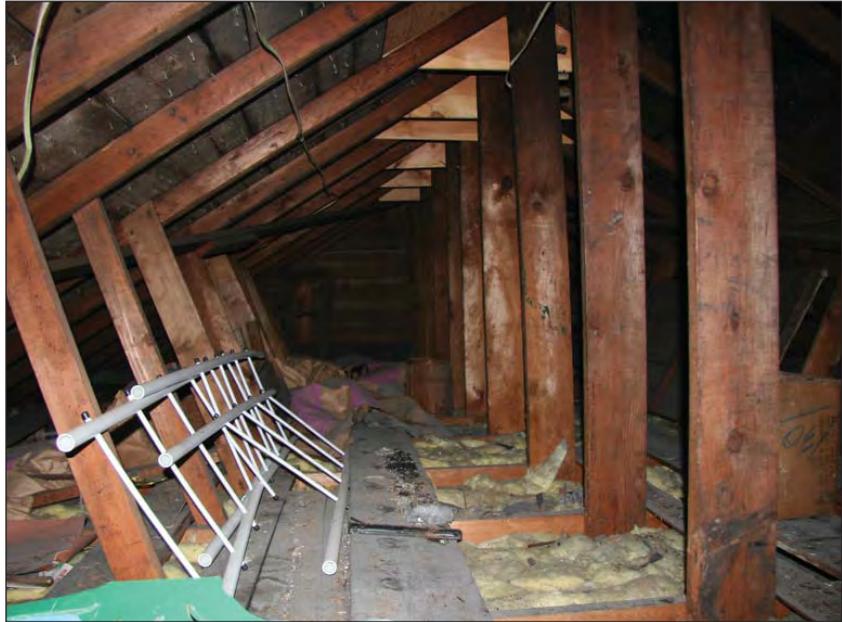
▲  
The roof penetration of the concrete masonry unit (CMU) chimney associated with the boiler in the crawl space of the 1937 frame addition failed and has caused damage to the interior sheathing.

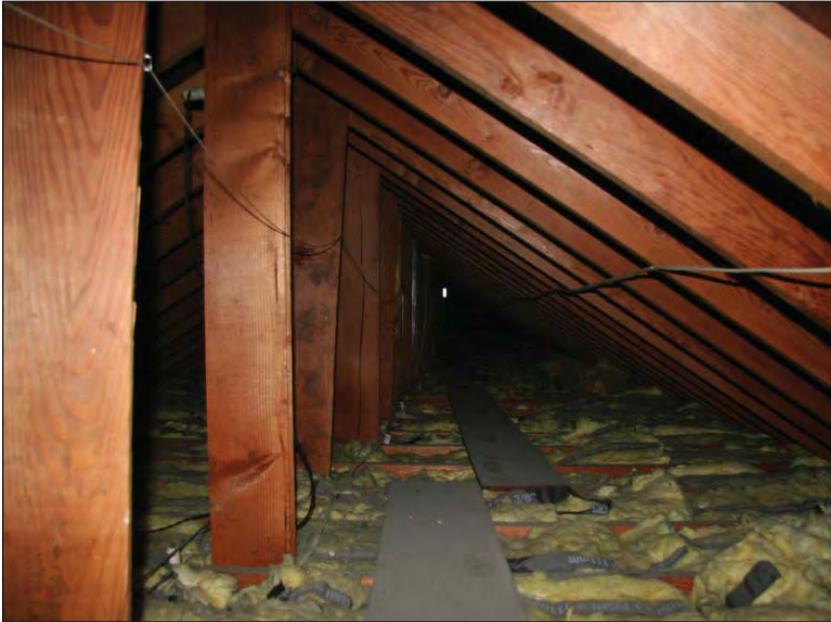
▲ The ridge connection of the 1937 frame addition.

Similar to the original section, the frame addition roof is in fair condition with no evidence of leaks or deflection. However, the member sizes and spacing may not meet current code for loading requirements.

The roof structure does not appear to be deflecting but the member size and spacing would likely be overstressed if calculations were computed. Some of the subroofing is cracked or missing and the inclusion of plywood to the roof assembly will improve the integrity.

2. Consider installing Grace Ice and Watershield over the plywood roof deck to improve the moisture control.
3. Review historic photographs to determine if the roof was clad in cedar shingles during the period of significance. If so, consider replacing the existing metal roof with cedar shingles to match original appearance. If cedar shingles are used, consider using a product such as Cedar Breather to allow air to circulate between the shingles and the bituminous membrane.

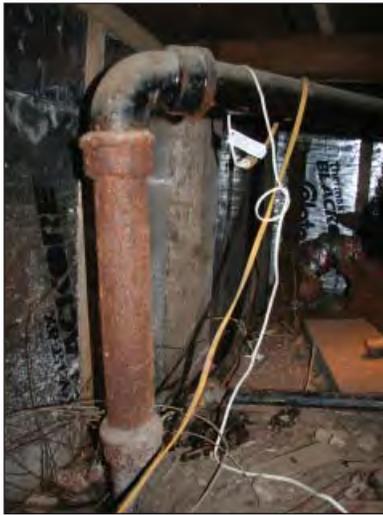
▲  
The sewer line beneath the service addition.

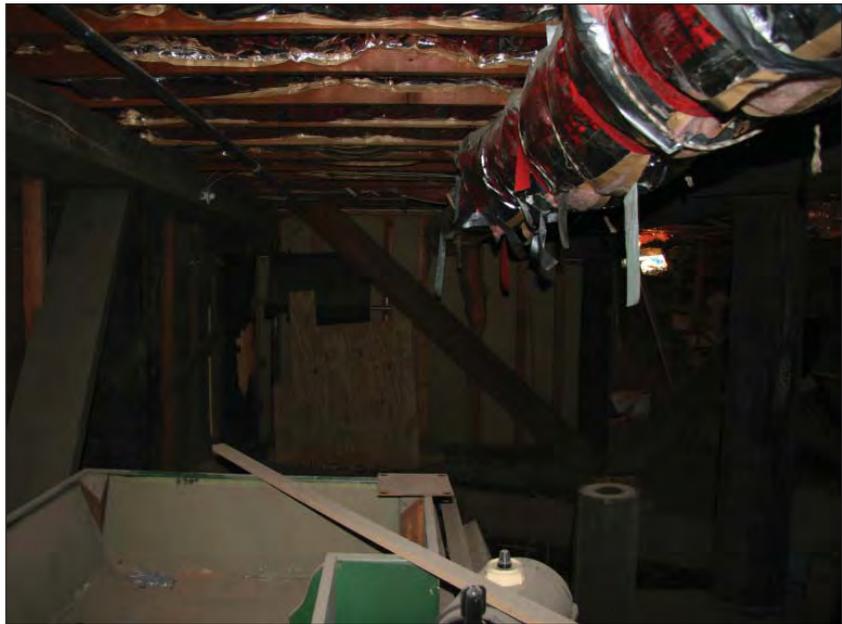
▶  
Abandoned insulated duct work from a forced air heating system in the crawl space of the 1937 frame addition.

1. Remove the abandoned forced air mechanical system and associated ducting. Carefully repair the holes in the floor where registers were located using in-kind materials.
2. Consider a “staple up” radiant floor system with foil backing. The design may include adding rigid insulation and plywood to the underside of joists to improve the performance. Consider consulting with a mechanical engineer or mechanical contractor for a system design.
3. Consider consulting with an historical architect and mechanical engineer to design a mechanical room in the “interstitial space” beneath the 1937 frame addition or the

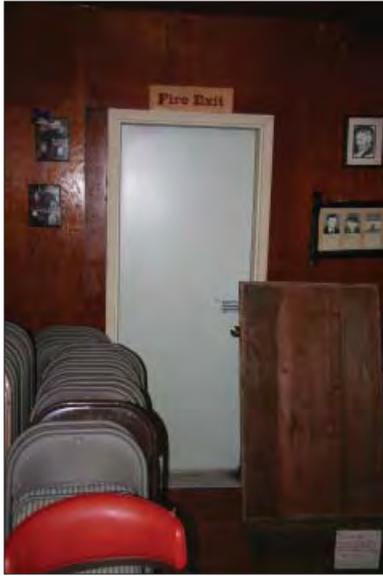
▲  
The secondary exit from the Igloo is located at the southeast corner of the 1937 frame addition.

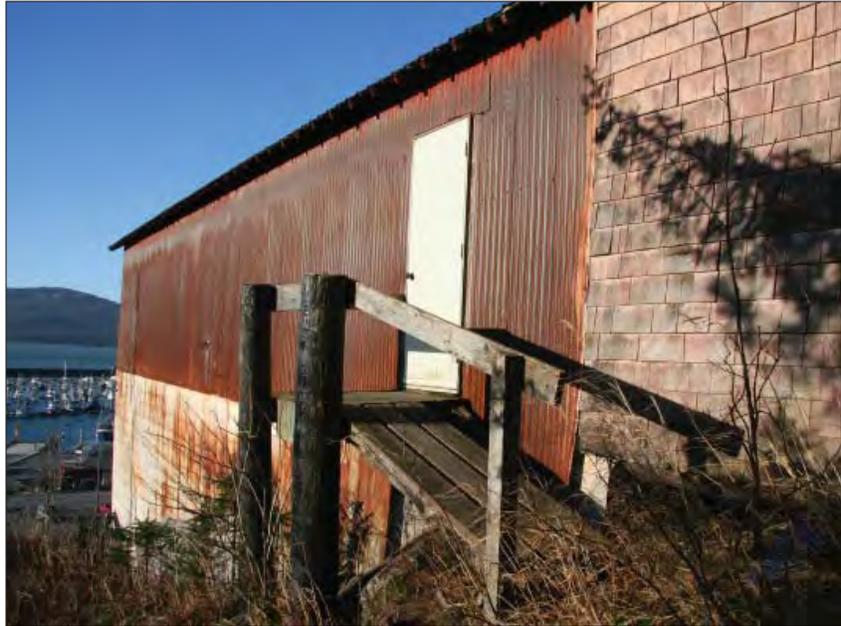
►  
The existing egress route configuration does not meet the building code and will require additional design work to comply.

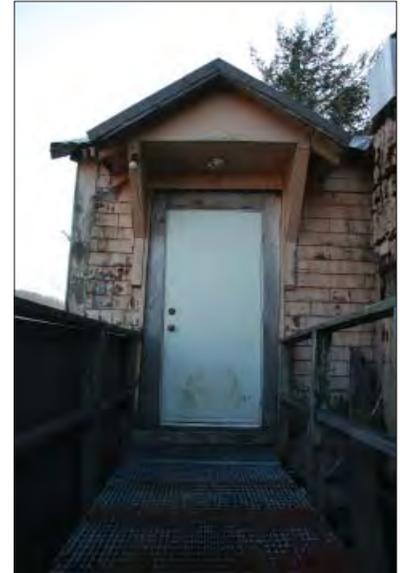
◀  
The elevated site of the Pioneer Igloo presents a challenge to meet accessibility requirements. Alternative solutions may be possible with additional studies.
