# Kodiak Regional Aquaculture Association - Pillar Creek Hatchery Upgrades

# PILLAR CREEK HATCHERY INSPECTION REPORT

Alaska Department of Fish and Game

March 2012

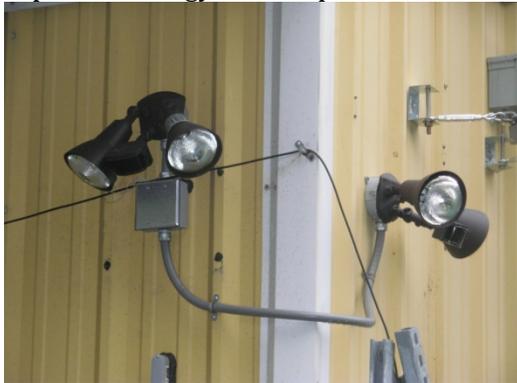
Exterior: Wall mounted incandescent floods with motion/daylight sensors. These luminaires are relatively new and in good condition. As lamps fail, they may be replaced with LED type for improved energy consumption and illumination.
