Yakutat - Ocean Cape Dock Major Maintenance

**ENGINEERS REPORT
SITKA SOUND SEAFOOD'S
PROCESSING PLANT
YAKUTAT, ALASKA**

Re: Yakutat Seafoods Process Building
Piling Inspection and Assessment

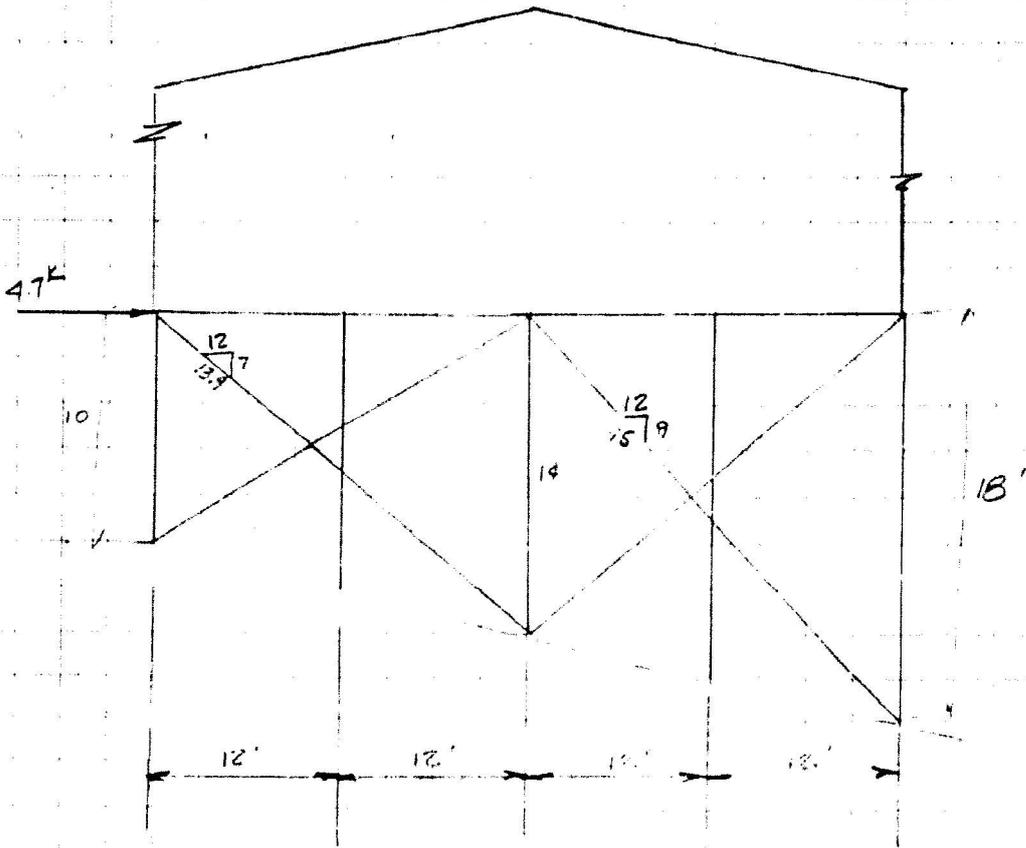
CHECK OF HORIZONTAL LOADS:

WIND LOAD - 27 psf x 35' HIGH = 945 #/LF.

@ 5' O.C., then, each row of piling has to resist $5 \times 945 = 4,725 \#$

THIS LOAD WILL BE DISTRIBUTED THROUGH 2 X-BRACCS
LETS TRY A 2X10 MEMBER:

THE X-BRACING WOULD BE ANALYZED AS A TENSION MEMBER
WITH ITS MAXIMUM CAPACITY EQUAL TO $F_L (1250 \text{ psi})$
if a 2X8 WOULD HAVE A CAPACITY OF $1.5 \times 7.5 \times 1250 = 14K$
